FIELD OBSERVATION REPORT – WEEK OF: 7/17/2023

Owner: Island Inn Condominium Association, Inc.

Project Address: 9980 Gulf Blvd., Treasure Island, FL 33706

Project No.: R2107-012

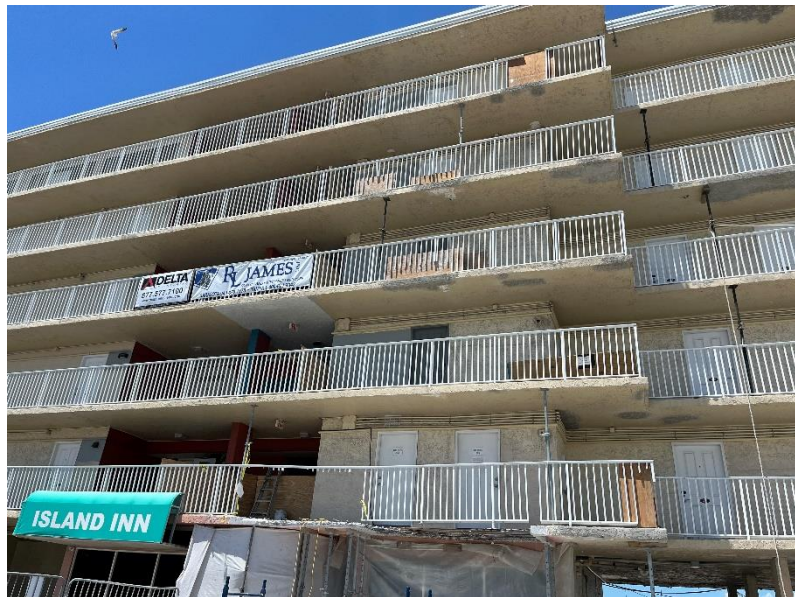
PHOTOGRAPH #1

ISLAND INN Overview

Overview of the progress of work.

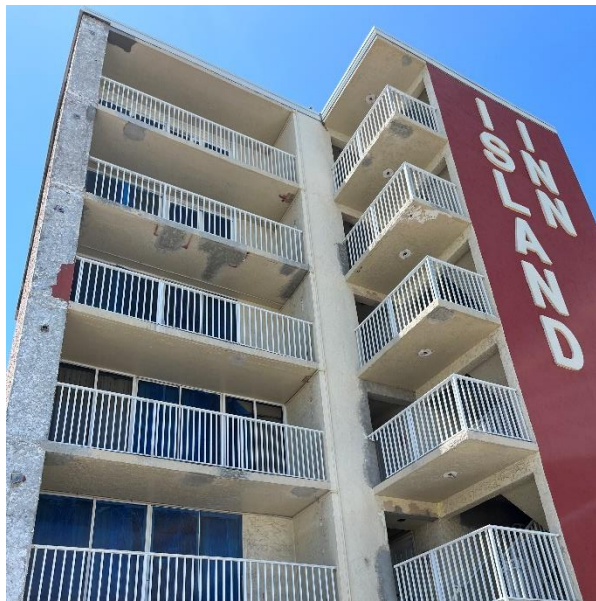
PHOTOGRAPH #2

ISLAND INN Overview

Overview of the progress of work.

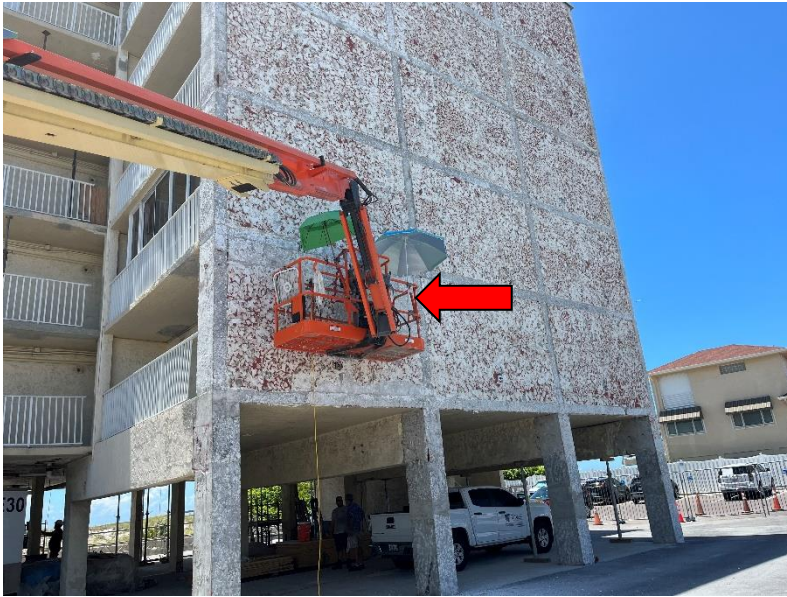
PHOTOGRAPH #3

**EAST ELEVATION
EXTERIOR WALL
Stone Removal**

Existing stone façade and mortar removal currently in progress at the exterior wall.

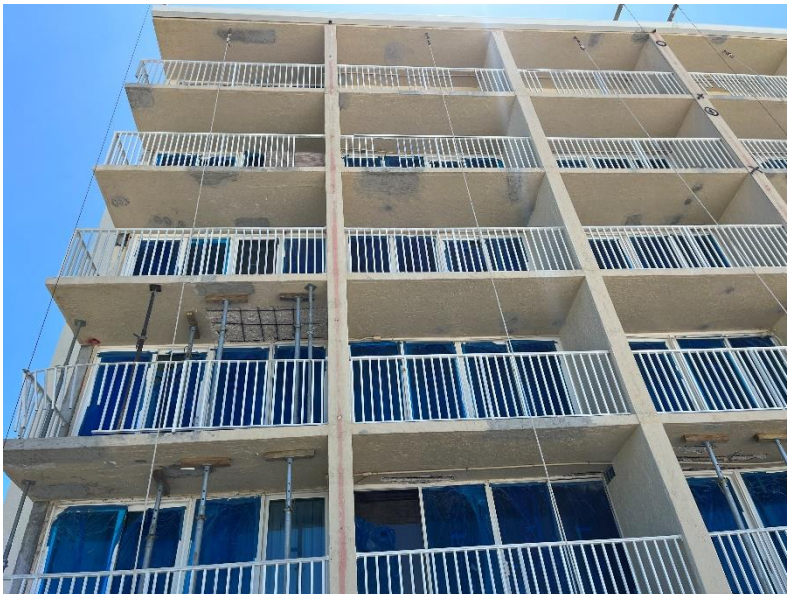
PHOTOGRAPH #4

1. Stucco damage was observed at various areas. Contractor has removed the debonded stucco and is currently performing stucco repairs (**Photographs #4, #5**).

**DROP #1 – REAR BALCONIES
Stucco Repairs**

Stucco repairs currently in progress at the rear balconies.

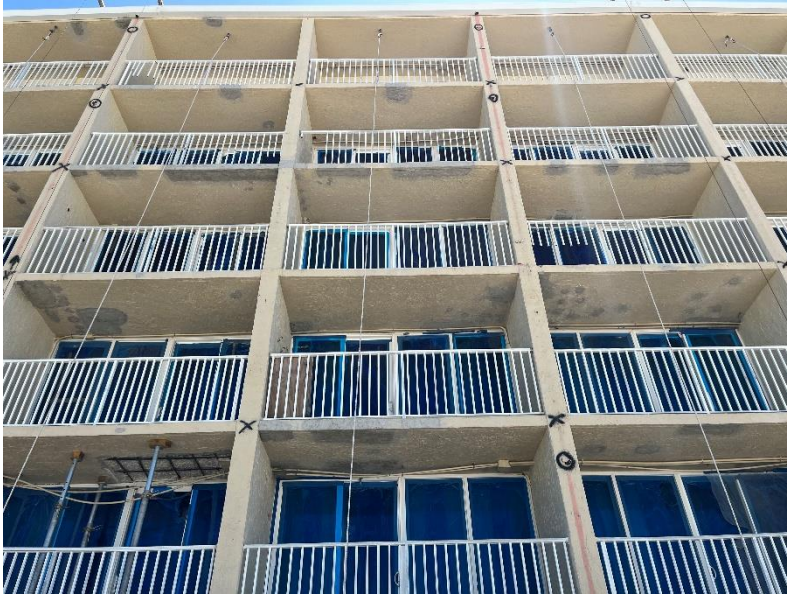
PHOTOGRAPH #5

DROP #2 – REAR BALCONIES
Stucco Repairs

Stucco repairs currently in progress at the rear balconies.

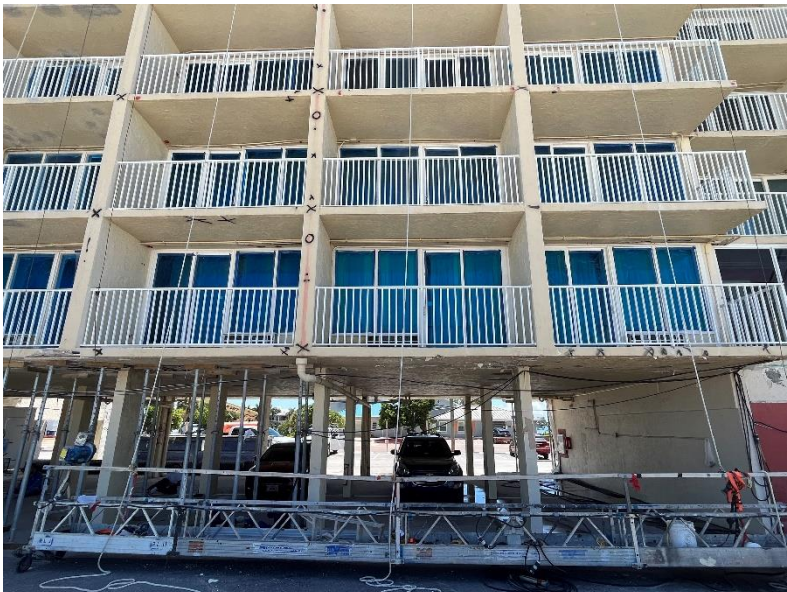
PHOTOGRAPH #6

DROP #3 – REAR BALCONIES
Concrete Repairs

Debonded concrete and stucco areas currently being marked at the rear balconies.

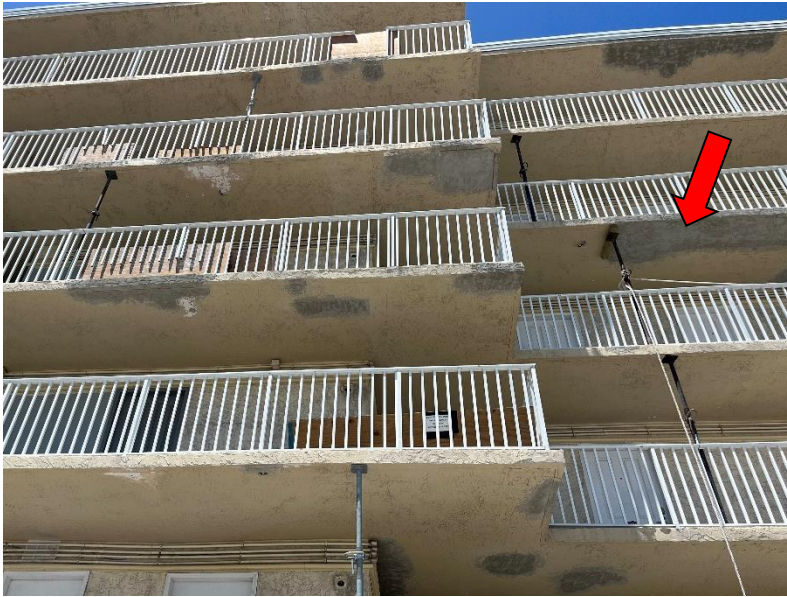
PHOTOGRAPH #7

**NORTH END WALKWAYS
Stucco Repairs**

Stucco repairs currently in progress at the rear balconies.

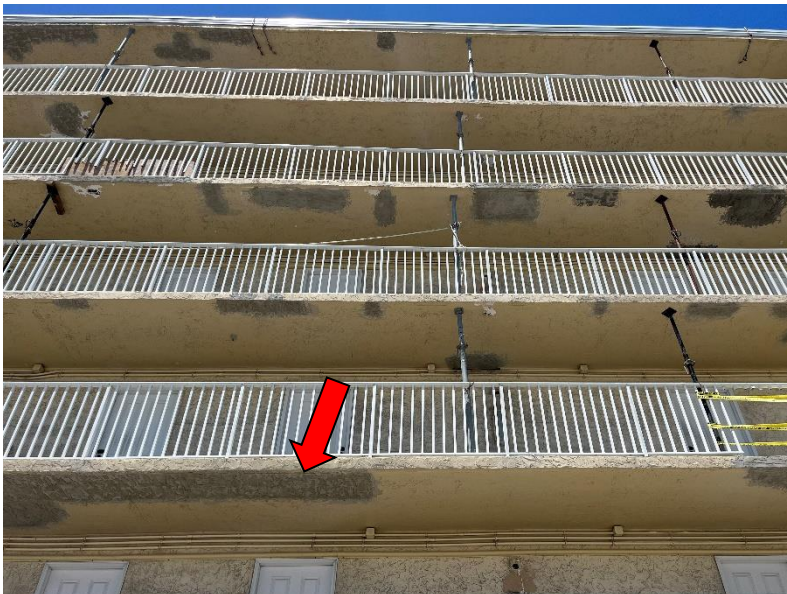
PHOTOGRAPH #8

**NORTH END WALKWAYS
Stucco Repairs**

Stucco repairs currently in progress at the rear balconies.

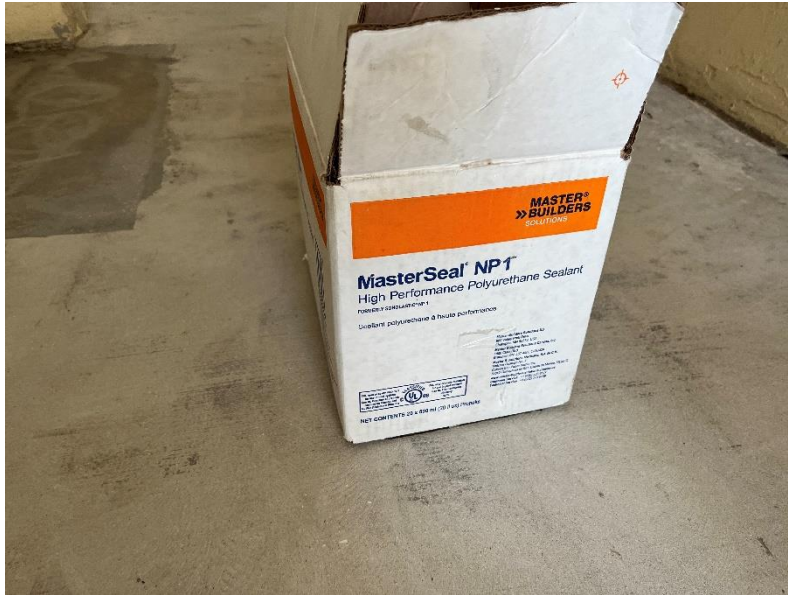
PHOTOGRAPH #9

**NORTH END WALKWAYS
Floor-to-Wall Cant Bead Mock-up**

MasterSeal NP1 polyurethane sealant used for the cant bead installation.

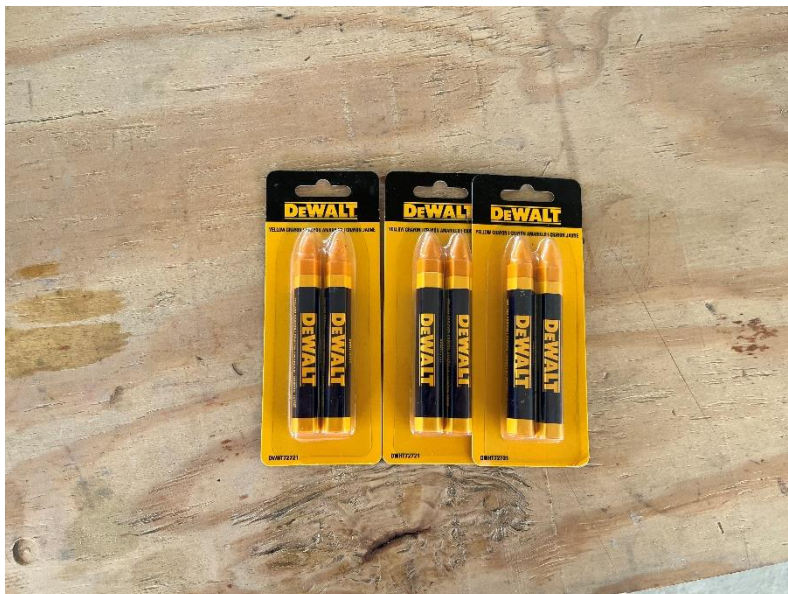
PHOTOGRAPH #10

**NORTH END WALKWAYS
Floor-to-Wall Cant Bead Mock-up**

DeWalt crayon wax used prior to cant bead installation as a bond breaker.

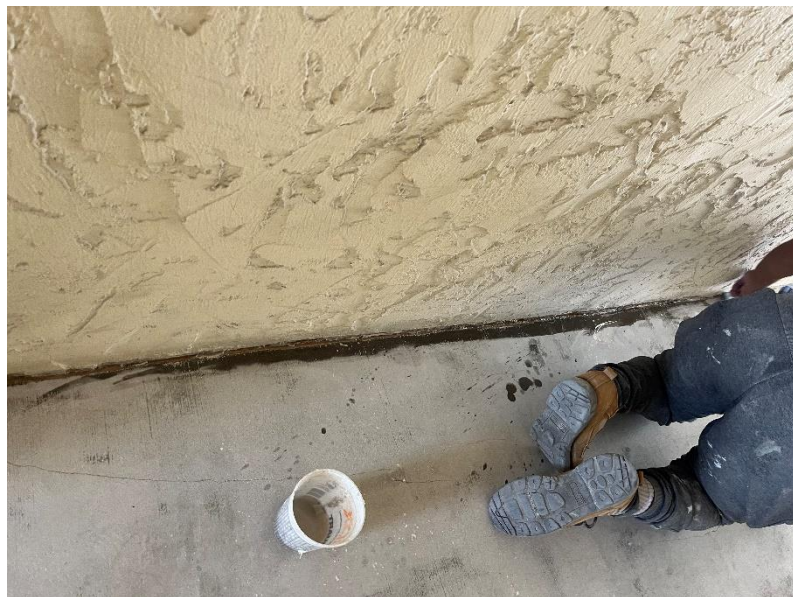
PHOTOGRAPH #11

**NORTH END WALKWAYS
Floor-to-Wall Cant Bead Mock-up**

Walkway decks cleared of dirt and debris and xylene applied at the floor-to-wall joint prior to cant bead installation.

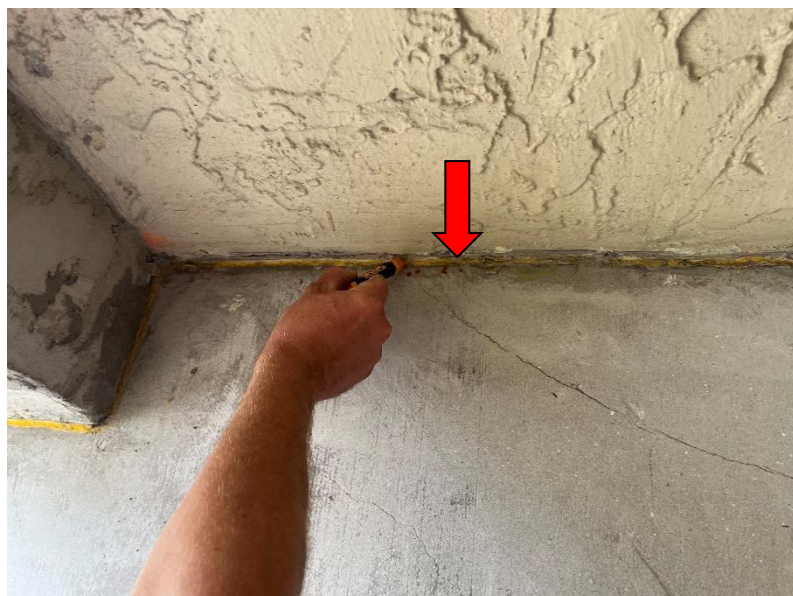
PHOTOGRAPH #12

**NORTH END WALKWAYS
Floor-to-Wall Cant Bead Mock-up**

DeWalt crayon wax used prior to cant bead installation as a bond breaker.

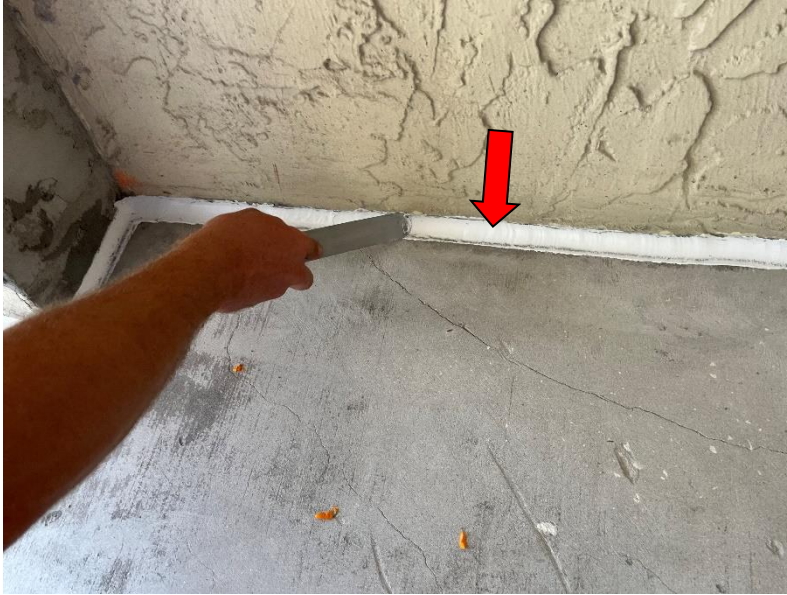
PHOTOGRAPH #13

**NORTH END WALKWAYS
Floor-to-Wall Cant Bead Mock-up**

MasterSeal NP1 polyurethane sealant applied and tooled at the floor-to-wall joint.

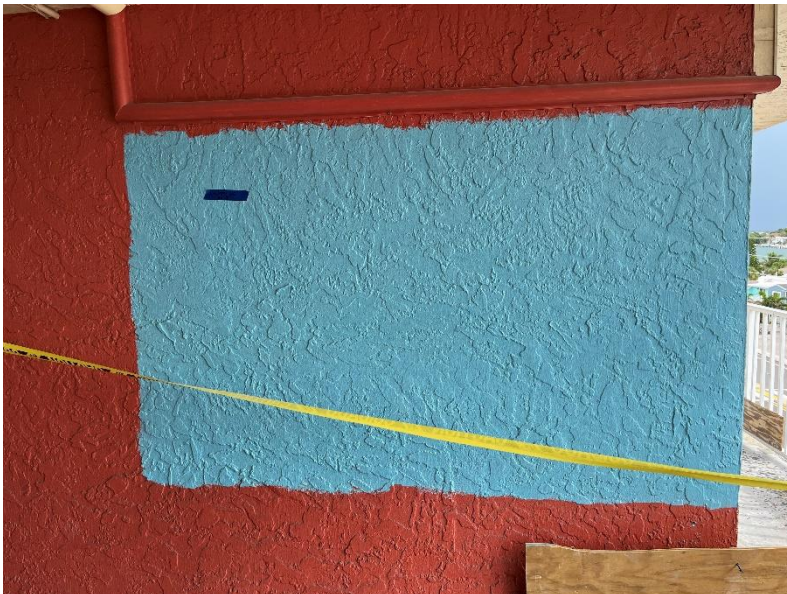
PHOTOGRAPH #14

**NORTH END WALKWAYS
Paint Coating Wall Samples**

The Association has chosen Manitou Blue as the exterior accent wall color, which currently has the existing reddish terracotta color.

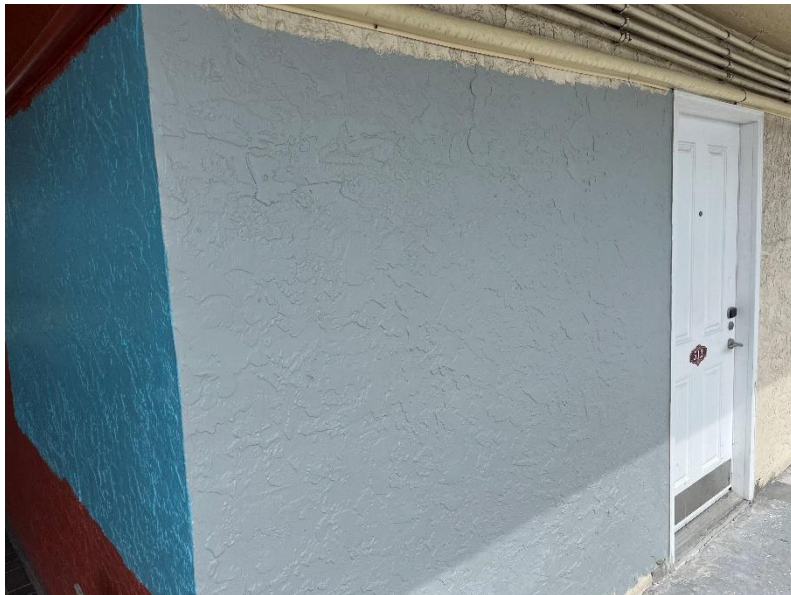
PHOTOGRAPH #15

NORTH END WALKWAYS
Paint Coating Wall Samples

The Association has chosen Grey Matters as the exterior body wall color, which currently has the existing tan color.

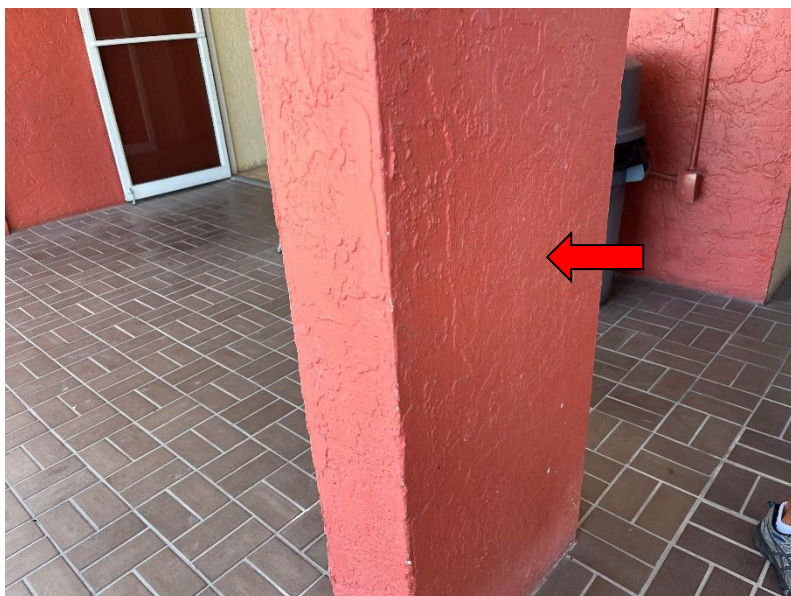
PHOTOGRAPH #16

NORTH END WALKWAYS
Paint Coating Wall Samples

The Association has chosen Manitou Blue as the exterior column color, which currently has the existing reddish terracotta color.

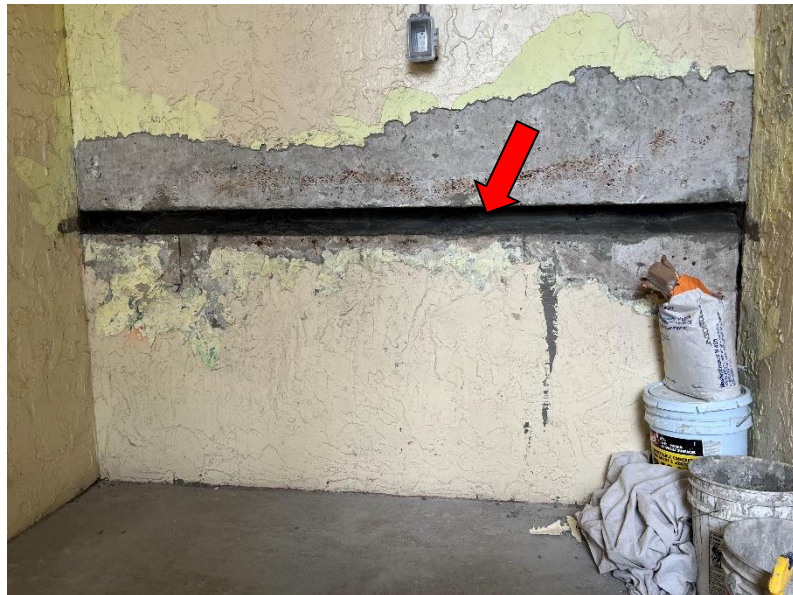
PHOTOGRAPH #17

**NORTH END STAIRCASE
Concrete Repairs**

MasterEmaco N425 currently being applied where damaged CMU block previously existed to fill the void in the wall.

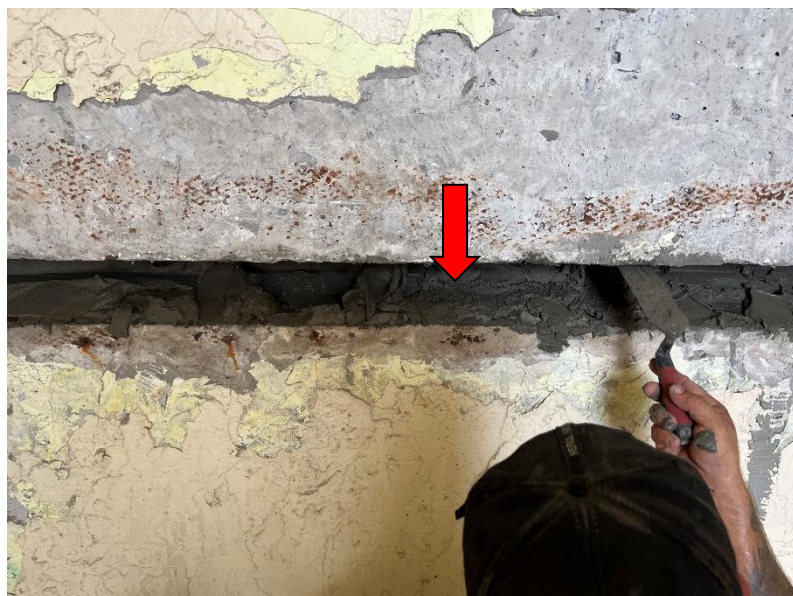
PHOTOGRAPH #18

**NORTH END STAIRCASE
Concrete Repairs**

MasterEmaco N425 currently being applied where damaged CMU block previously existed to fill the void in the wall.

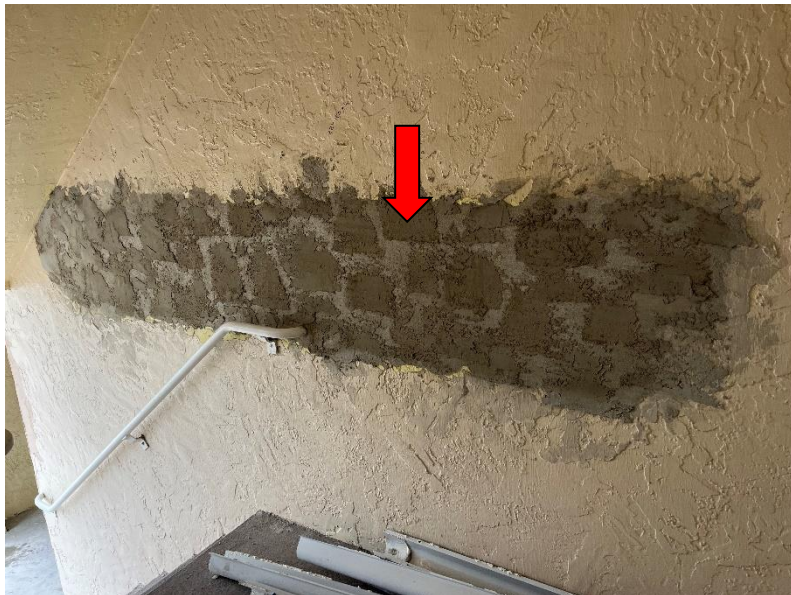
PHOTOGRAPH #19

NORTH END STAIRCASE
Stucco Repairs

Stucco finish coat applied at the previously damaged areas.

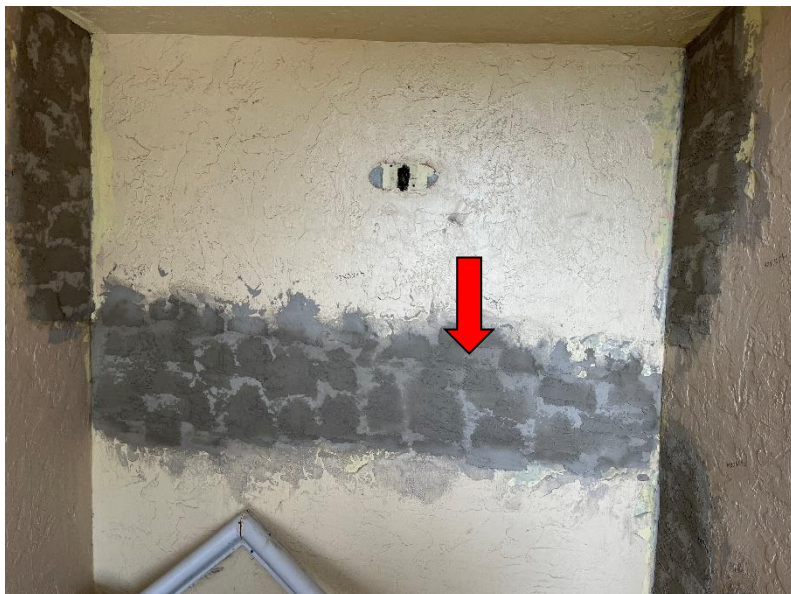
PHOTOGRAPH #20

NORTH END STAIRCASE
Stucco Repairs

Stucco finish coat applied at the previously damaged areas.

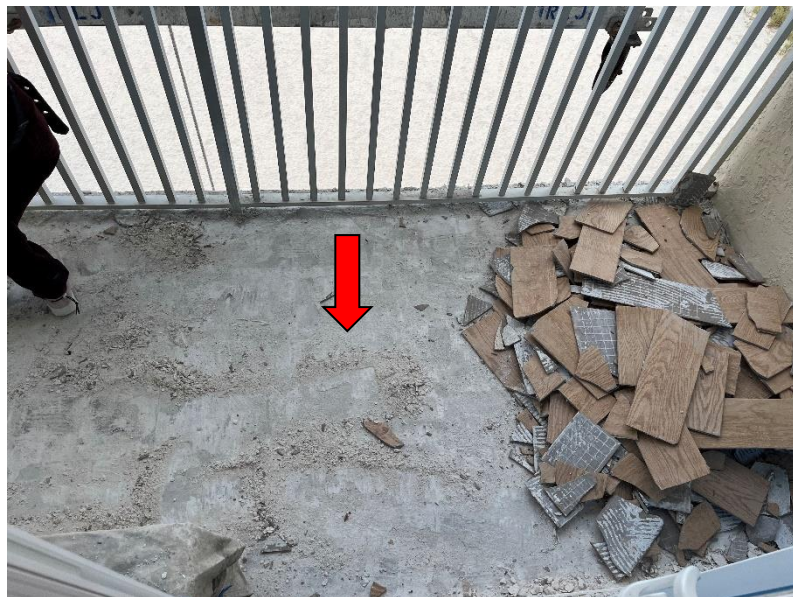
PHOTOGRAPH #21

UNIT #609
Balcony Tile Removal

Existing balcony tiles currently being chipped and removed from the rear balconies and disposed of in the dumpster.

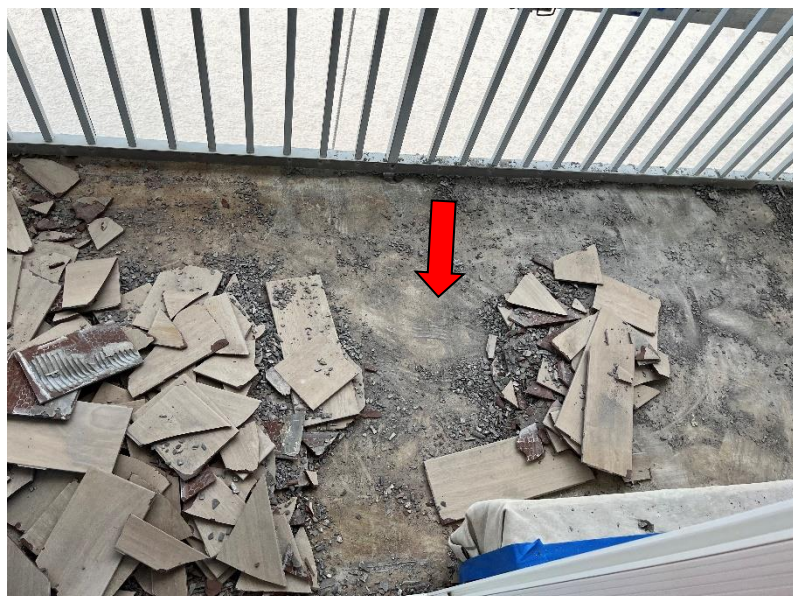
PHOTOGRAPH #22

UNIT #610
Balcony Tile Removal

Existing balcony tiles currently being chipped and removed from the rear balconies and disposed of in the dumpster.

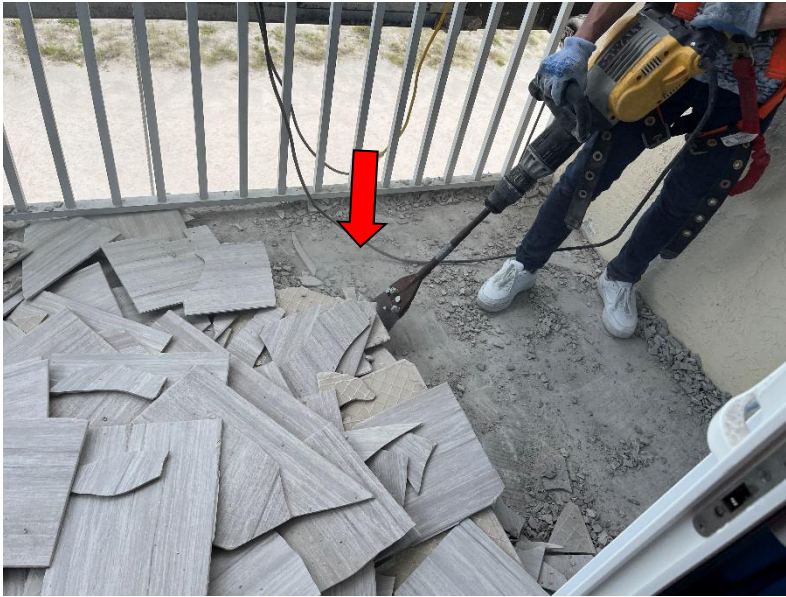
PHOTOGRAPH #23

UNIT #611
Balcony Tile Removal

Existing balcony tiles currently being chipped and removed from the rear balconies and disposed of in the dumpster.

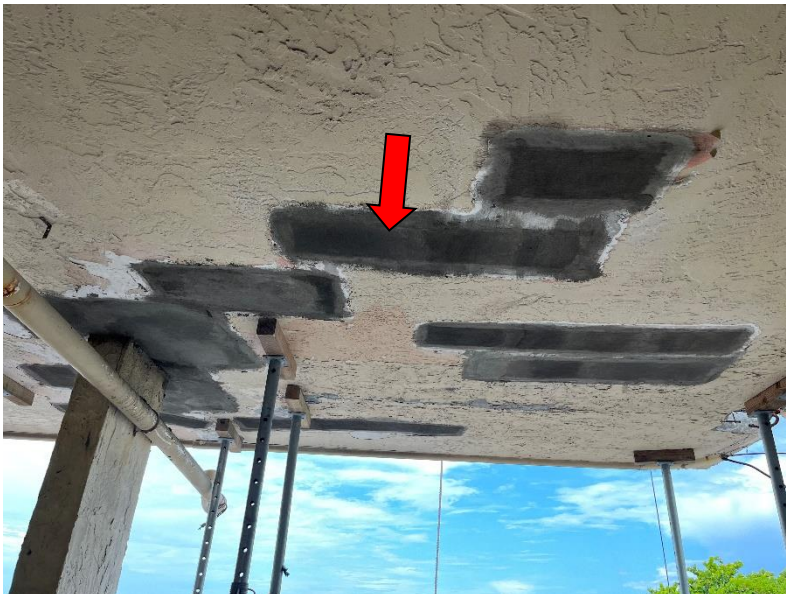
PHOTOGRAPH #24

PARKING GARAGE
Stucco Repairs

Stucco initial coat currently being applied at the damaged areas of the parking garage ceiling.

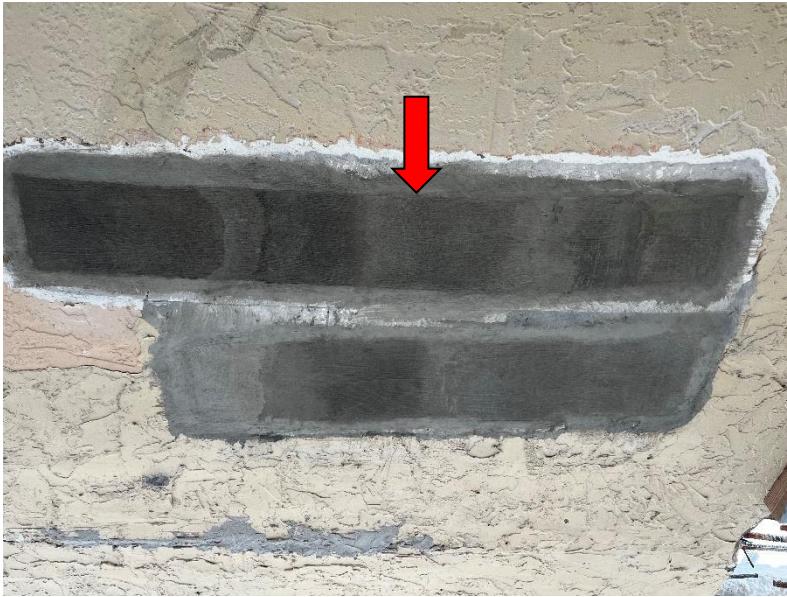
PHOTOGRAPH #25

**PARKING GARAGE
Stucco Repairs**

Stucco initial coat currently being applied at the damaged areas of the parking garage ceiling.

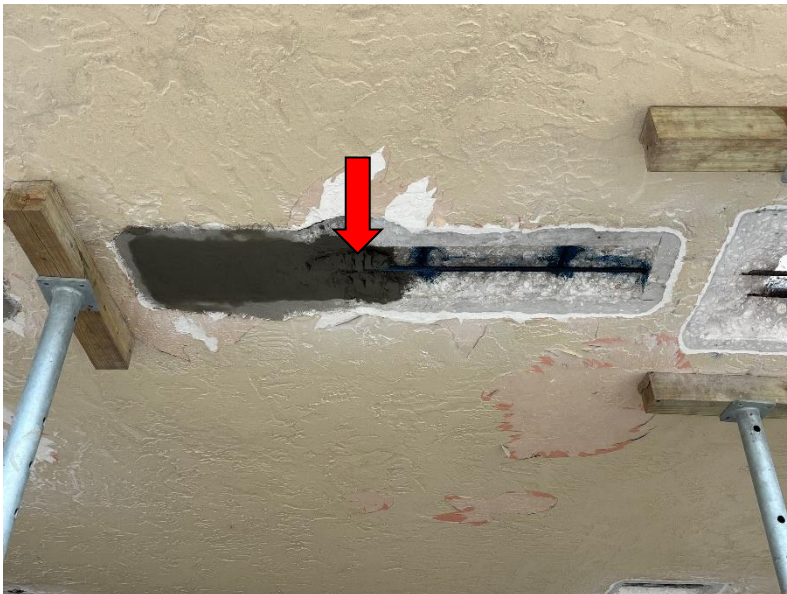
PHOTOGRAPH #26

**PARKING GARAGE
Stucco Repairs**

Stucco initial coat currently being applied at the damaged areas of the parking garage ceiling.
