FIELD OBSERVATION REPORT – WEEK OF: 8/7/2023

Permit No.: BLDC-005621-2023
Owner: Island Inn Condominium Association, Inc.
Project Address: 9980 Gulf Blvd., Treasure Island, FL 33706
Contractor: RL James, Inc.
Inspector(s): Justin Chavis, EI and Dan Reed
Type of Assessment: Progress

FIELD OBSERVATION REPORT – WEEK OF: 8/7/2023
R2107-012 Island Inn, Concrete Repairs:

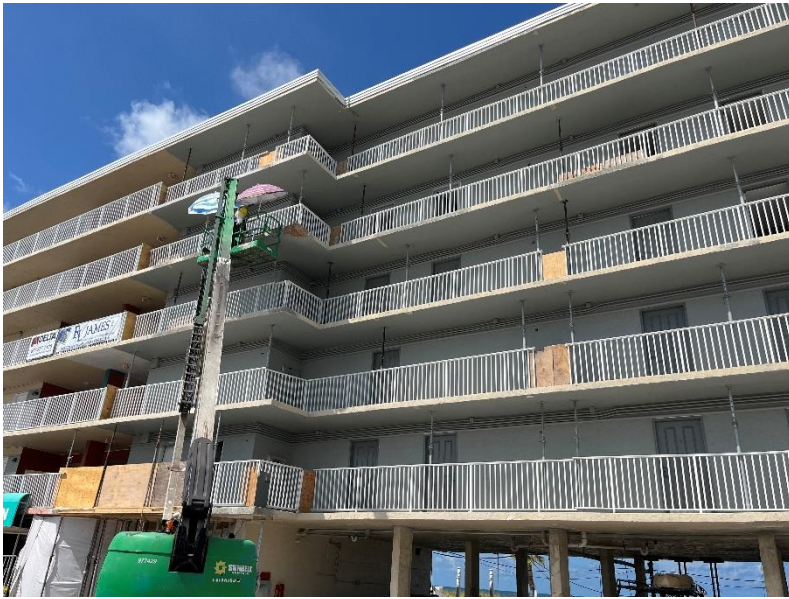
PHOTOGRAPH #1

1. Sherwin Williams Loxon primer coating applied over stucco repaired areas at the walkway ceilings damage was observed at various areas (**Photograph #1**).

ISLAND INN Overview

Overview of the progress of work.

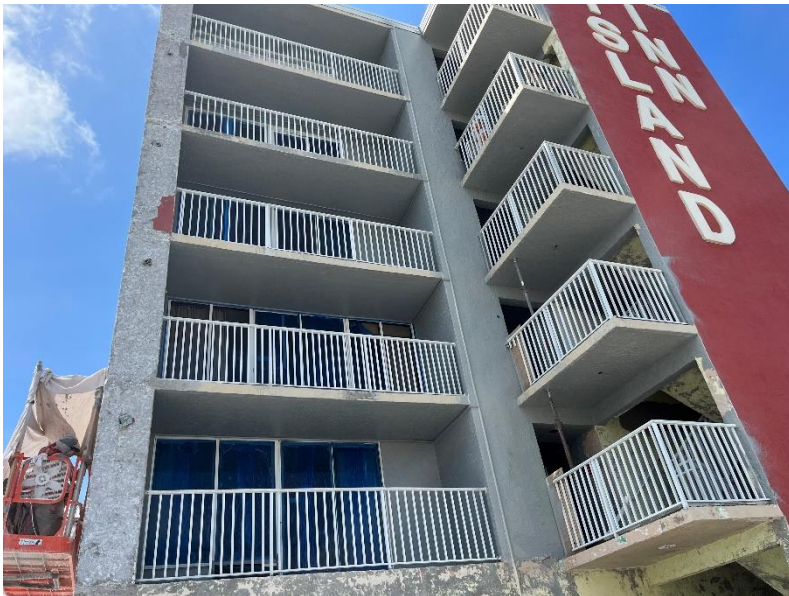
PHOTOGRAPH #2

ISLAND INN Overview

Overview of the progress of work.

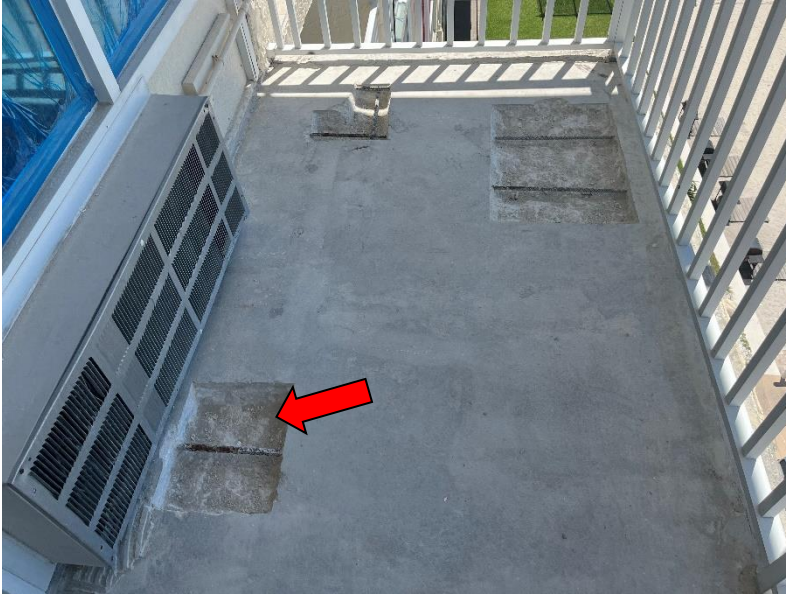
PHOTOGRAPH #3

**NORTH END REAR BALCONIES
UNIT #611
Concrete Repairs**

Debonded concrete chipped and removed,
exposing rusted reinforcing steel.

1. Perform concrete repairs to concrete damaged areas at balcony decks per the project manual and manufacturer's installation instructions. If the sliding glass door is impacting the ability to properly perform the repair, then it is recommended to remove the SGD, complete the repair, and re-install the SGD afterwards (**Photos #3 - #23**).

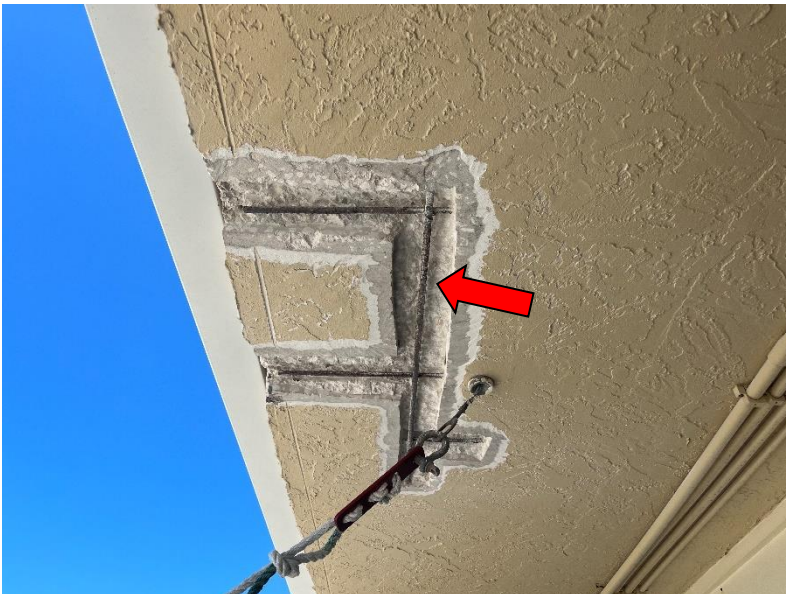
PHOTOGRAPH #4

**NORTH END REAR BALCONIES
UNIT #610
Concrete Repairs**

Debonded concrete chipped and removed,
exposing rusted reinforcing steel.

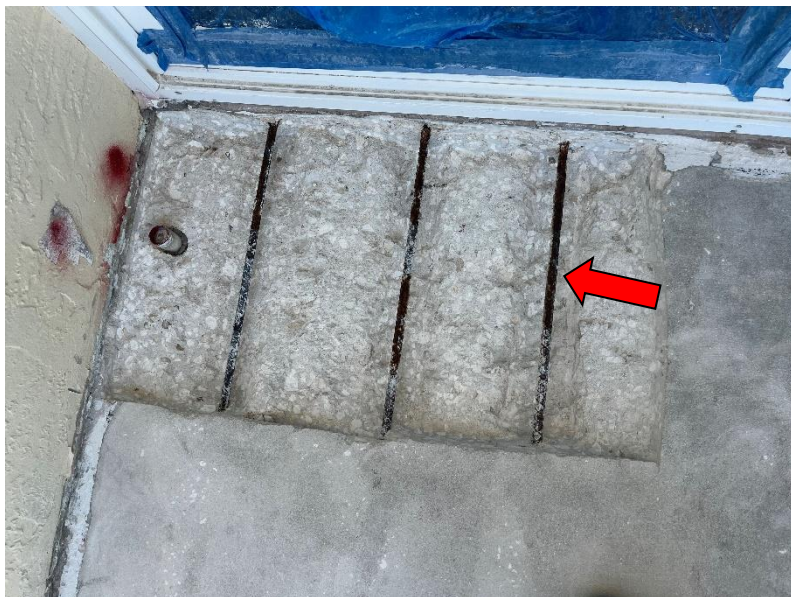
PHOTOGRAPH #5

**NORTH END REAR BALCONIES
UNIT #609
Concrete Repairs**

Debonded concrete chipped and removed,
exposing rusted reinforcing steel.

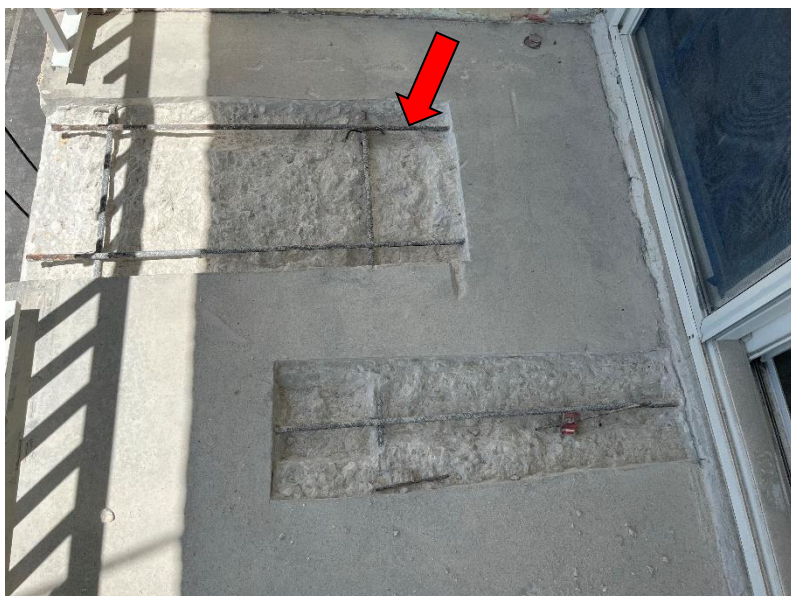
PHOTOGRAPH #6

**NORTH END REAR BALCONIES
UNIT #511
Concrete Repairs**

Debonded concrete chipped and removed,
exposing rusted reinforcing steel.

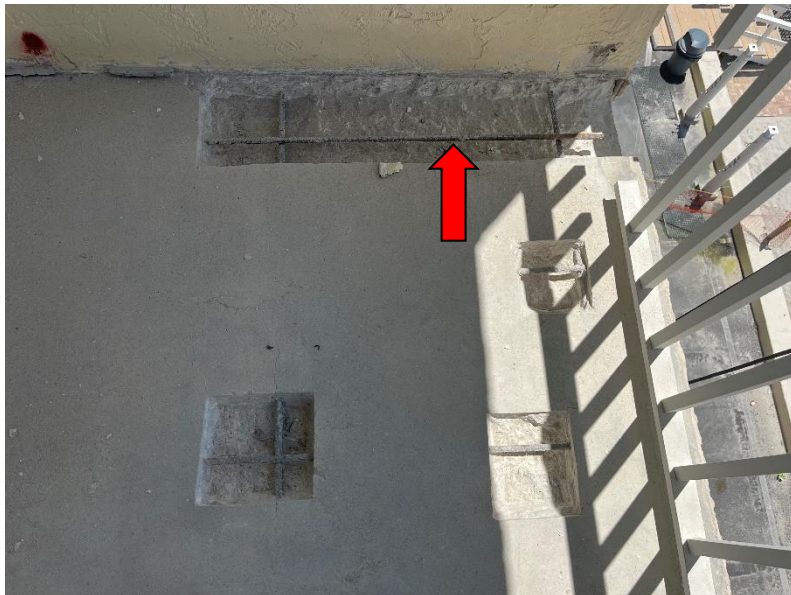
PHOTOGRAPH #7

**NORTH END REAR BALCONIES
UNIT #510
Concrete Repairs**

Debonded concrete chipped and removed,
exposing rusted reinforcing steel.

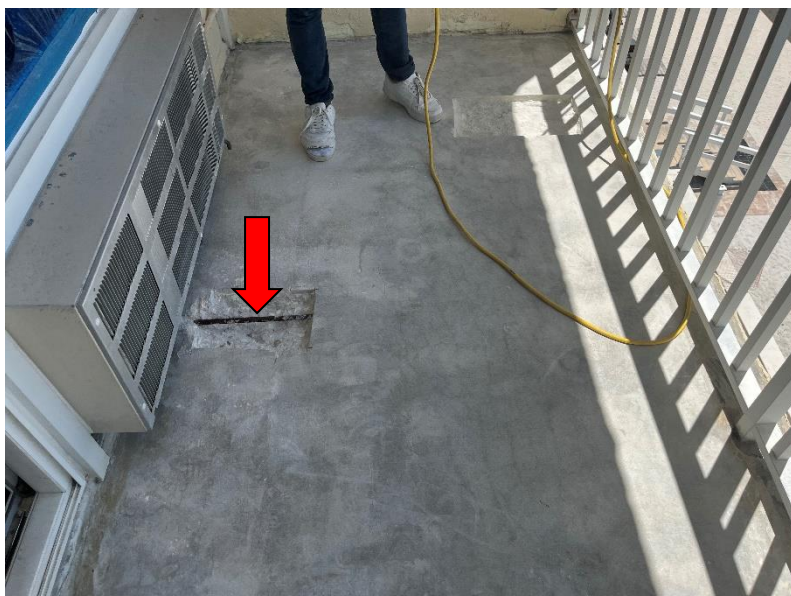
PHOTOGRAPH #8

**NORTH END REAR BALCONIES
UNIT #509
Concrete Repairs**

Debonded concrete chipped and removed,
exposing rusted reinforcing steel.

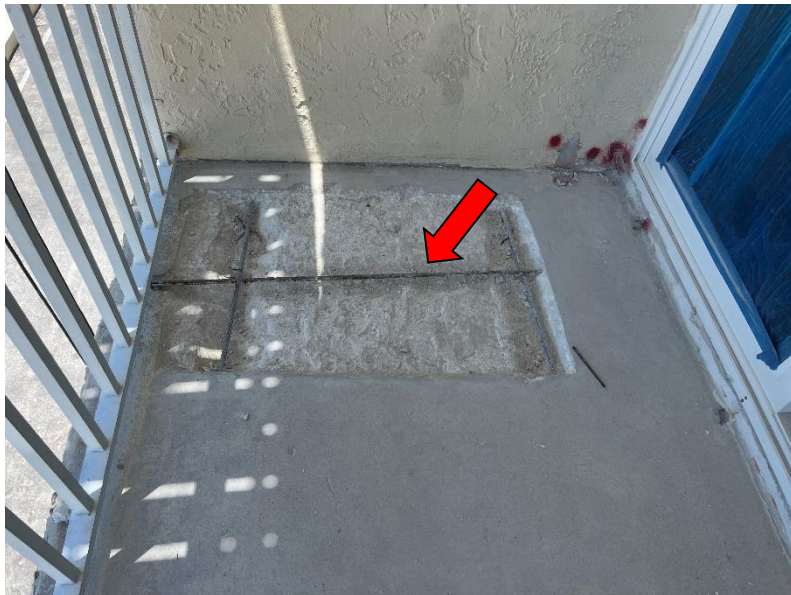
PHOTOGRAPH #9

**NORTH END REAR BALCONIES
UNIT #411
Concrete Repairs**

Debonded concrete chipped and removed,
exposing rusted reinforcing steel.

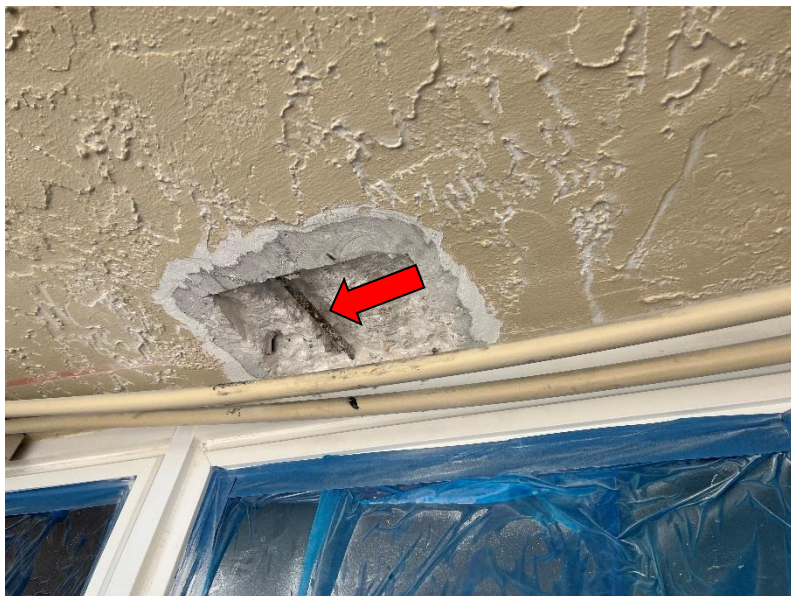
PHOTOGRAPH #10

**NORTH END REAR BALCONIES
UNIT #410
Concrete Repairs**

Debonded concrete chipped and removed,
exposing rusted reinforcing steel.

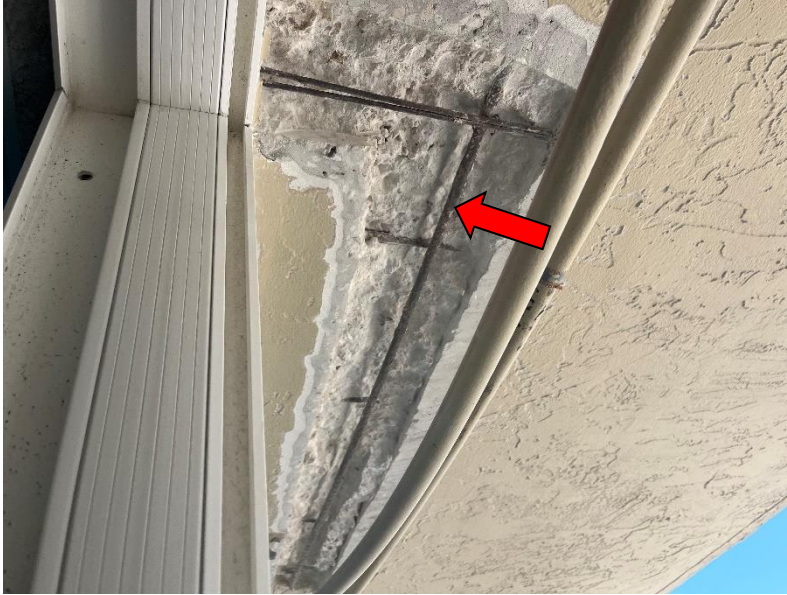
PHOTOGRAPH #11

**NORTH END REAR BALCONIES
UNIT #409
Concrete Repairs**

Debonded concrete chipped and removed,
exposing rusted reinforcing steel.

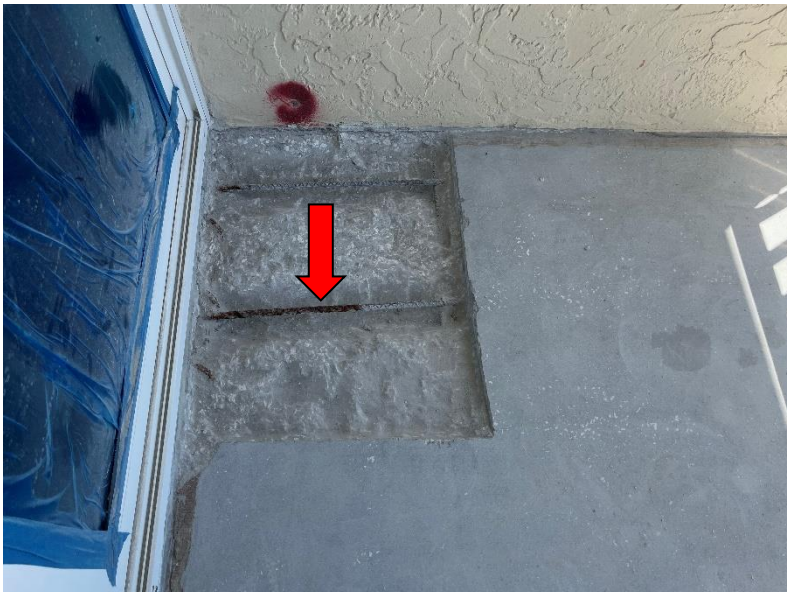
PHOTOGRAPH #12

**NORTH END REAR BALCONIES
UNIT #310
Concrete Repairs**

Debonded concrete chipped and removed,
exposing rusted reinforcing steel.

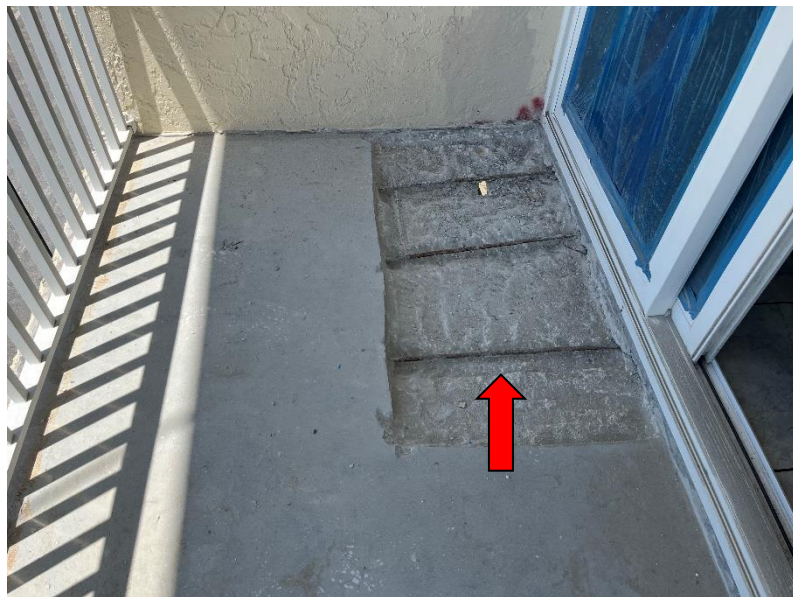
PHOTOGRAPH #13

**NORTH END REAR BALCONIES
UNIT #310
Concrete Repairs**

Debonded concrete chipped and removed,
exposing rusted reinforcing steel.

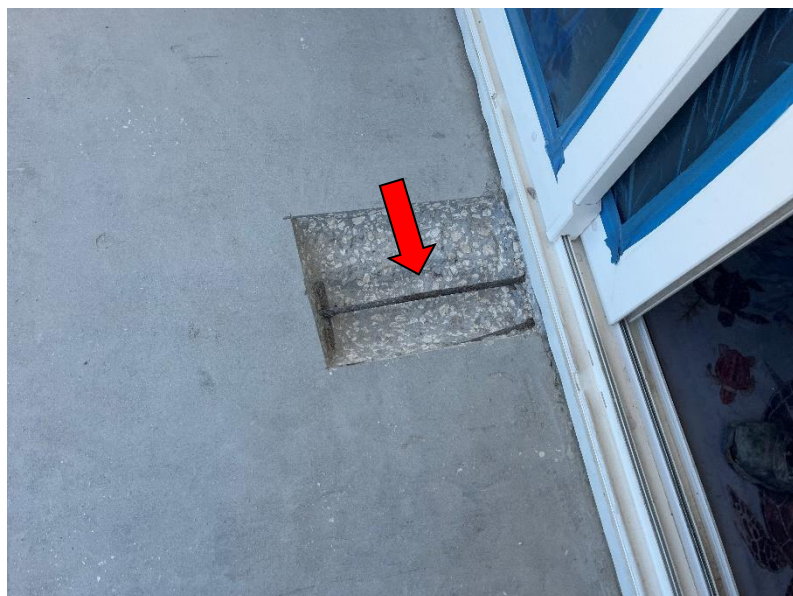
PHOTOGRAPH #14

**NORTH END REAR BALCONIES
UNIT #309
Concrete Repairs**

Debonded concrete chipped and removed,
exposing rusted reinforcing steel.

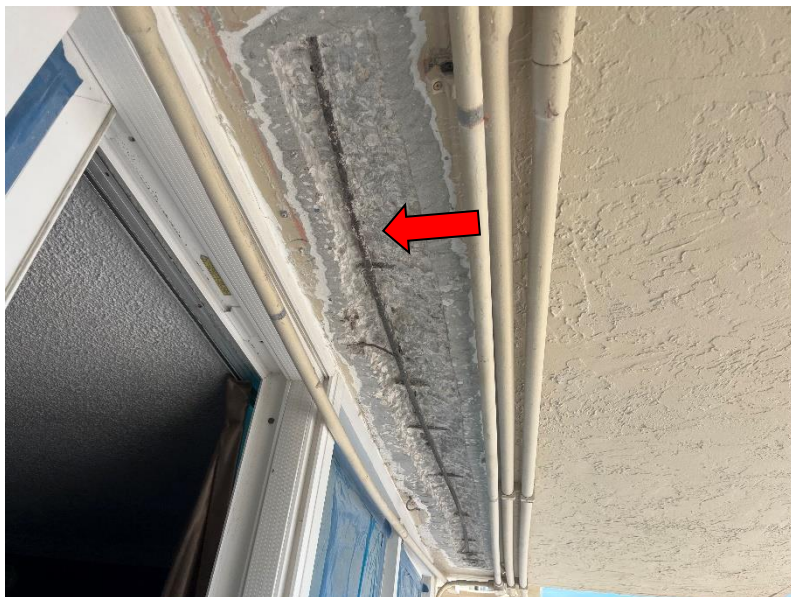
PHOTOGRAPH #15

**NORTH END REAR BALCONIES
UNIT #211
Concrete Repairs**

Debonded concrete chipped and removed,
exposing rusted reinforcing steel.

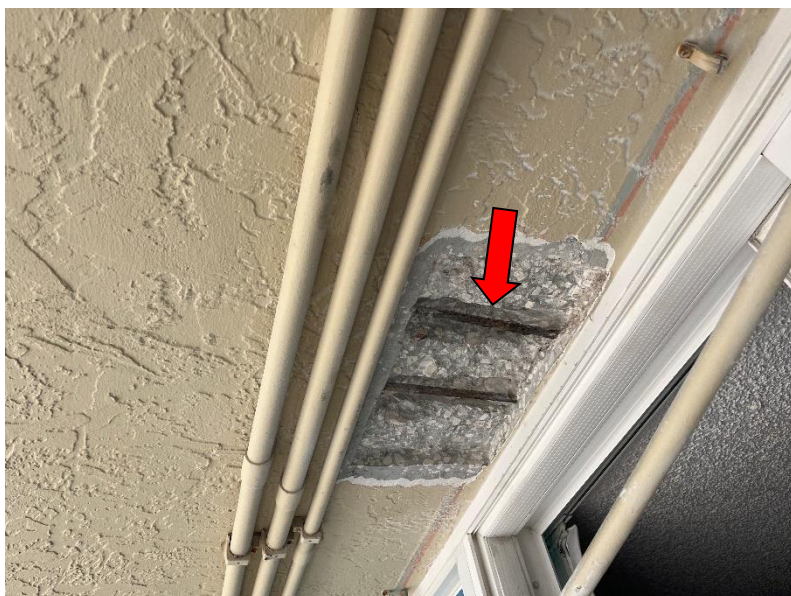
PHOTOGRAPH #16

**NORTH END REAR BALCONIES
UNIT #210
Concrete Repairs**

Debonded concrete chipped and removed,
exposing rusted reinforcing steel.

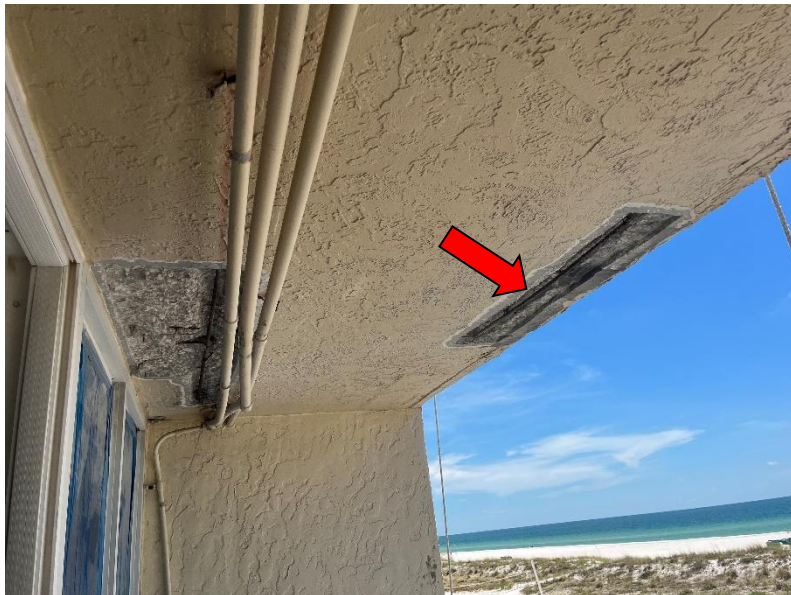
PHOTOGRAPH #17

**NORTH END REAR BALCONIES
UNIT #209
Concrete Repairs**

Debonded concrete chipped and removed,
exposing rusted reinforcing steel.

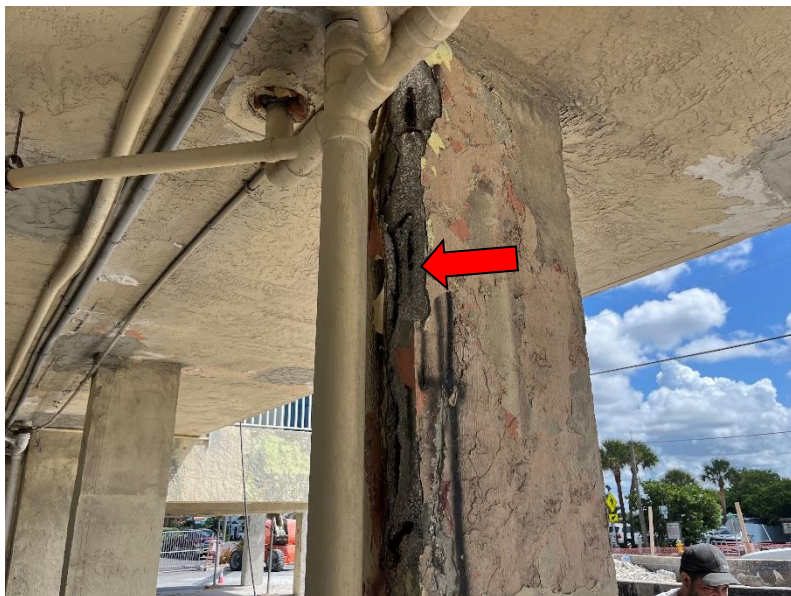
PHOTOGRAPH #18

**NORTH END PARKING GARAGE
Concrete Repairs**

Debonded concrete chipped and removed,
exposing rusted reinforcing steel.

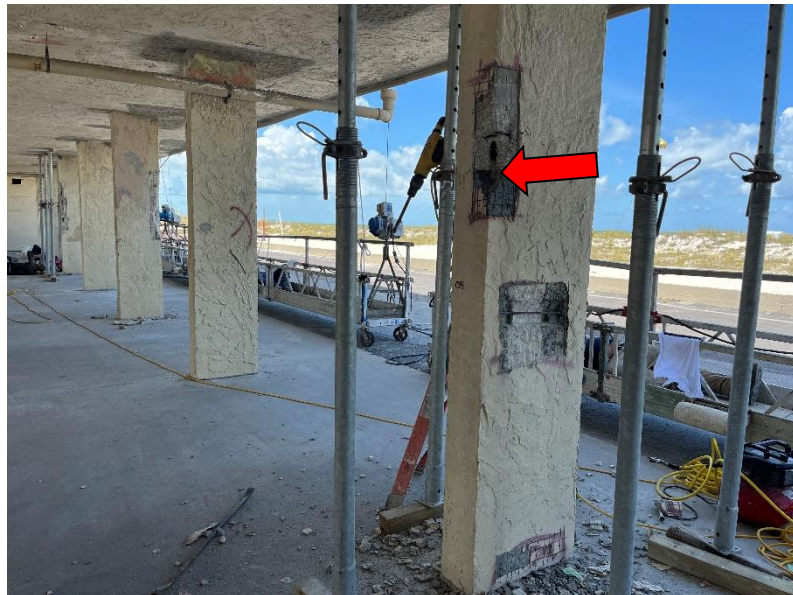
PHOTOGRAPH #19

**NORTH END PARKING GARAGE
Concrete Repairs**

Debonded concrete chipped and removed,
exposing rusted reinforcing steel.

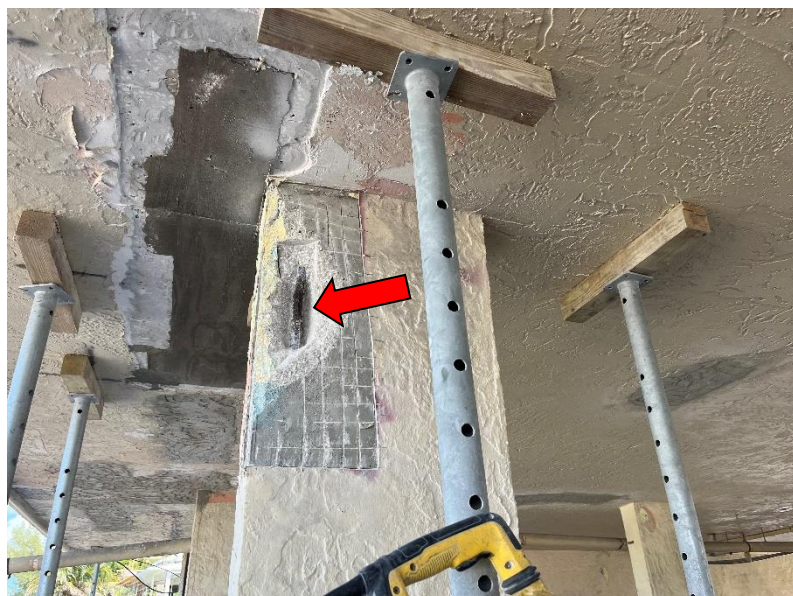
PHOTOGRAPH #20

**NORTH END PARKING GARAGE
Concrete Repairs**

Debonded concrete chipped and removed,
exposing rusted reinforcing steel.

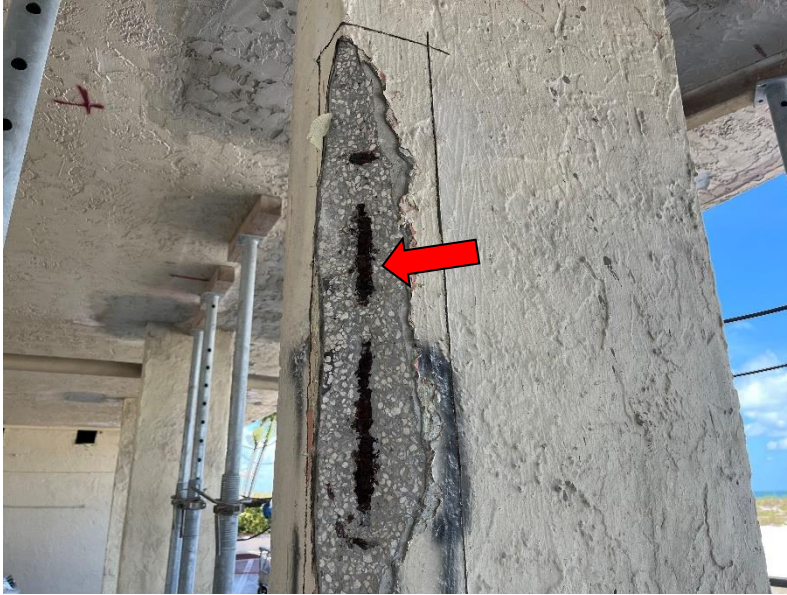
PHOTOGRAPH #21

**NORTH END PARKING GARAGE
Concrete Repairs**

Debonded concrete chipped and removed,
exposing rusted reinforcing steel.

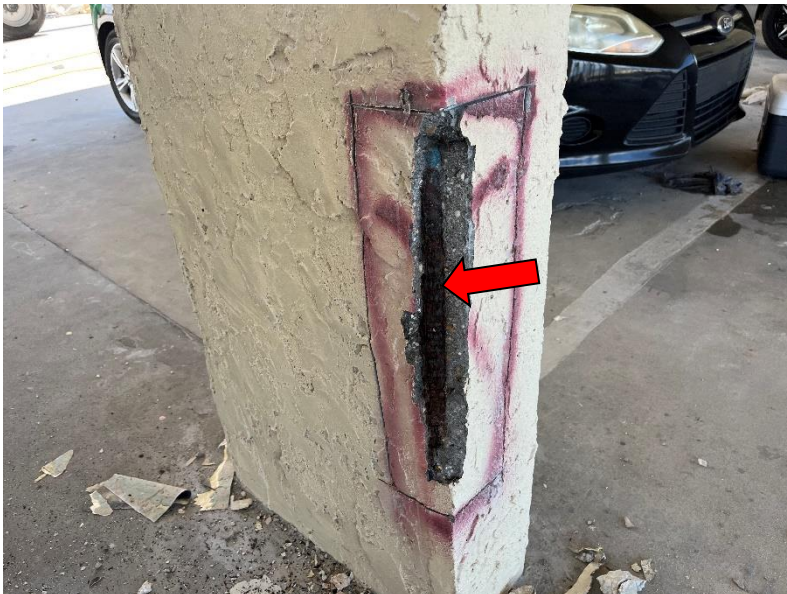
PHOTOGRAPH #22

**NORTH END PARKING GARAGE
Concrete Repairs**

Debonded concrete chipped and removed,
exposing rusted reinforcing steel.

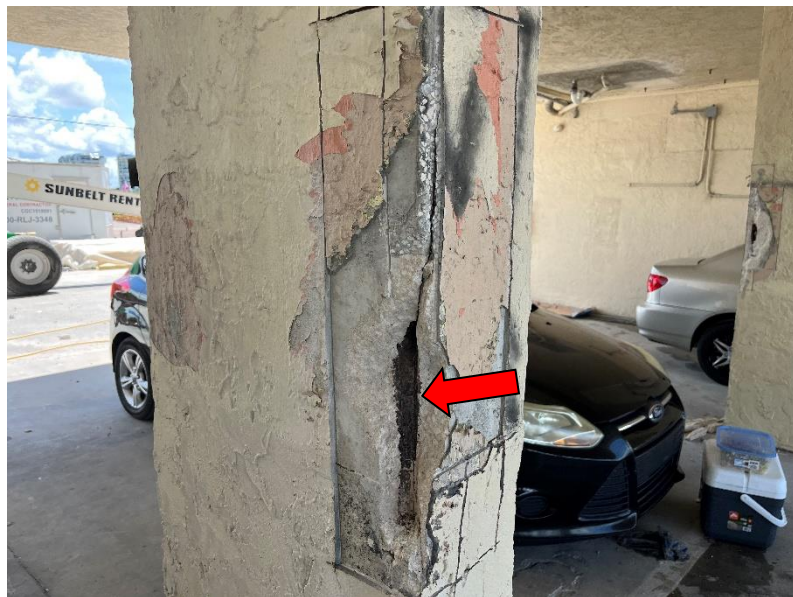
PHOTOGRAPH #23

NORTH END PARKING GARAGE
Concrete Repairs

Debonded concrete chipped and removed, exposing rusted reinforcing steel.

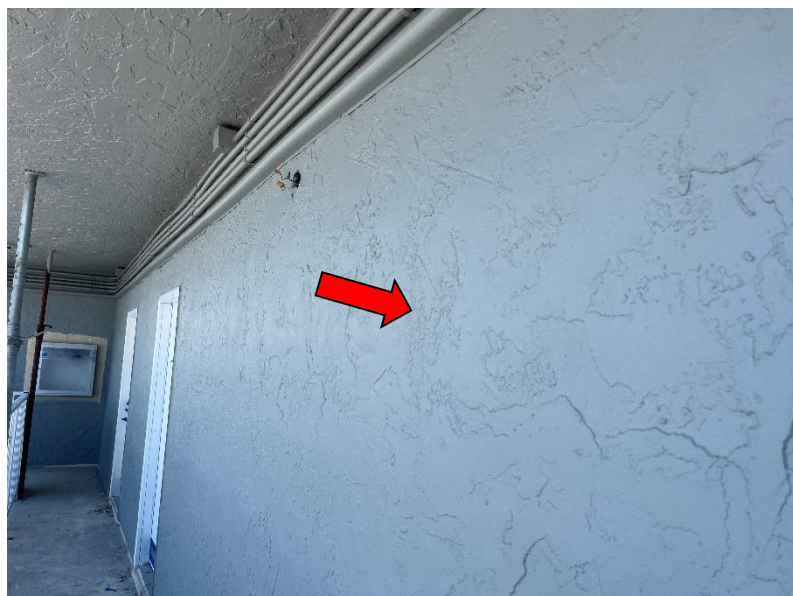
PHOTOGRAPH #24

NORTH END WALKWAYS
6TH FLOOR
Exterior Coatings

Sherwin Williams Loxon coating finish applied over the exterior walls and ceilings.

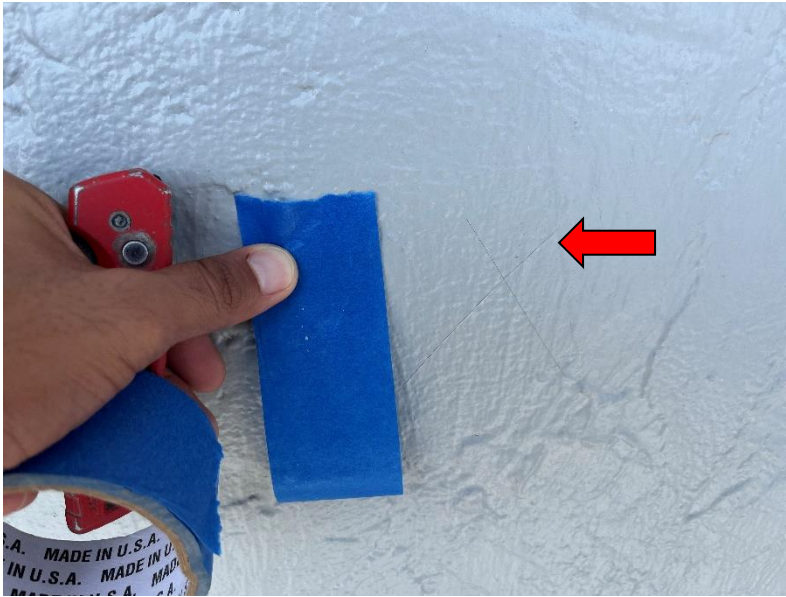
PHOTOGRAPH #25

**NORTH END WALKWAYS
6TH FLOOR
Exterior Coatings**

ASTM D3359 Method A 'X Cut' tape test performed to coating finish on walkway exterior wall and 'passed'.

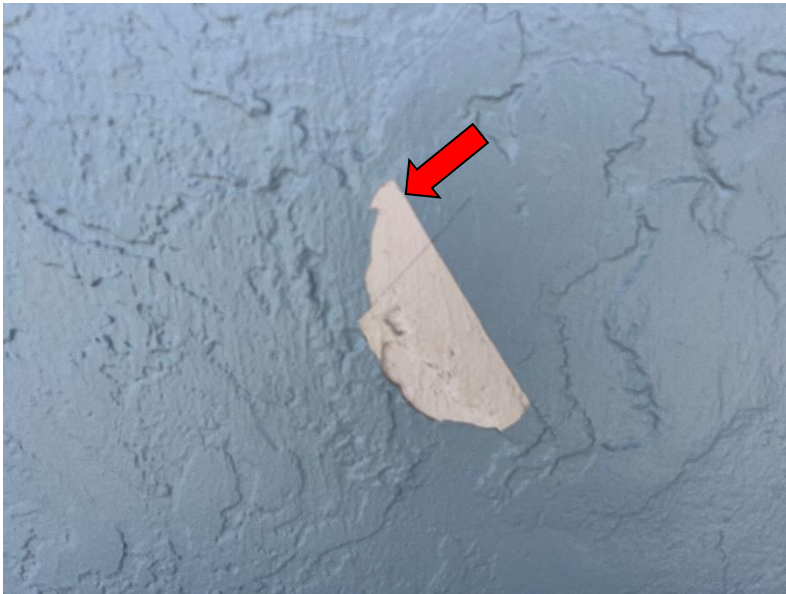
PHOTOGRAPH #26

**NORTH END WALKWAYS
4TH FLOOR
Exterior Coatings**

ASTM D3359 Method A 'X Cut' tape test performed to coating finish on walkway exterior wall and 'failed'.

2. Remove delaminated paint coatings along the walkways and re-paint exterior walls as per manufacturer's installation instructions (**Photo #26**).
3. Install shoring posts to concrete damaged areas per Engineer's shoring drawings (**See previous reports**).

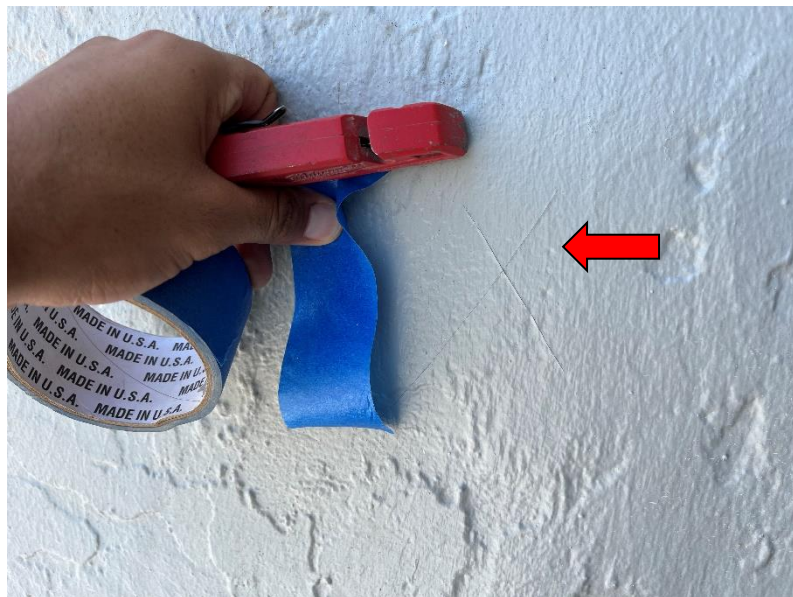
PHOTOGRAPH #27

**NORTH END WALKWAYS
4TH FLOOR
Exterior Coatings**

ASTM D3359 Method A 'X Cut' tape test performed to coating finish on walkway exterior wall and 'passed'.

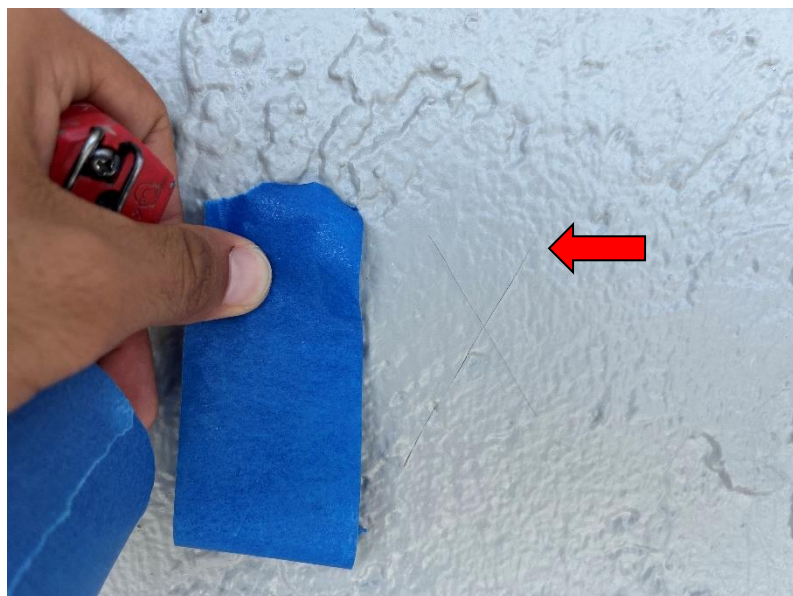
PHOTOGRAPH #28

**NORTH END WALKWAYS
3RD FLOOR
Exterior Coatings**

ASTM D3359 Method A 'X Cut' tape test performed to coating finish on walkway exterior wall and 'passed'.

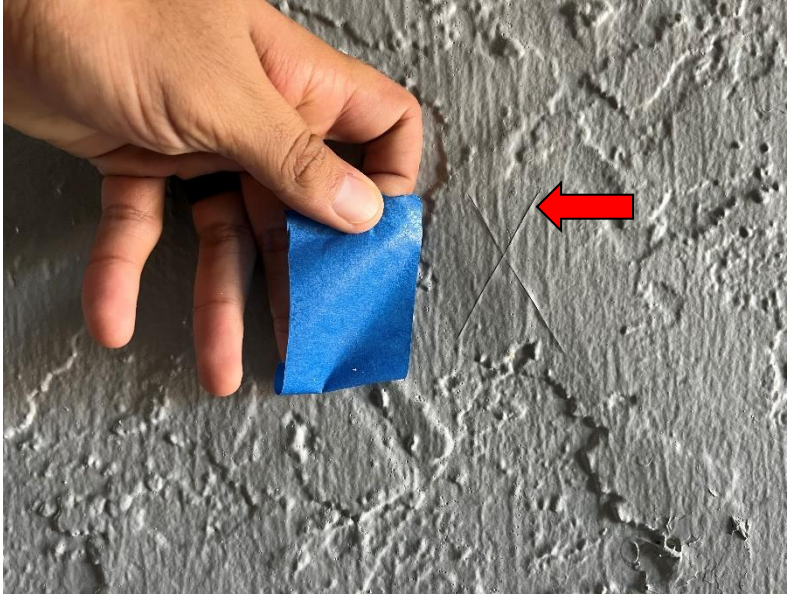
PHOTOGRAPH #29

**NORTH END WALKWAYS
2ND FLOOR
Exterior Coatings**

ASTM D3359 Method A 'X Cut' tape test performed to coating finish on walkway exterior wall and 'passed'.
