**FIELD OBSERVATION REPORT – WEEK OF: 5/8/2023**

Permit No.: \_\_\_\_\_  
Owner: Island Inn Condominium Association, Inc.  
Project Address: 9980 Gulf Blvd., Treasure Island, FL 33706  
Contractor: RL James, Inc.  
Inspector(s): Justin Chavis, EI and Dan Reed  
Type of Assessment: Progress

Project No.: R2107-012  
Contact: John Aucamp  
Phone: 201-595-9313  
Contact: Bob Branscombe  
Phone: 239-980-3149

R2107-012 Island Inn, Concrete Repairs:

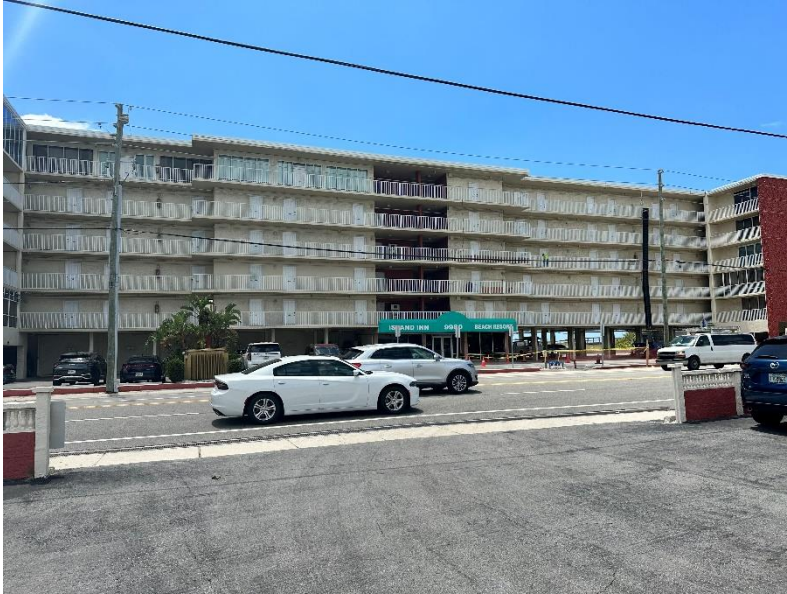
**PHOTOGRAPH #1**

### **ISLAND INN Overview**

Overview of the progress of work.

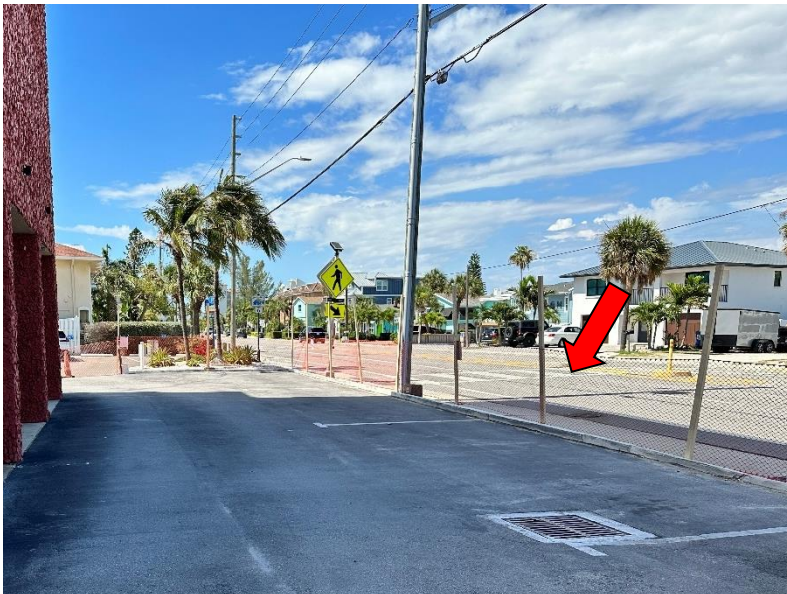
**PHOTOGRAPH #2**

### **ISLAND INN Site Fencing**

Site fencing installed around the perimeter of the property.

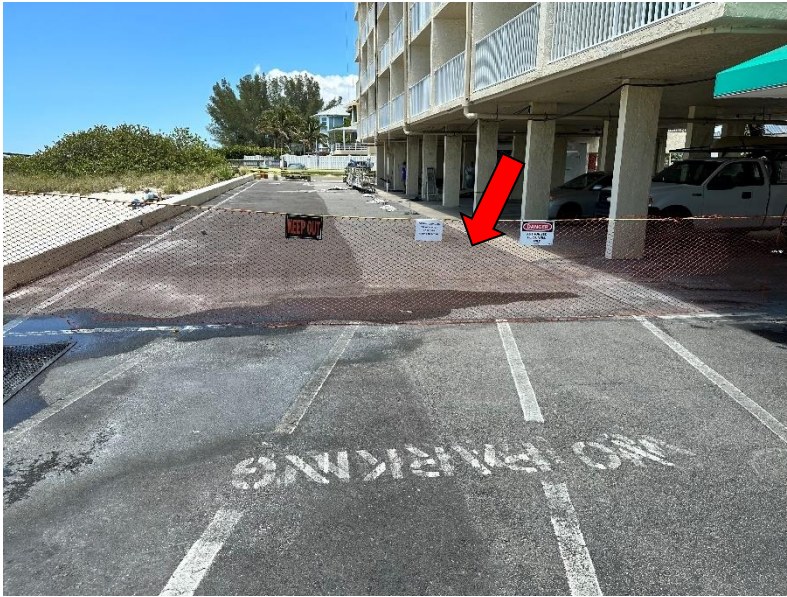
**PHOTOGRAPH #3**

**ISLAND INN  
Site Fencing**

Site fencing installed around the perimeter of the property.

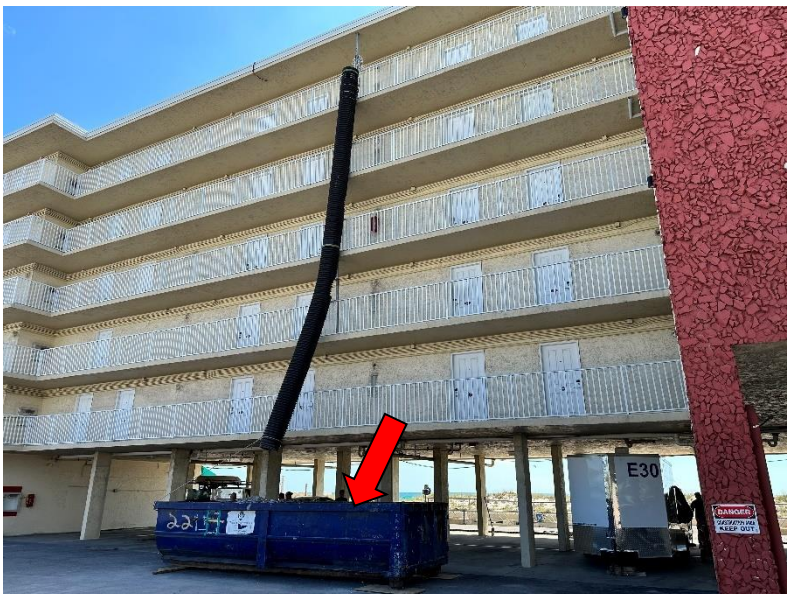
**PHOTOGRAPH #4**

**ISLAND INN  
Dumpsters**

Dumpster delivered and positioned in front of the building.

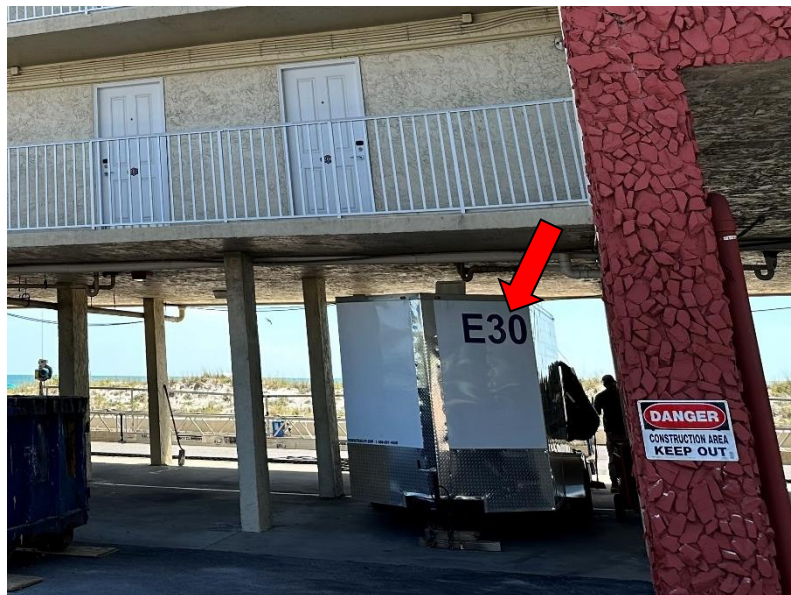
**PHOTOGRAPH #5**

**ISLAND INN  
Storage Trailer**

Contractor mobilized to the site with storage trailer and material.

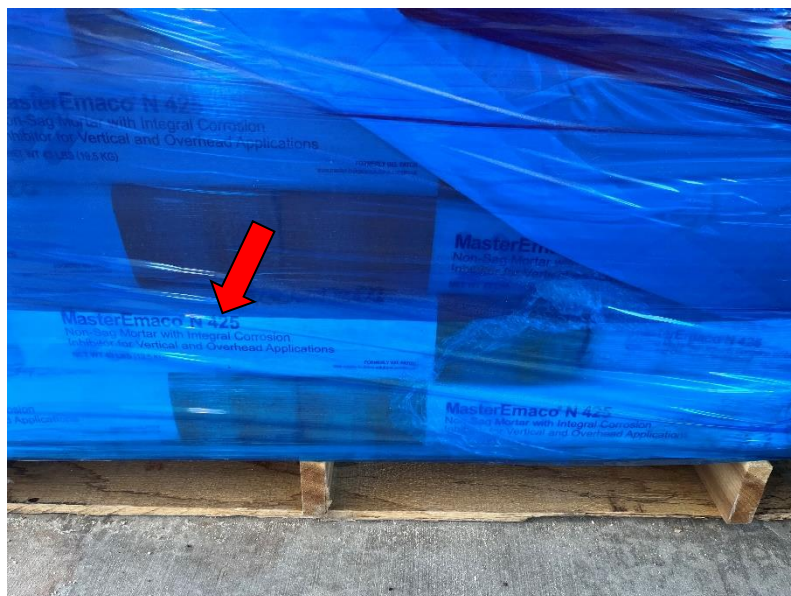
**PHOTOGRAPH #6**

**ISLAND INN  
Storage Material**

MasterEmaco N425 delivered and stored on-site.

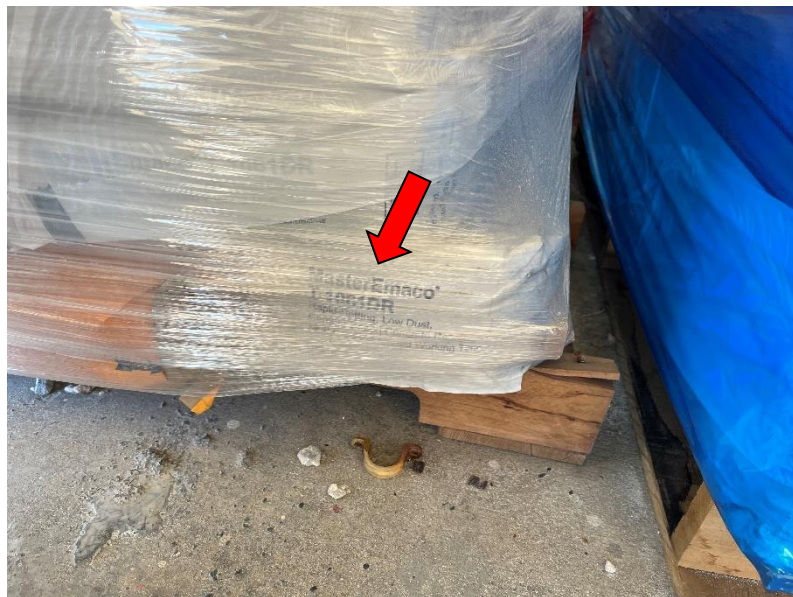
**PHOTOGRAPH #7**

**ISLAND INN  
Storage Material**

MasterEmaco 1061DR delivered and stored on-site.

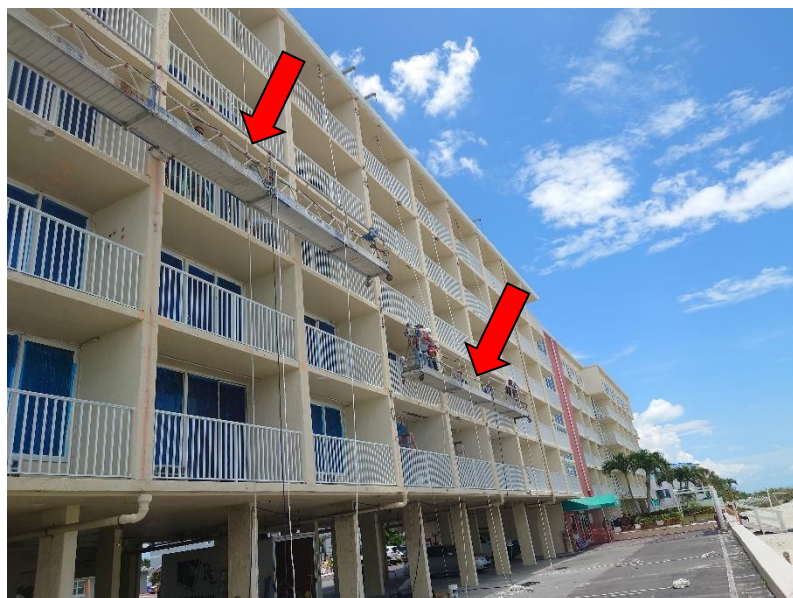
**PHOTOGRAPH #8**

**DROPS #1 & 2  
Swing Stage Set-up**

Swing stages set up at the rear (north side) of the building along Drops #1 & 2.

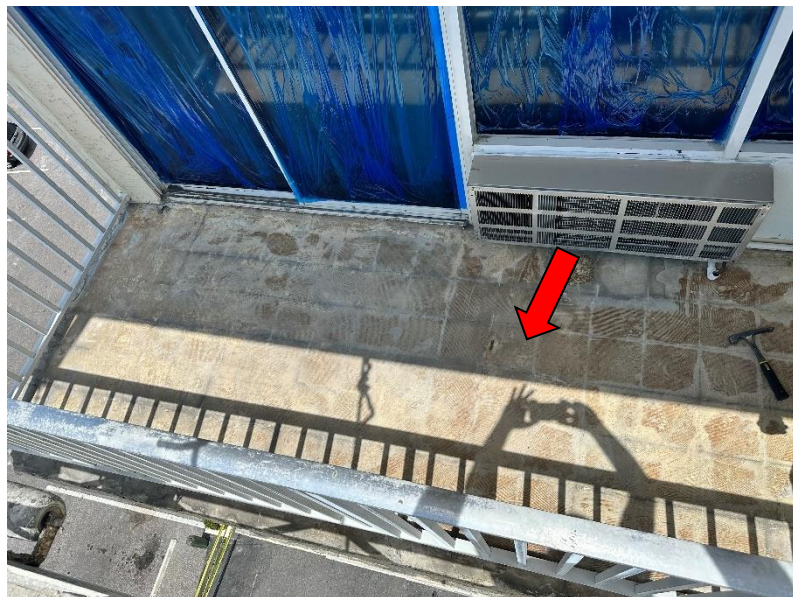
**PHOTOGRAPH #9**

**DROP #1 – SIXTH FLOOR  
Balcony Tile Removal**

Tile removed from rear balconies exposing the concrete slab.

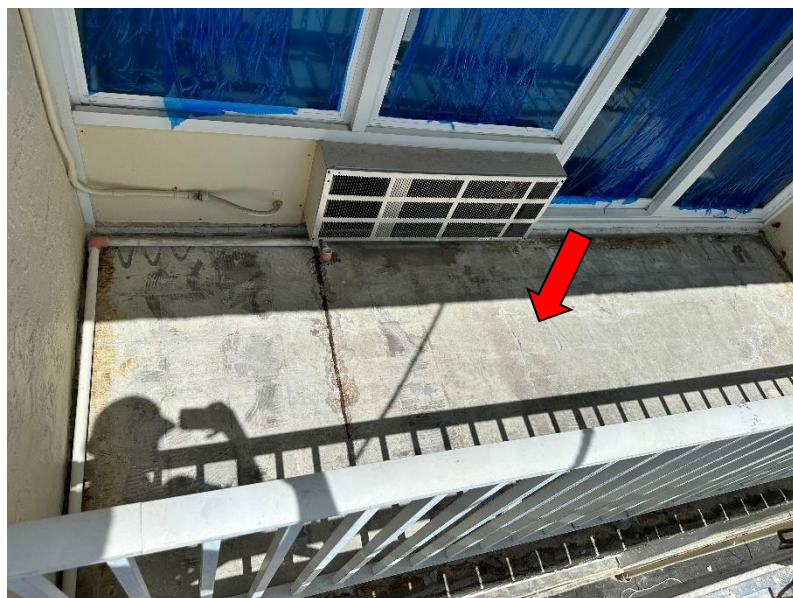
**PHOTOGRAPH #10**

**DROP #1 – FIFTH FLOOR  
Balcony Tile Removal**

Tile removed from rear balconies exposing the concrete slab.

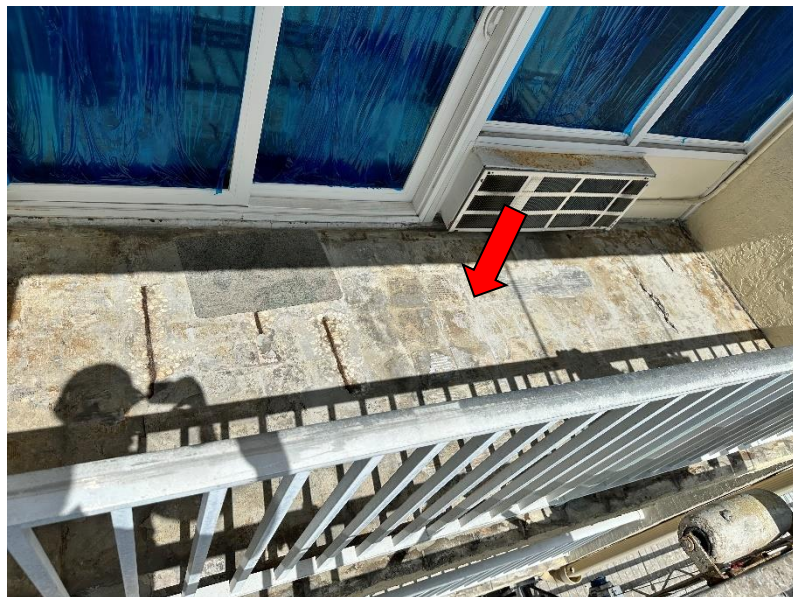
**PHOTOGRAPH #11**

**DROP #1 – THIRD FLOOR  
Balcony Tile Removal**

Tile removed from rear balconies exposing the concrete slab.

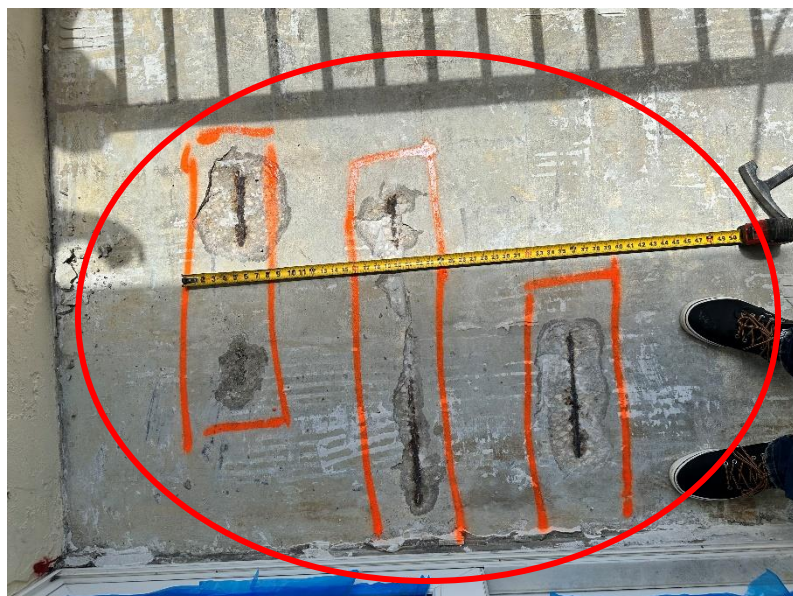
**PHOTOGRAPH #12**

**DROP #1 – SIXTH FLOOR  
Concrete Repairs**

Damaged concrete and reinforcing steel observed and areas spray marked at the balcony deck.

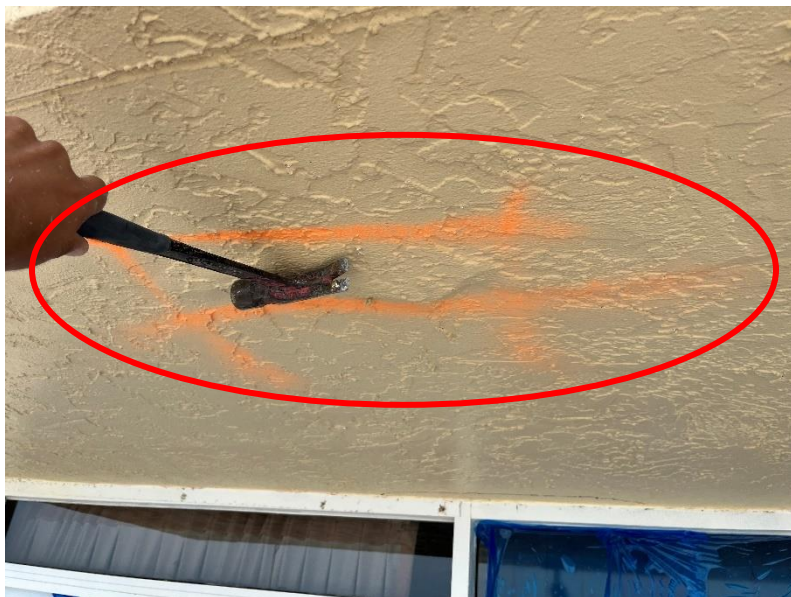
**PHOTOGRAPH #13**

**DROP #1 – SIXTH FLOOR  
Concrete Repairs**

Damaged concrete observed and areas spray marked at the overhead balcony deck.

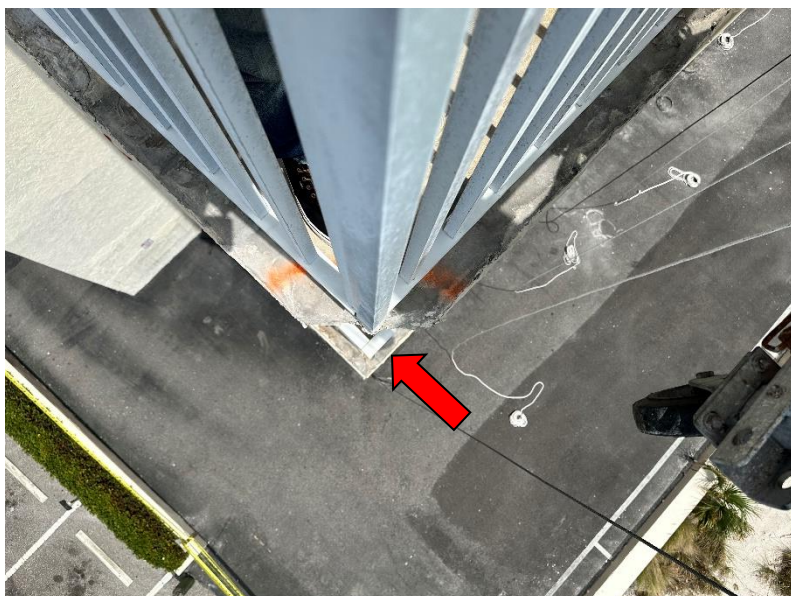
**PHOTOGRAPH #14**

**DROP #1 – SIXTH FLOOR  
Concrete Repairs**

Damaged concrete observed and area spray marked at the corner of the balcony deck.

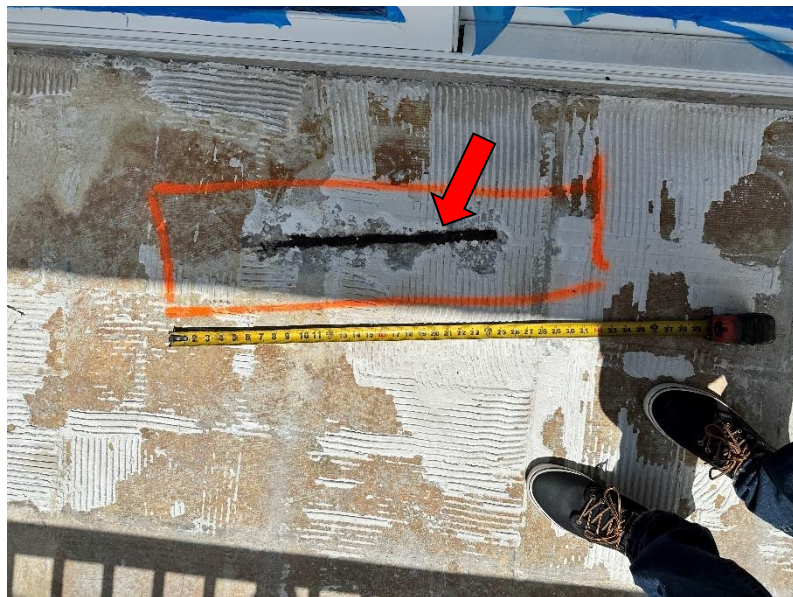
**PHOTOGRAPH #15**

**DROP #1 – FIFTH FLOOR  
Concrete Repairs**

Damaged concrete and reinforcing steel observed and areas spray marked at the balcony deck.

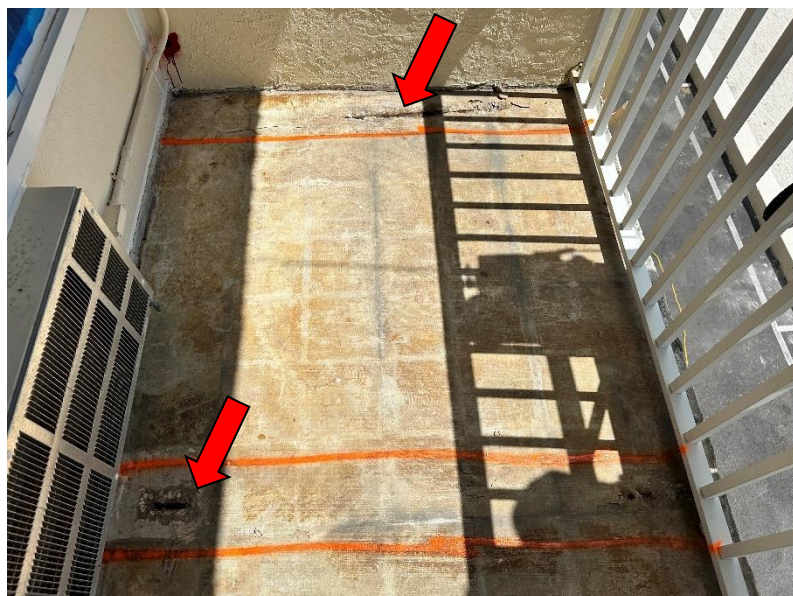
**PHOTOGRAPH #16**

**DROP #1 – FOURTH FLOOR  
Concrete Repairs**

Damaged concrete and reinforcing steel observed and areas spray marked at the balcony deck.

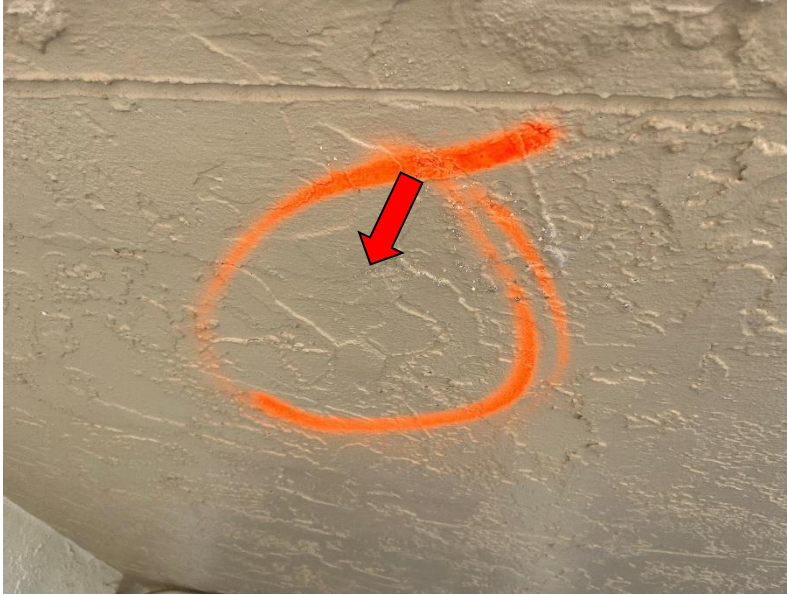
**PHOTOGRAPH #17**

**DROP #1 – FOURTH FLOOR  
Concrete Repairs**

Damaged concrete observed and areas spray marked at the overhead balcony deck.

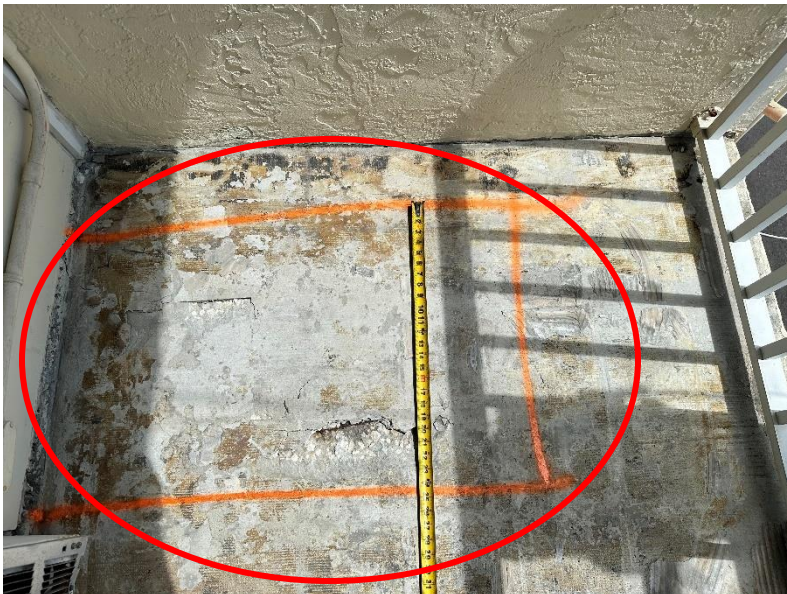
**PHOTOGRAPH #18**

**DROP #1 – THIRD FLOOR  
Concrete Repairs**

Damaged concrete and reinforcing steel observed and areas spray marked at the balcony deck.

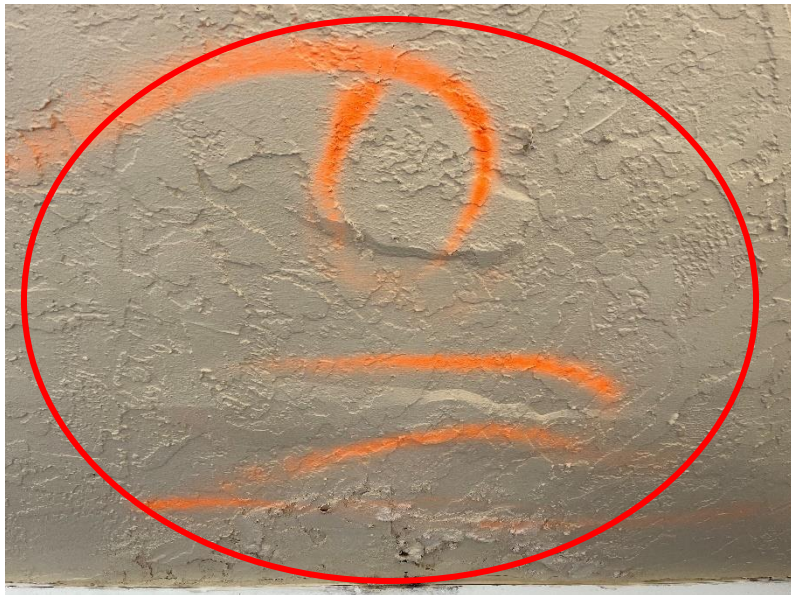
**PHOTOGRAPH #19**

**DROP #1 – THIRD FLOOR  
Concrete Repairs**

Damaged concrete observed and areas spray marked at the overhead balcony deck.

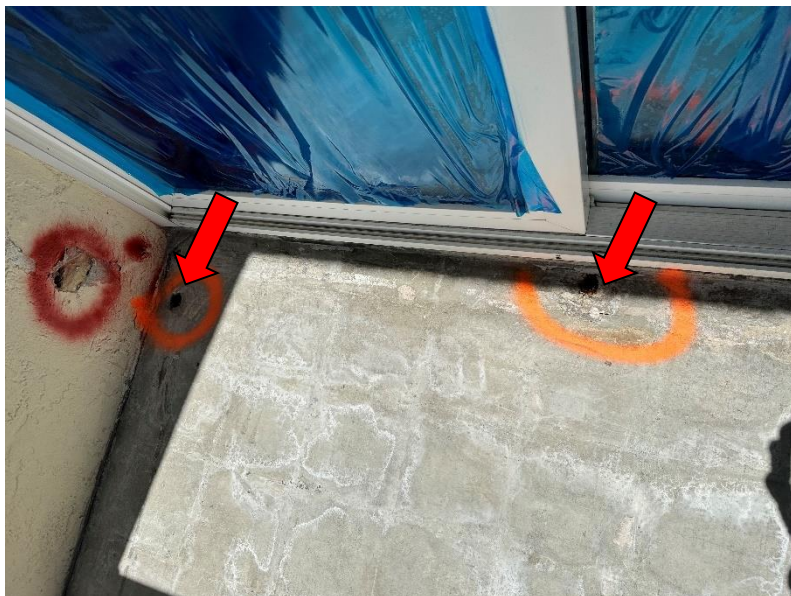
**PHOTOGRAPH #20**

**DROP #1 – SECOND FLOOR  
Concrete Repairs**

Damaged concrete and reinforcing steel observed and areas spray marked at the balcony deck.

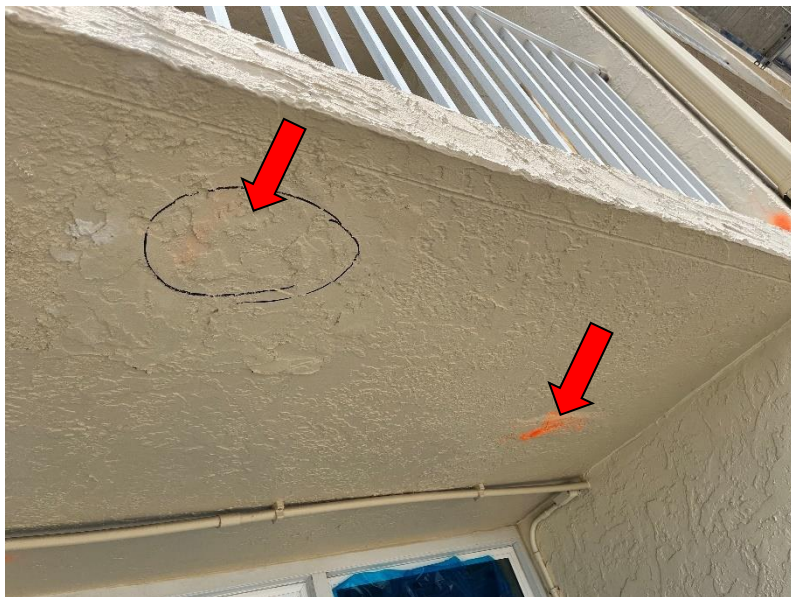
**PHOTOGRAPH #21**

**DROP #1 – SECOND FLOOR  
Concrete Repairs**

Damaged concrete observed and areas spray marked at the overhead balcony deck.

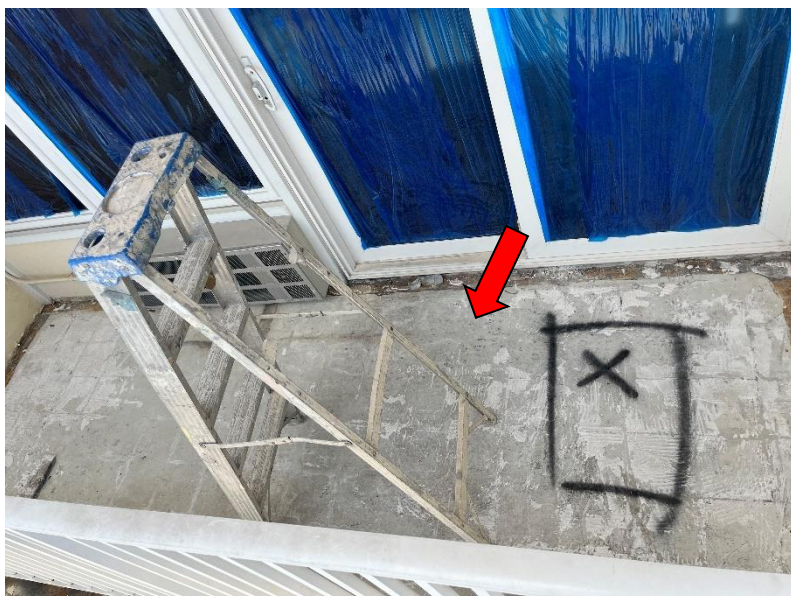
**PHOTOGRAPH #22**

**DROP #2 – SIXTH FLOOR  
Balcony Tile Removal**

Tile removed from rear balconies exposing the concrete slab.

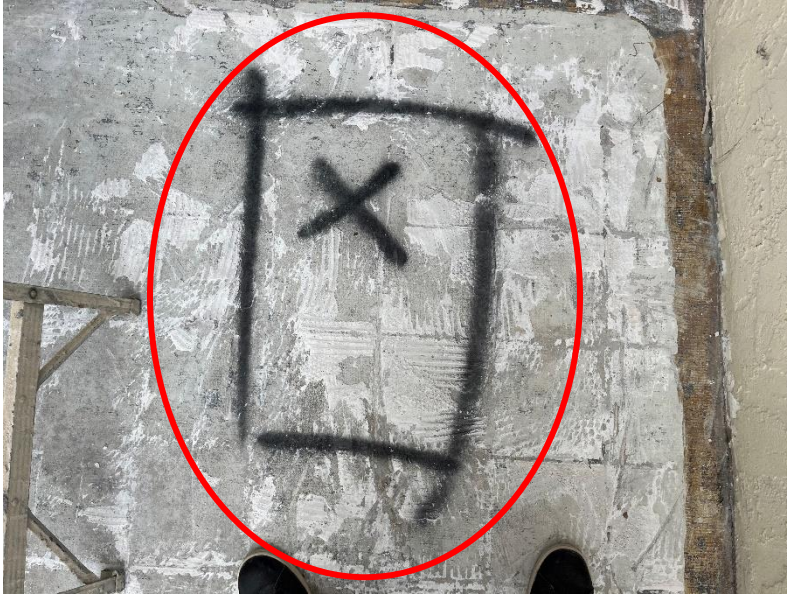
**PHOTOGRAPH #23**

**DROP #2 – SIXTH FLOOR  
Concrete Repairs**

Damaged concrete observed and areas spray marked at the balcony deck.

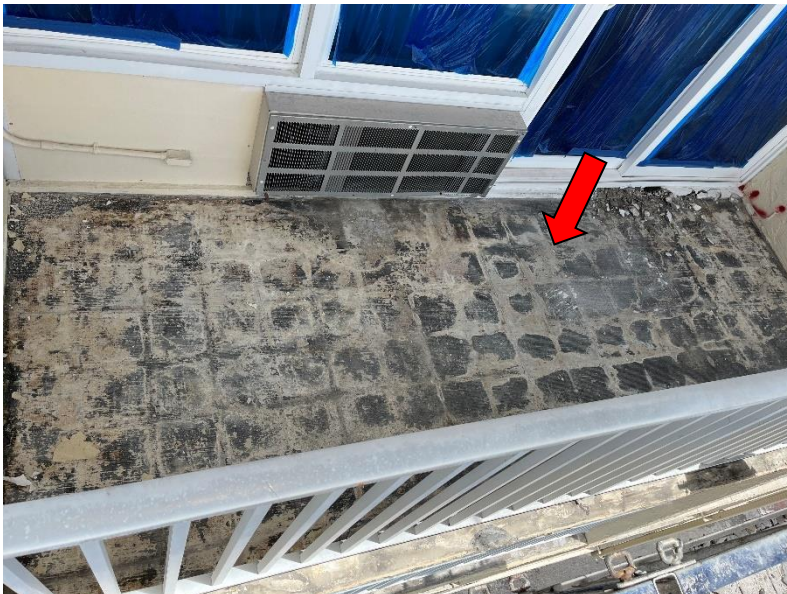
**PHOTOGRAPH #24**

**DROP #2 – FIFTH FLOOR  
Balcony Tile Removal**

Tile removed from rear balconies exposing the concrete slab.

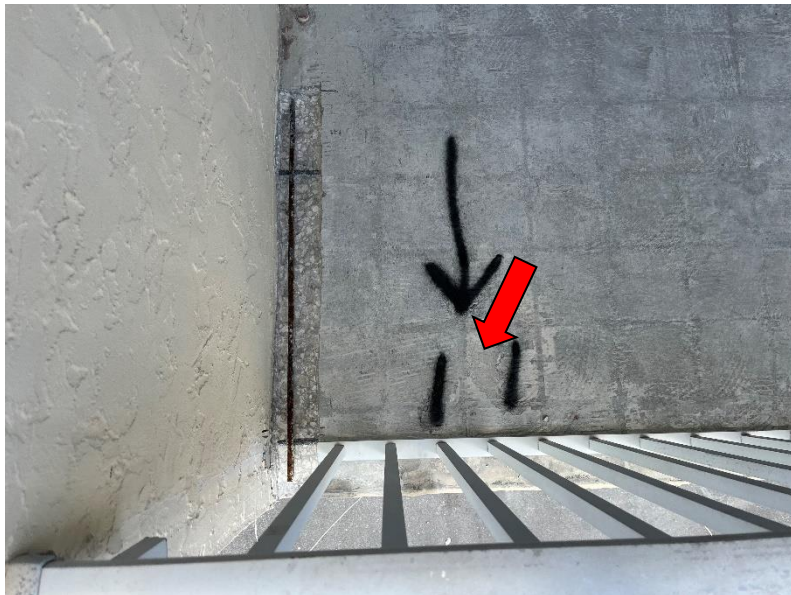
**PHOTOGRAPH #25**

**DROP #2 – FIFTH FLOOR  
Concrete Repairs**

Damaged concrete and areas spray marked at the balcony deck.

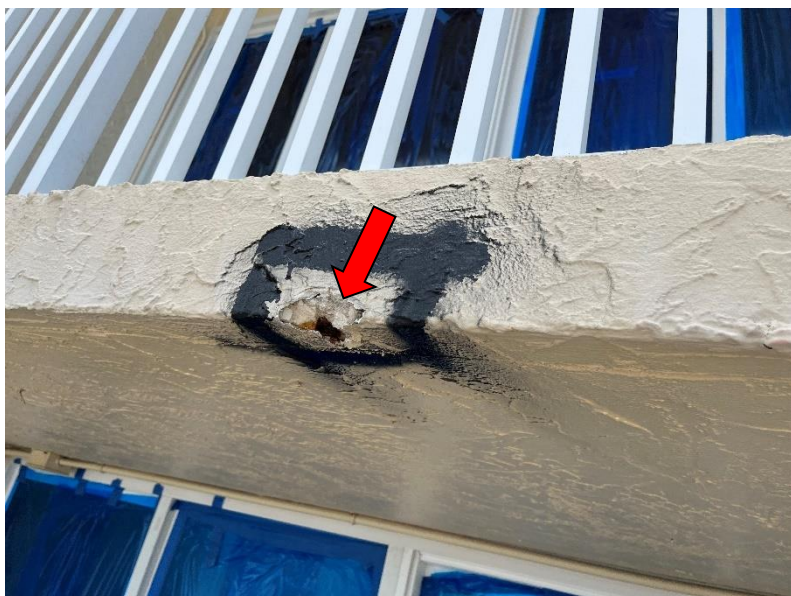
**PHOTOGRAPH #26**

**DROP #2 – FIFTH FLOOR  
Concrete Repairs**

Damaged concrete and areas spray marked at the balcony deck slab edge.

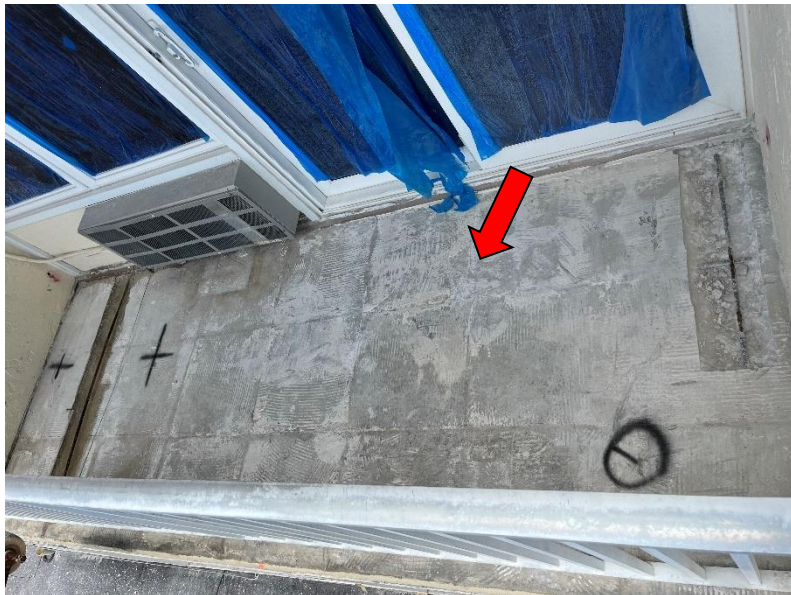
**PHOTOGRAPH #27**

**DROP #2 – FOURTH FLOOR  
Balcony Tile Removal**

Tile removed from rear balconies exposing the concrete slab.

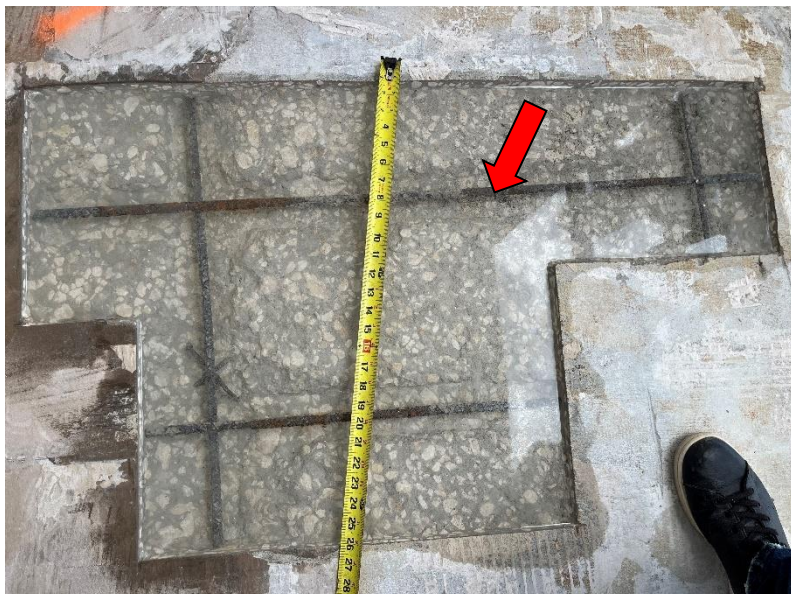
**PHOTOGRAPH #28**

**DROP #2 – FOURTH FLOOR  
Concrete Repairs**

Damaged concrete and reinforcing steel observed and areas spray marked at the balcony deck.

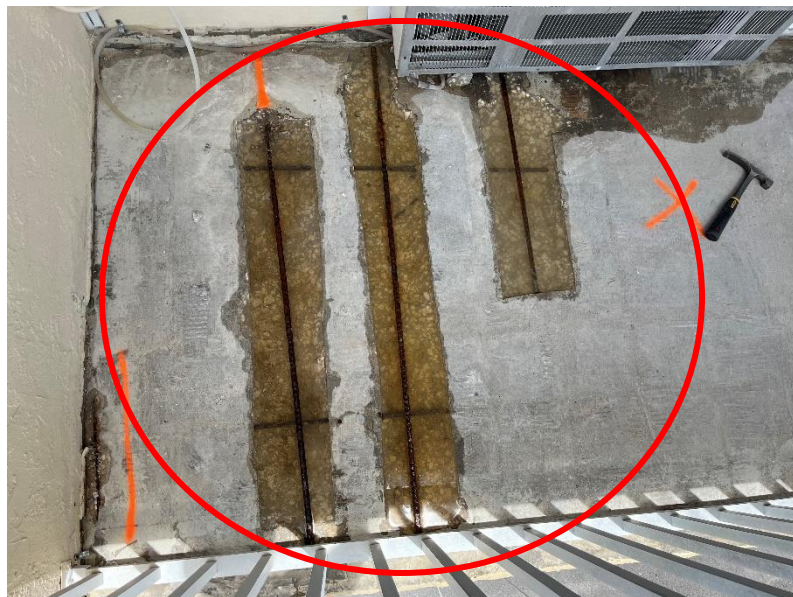
**PHOTOGRAPH #29**

**DROP #2 – FOURTH FLOOR  
Concrete Repairs**

Damaged concrete and reinforcing steel observed and areas spray marked at the balcony deck.

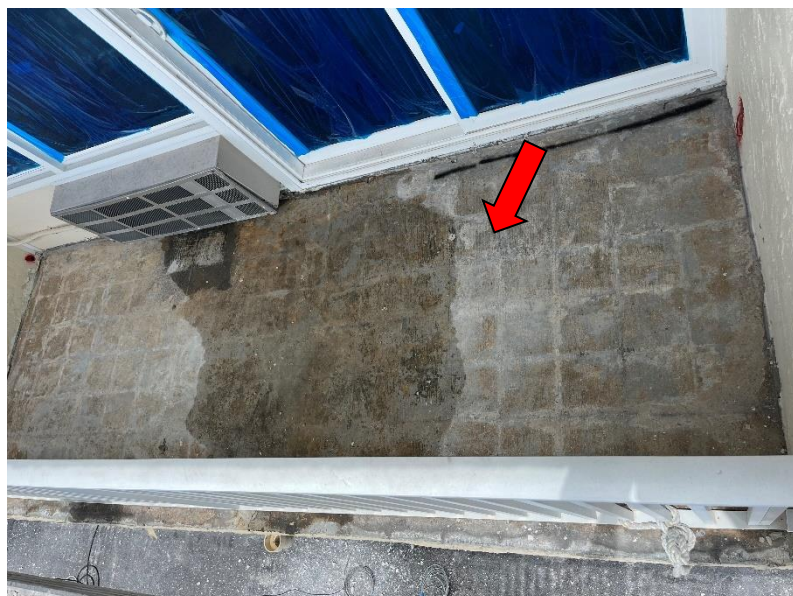
**PHOTOGRAPH #30**

**DROP #2 – THIRD FLOOR  
Balcony Tile Removal**

Tile removed from rear balconies exposing the concrete slab.

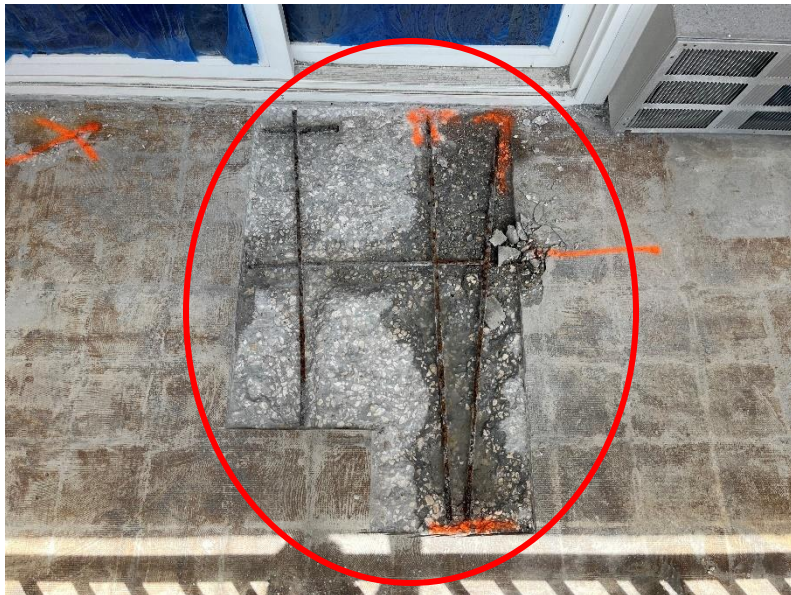
**PHOTOGRAPH #31**

**DROP #2 – THIRD FLOOR  
Concrete Repairs**

Damaged concrete and reinforcing steel observed and areas spray marked at the balcony deck.

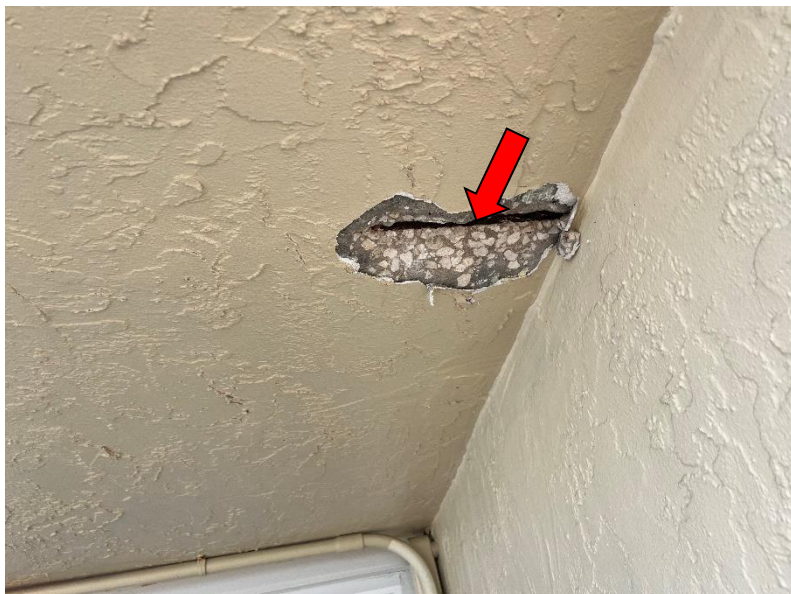
**PHOTOGRAPH #32**

**DROP #2 – THIRD FLOOR  
Concrete Repairs**

Damaged concrete and reinforcing steel observed and areas spray marked at the overhead balcony deck.

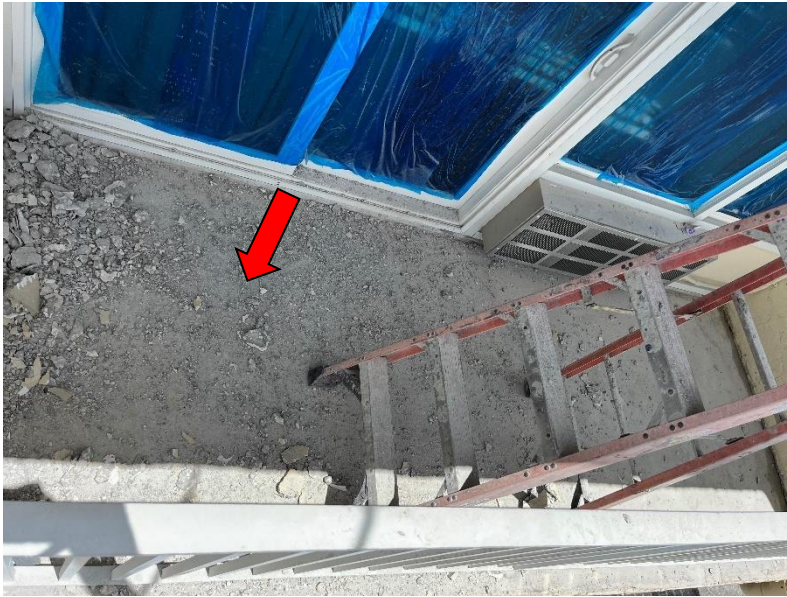
**PHOTOGRAPH #33**

**DROP #2 – SECOND FLOOR  
Balcony Tile Removal**

Tile removed from rear balconies exposing the concrete slab.

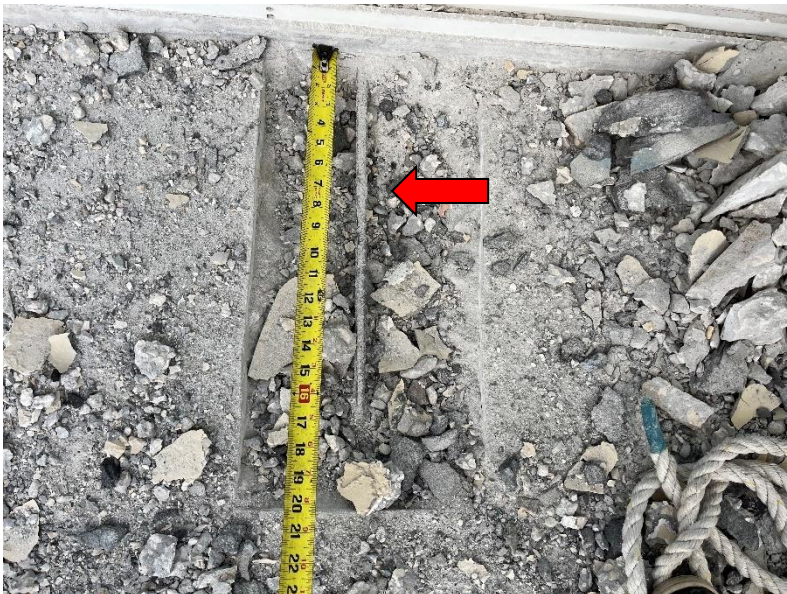
**PHOTOGRAPH #34**

**DROP #2 – SECOND FLOOR  
Concrete Repairs**

Damaged concrete removed and rusted reinforcing steel fully exposed in preparation for concrete repairs.

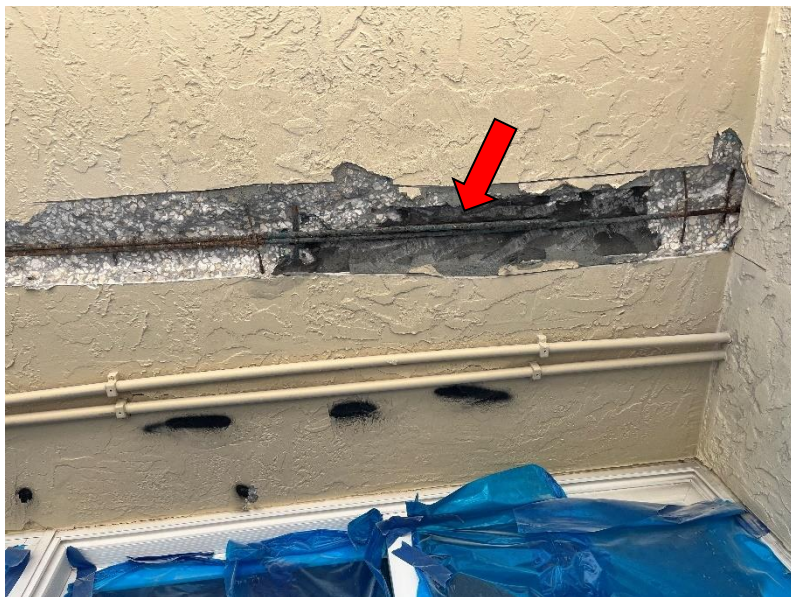
**PHOTOGRAPH #35**

**DROP #2 – SECOND FLOOR  
Concrete Repairs**

Damaged concrete removed and rusted reinforcing steel fully exposed in preparation for concrete repairs.

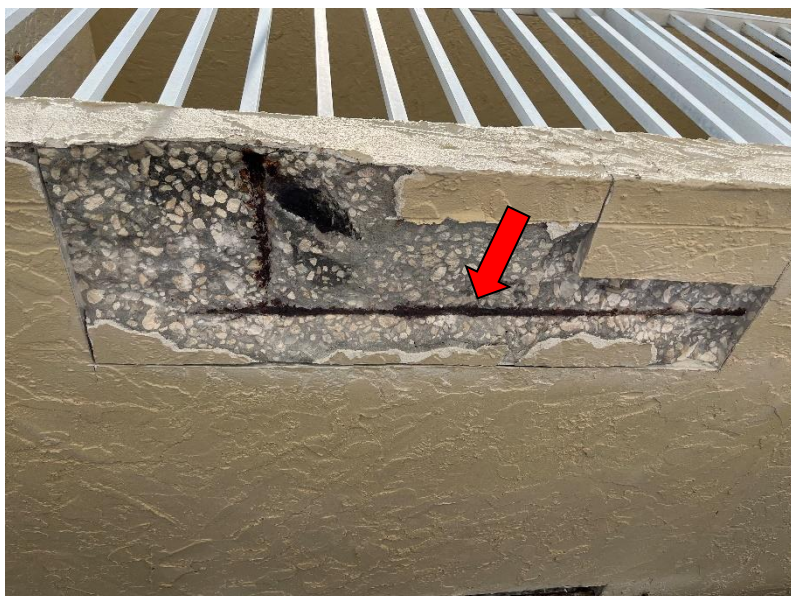
**PHOTOGRAPH #36**

**DROP #2 – SECOND FLOOR  
Concrete Repairs**

Damaged concrete removed and rusted reinforcing steel fully exposed in preparation for concrete repairs.

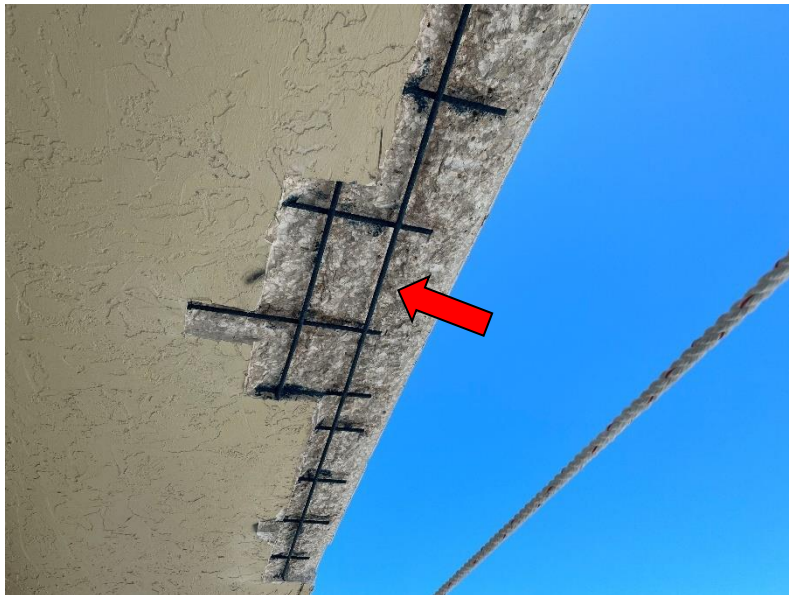
**PHOTOGRAPH #37**

**WALKWAYS – SIXTH FLOOR**  
**Concrete Repairs**

Damaged reinforcing steel fully exposed, cleaned and epoxy coated at the overhead walkway deck.

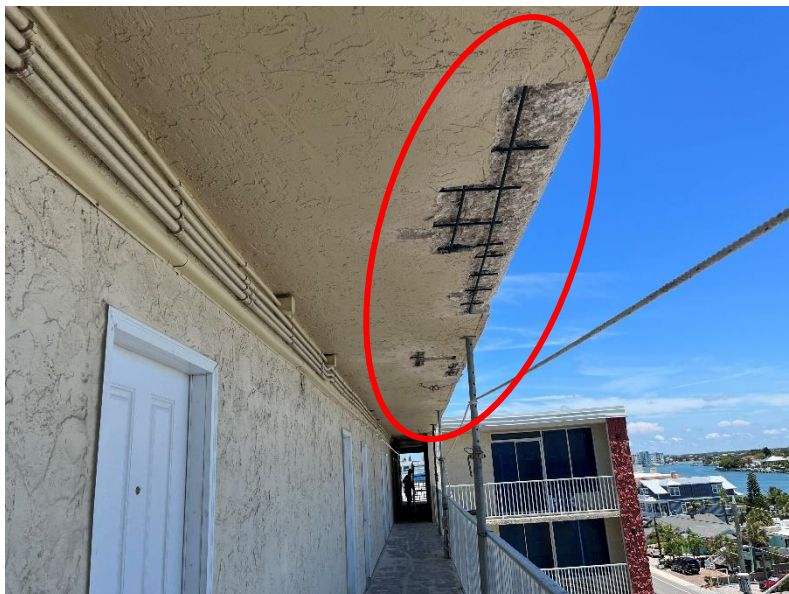
**PHOTOGRAPH #38**

**WALKWAYS – SIXTH FLOOR**  
**Concrete Repairs**

Damaged reinforcing steel fully exposed, cleaned and epoxy coated at the overhead walkway deck.

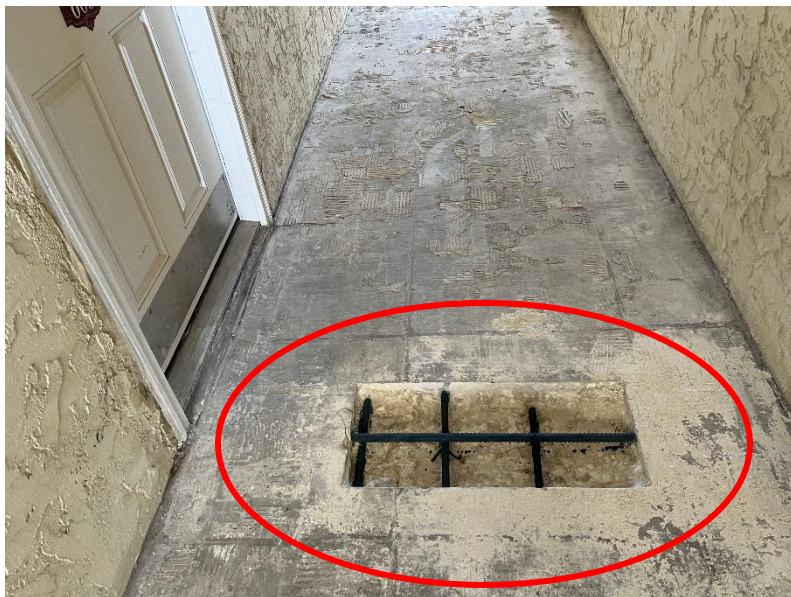
**PHOTOGRAPH #39**

**WALKWAYS – SIXTH FLOOR**  
**Concrete Repairs**

Damaged reinforcing steel fully exposed, cleaned and epoxy coated at the walkway deck.

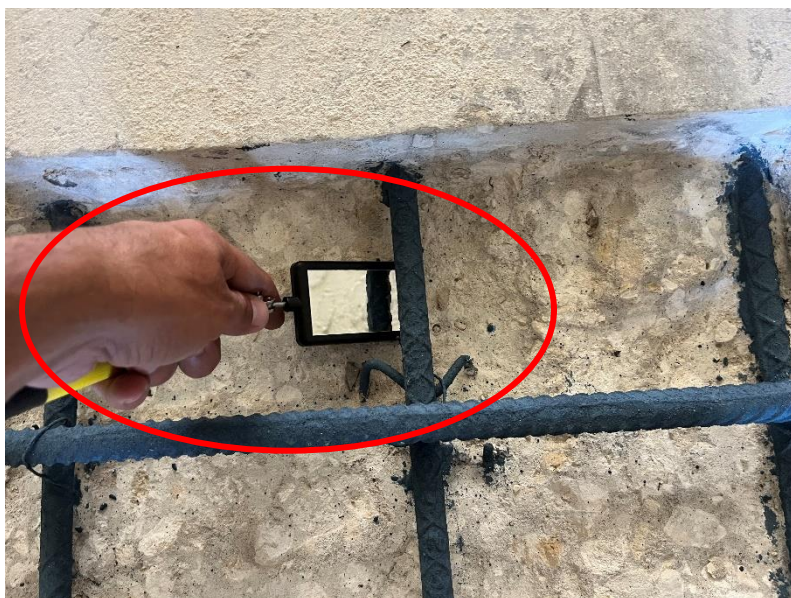
**PHOTOGRAPH #40**

**WALKWAYS – SIXTH FLOOR**  
**Concrete Repairs**

Epoxy coating not fully applied over reinforcing steel.

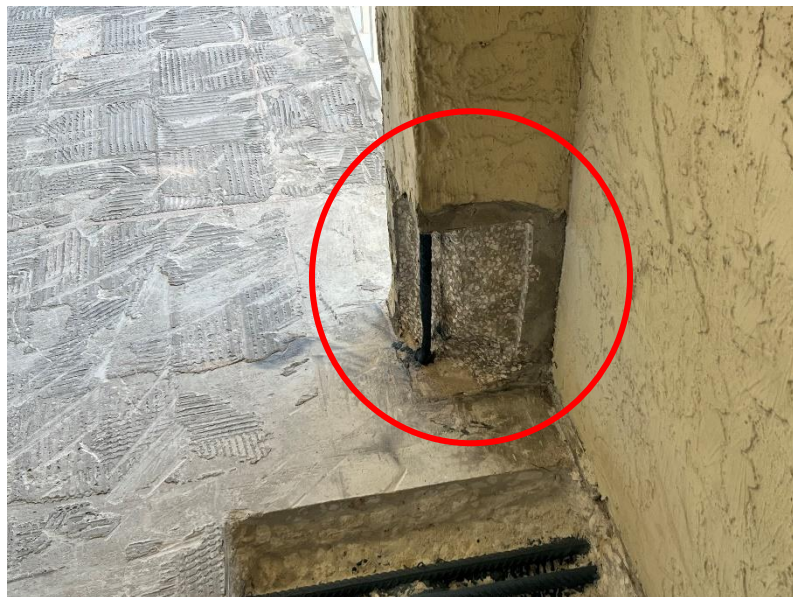
**PHOTOGRAPH #41**

**WALKWAYS – SIXTH FLOOR**  
**Concrete Repairs**

Damaged reinforcing steel fully exposed, cleaned and epoxy coated at the column.

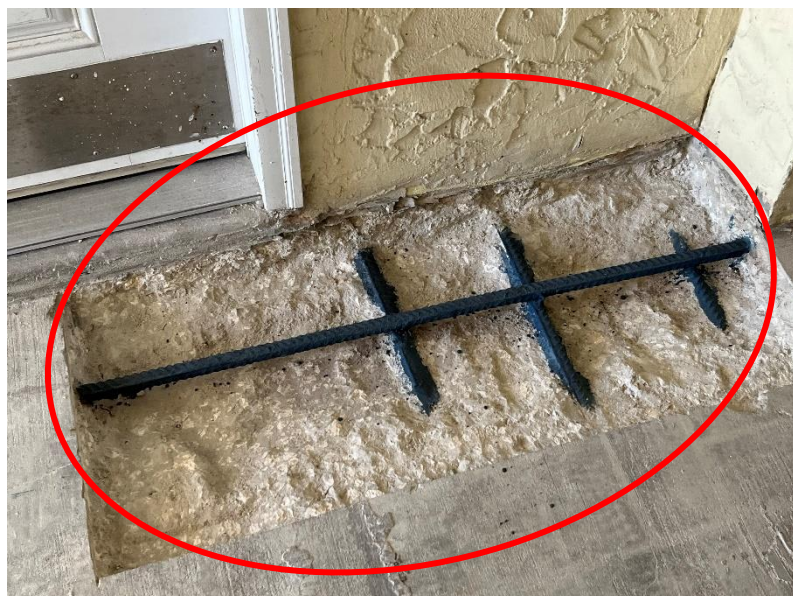
**PHOTOGRAPH #42**

**WALKWAYS – FIFTH FLOOR**  
**Concrete Repairs**

Damaged reinforcing steel fully exposed, cleaned and epoxy coated at the walkway deck.

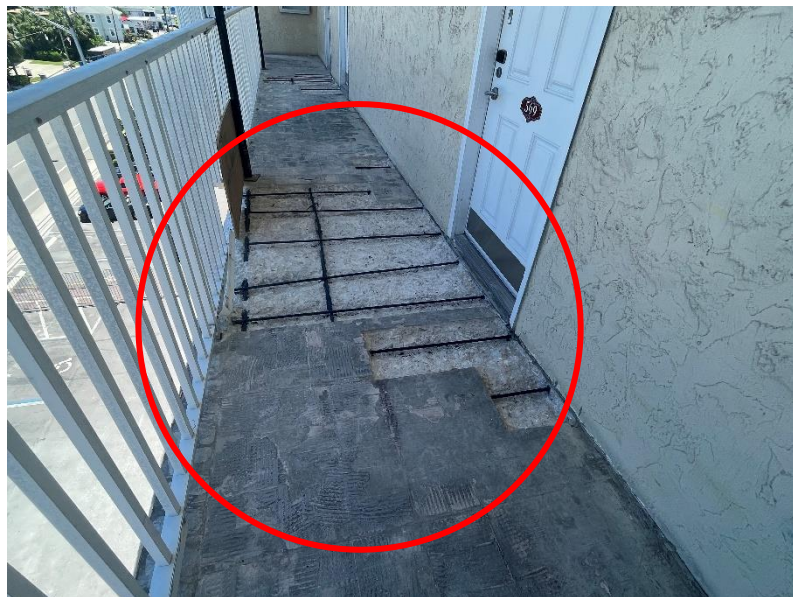
**PHOTOGRAPH #43**

**WALKWAYS – FIFTH FLOOR**  
**Concrete Repairs**

Damaged reinforcing steel fully exposed, cleaned and epoxy coated at the walkway deck.

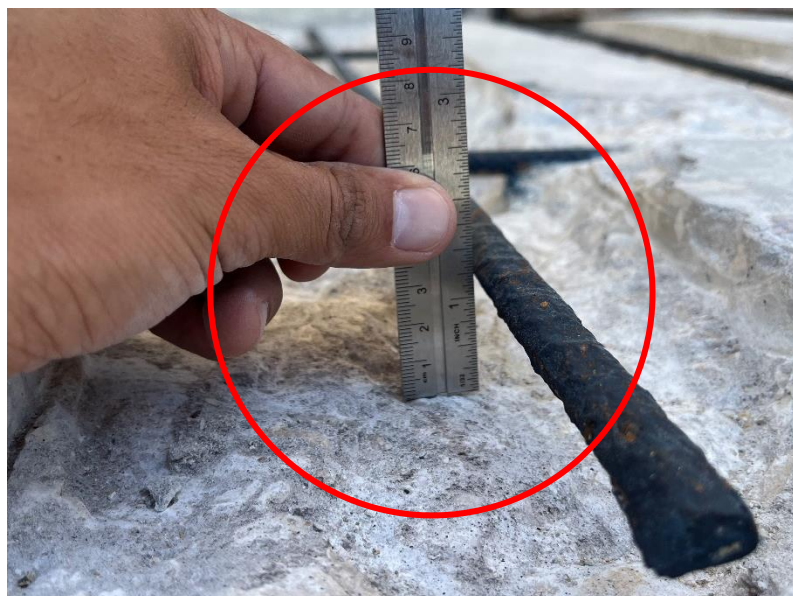
**PHOTOGRAPH #44**

**WALKWAYS – FIFTH FLOOR**  
**Concrete Repairs**

Area underneath reinforcing steel for new concrete coverage is 3/4" minimum as per manufacturer's installation instructions.

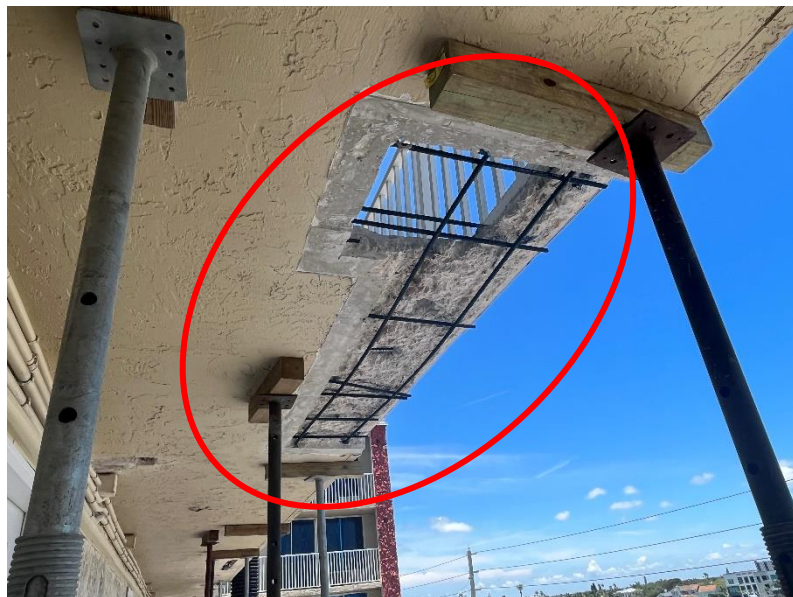
**PHOTOGRAPH #45**

**WALKWAYS – FOURTH FLOOR**  
**Concrete Repairs**

Damaged reinforcing steel fully exposed, cleaned and epoxy coated at the overhead walkway deck.
