**FIELD OBSERVATION REPORT – WEEK OF: 5/8/2023**

Permit No.: \_\_\_\_\_  
Owner: Island Inn Condominium Association, Inc.  
Project Address: 9980 Gulf Blvd., Treasure Island, FL 33706  
Contractor: RL James, Inc.  
Inspector(s): Justin Chavis, EI and Dan Reed  
Type of Assessment: Progress

Project No.: R2107-012  
Contact: John Aucamp  
Phone: 201-595-9313  
Contact: Bob Branscombe  
Phone: 239-980-3149

R2107-012 Island Inn, Concrete Repairs:

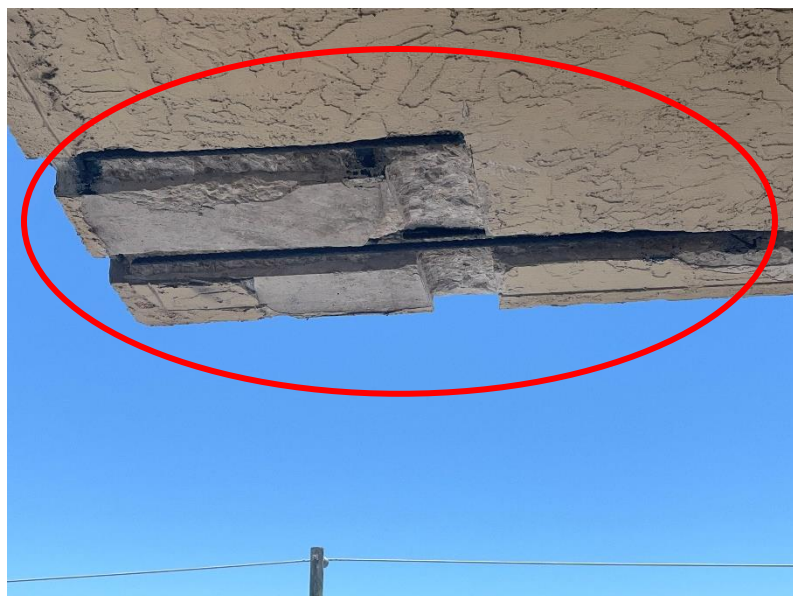
**PHOTOGRAPH #46**

**WALKWAYS – FOURTH FLOOR**  
**Concrete Repairs**

Damaged reinforcing steel fully exposed, cleaned and epoxy coated at the overhead walkway deck.

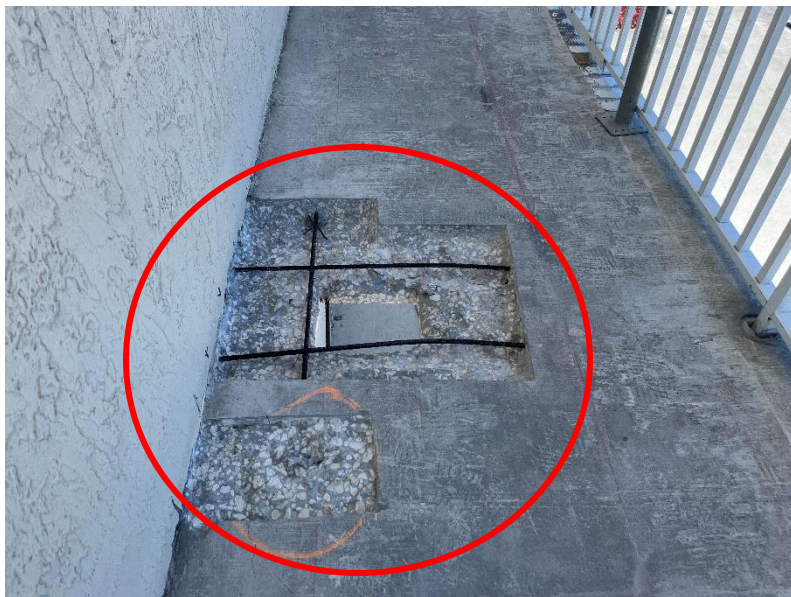
**PHOTOGRAPH #47**

**WALKWAYS – THIRD FLOOR**  
**Concrete Repairs**

Damaged reinforcing steel fully exposed, cleaned and epoxy coated at the walkway deck.

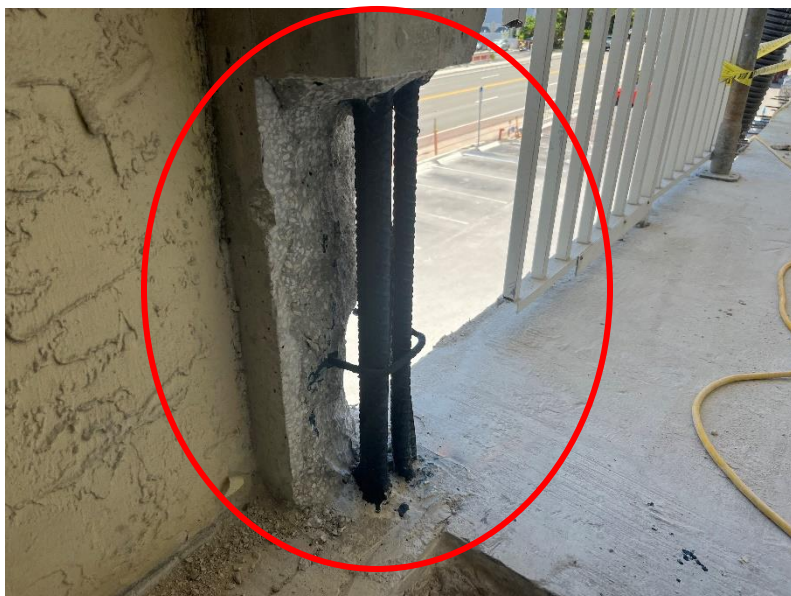
**PHOTOGRAPH #48**

**WALKWAYS – THIRD FLOOR**  
**Concrete Repairs**

Damaged concrete removed and rusted reinforcing steel fully exposed in preparation for concrete repairs.

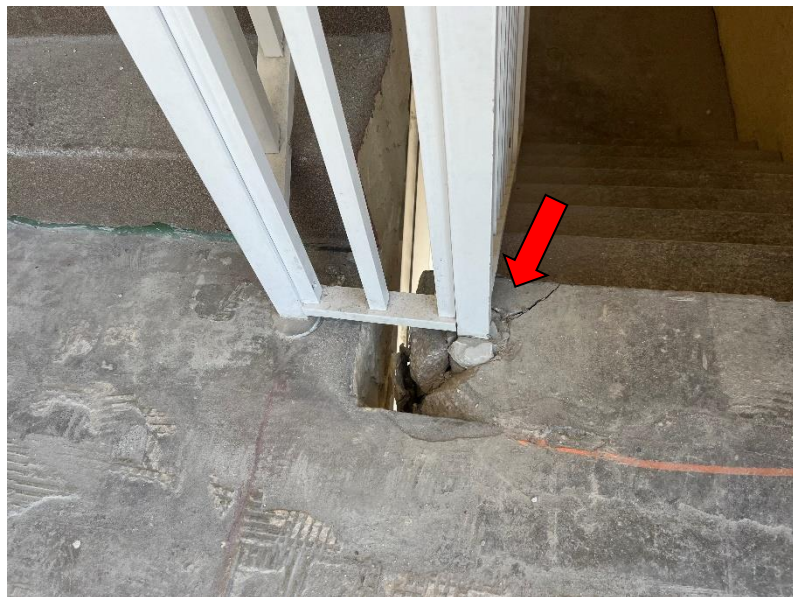
**PHOTOGRAPH #49**

**WALKWAYS – THIRD FLOOR**  
**Concrete Repairs**

Damaged concrete observed at the walkway staircase.

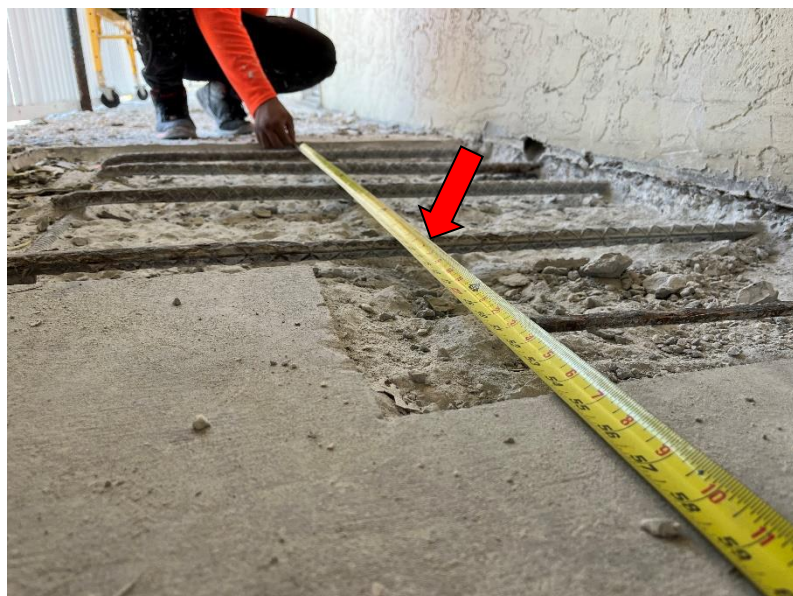
**PHOTOGRAPH #50**

**WALKWAYS – SECOND FLOOR**  
**Concrete Repairs**

Existing reinforcing steel does not have proper concrete coverage of 3/4" minimum. This is typical of many areas throughout the walkway and balcony decks.
