**FIELD OBSERVATION REPORT – WEEK OF: 7/3/2023**

Project No.: R2107-012  
Contact: John Aucamp  
Phone: 201-595-9313  
Contact: Bob Branscombe  
Phone: 239-980-3149

**FIELD OBSERVATION REPORT – WEEK OF: 7/3/2023**  
**R2107-012 Island Inn, Concrete Repairs:**

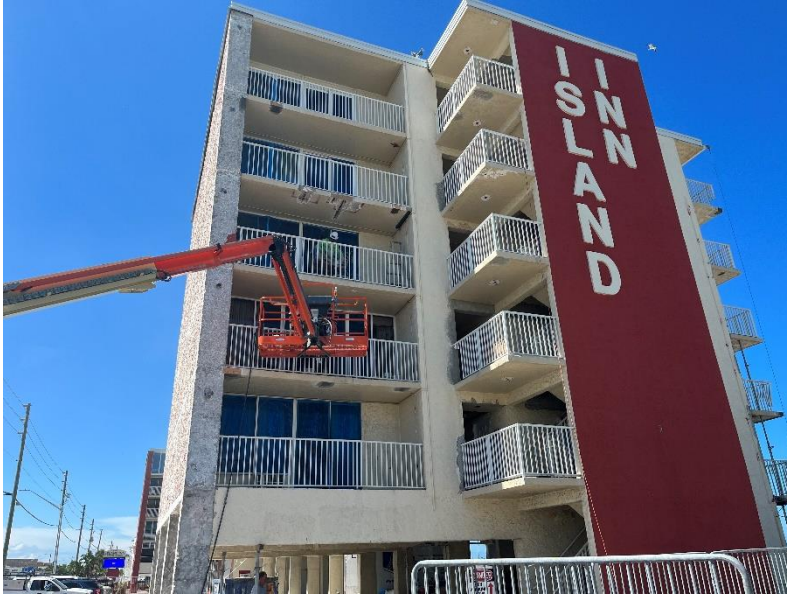
**PHOTOGRAPH #1**

### **ISLAND INN Overview**

Overview of the progress of work.

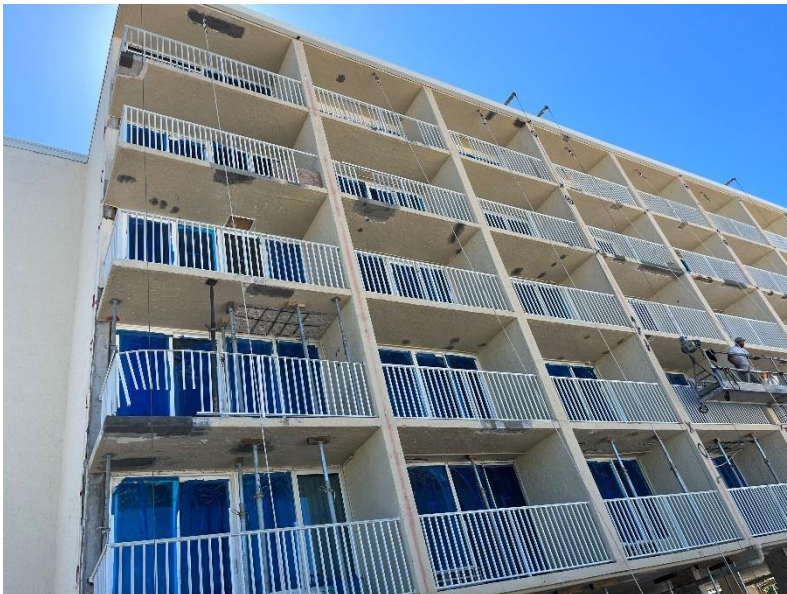
**PHOTOGRAPH #2**

### **ISLAND INN Overview**

Overview of the progress of work.

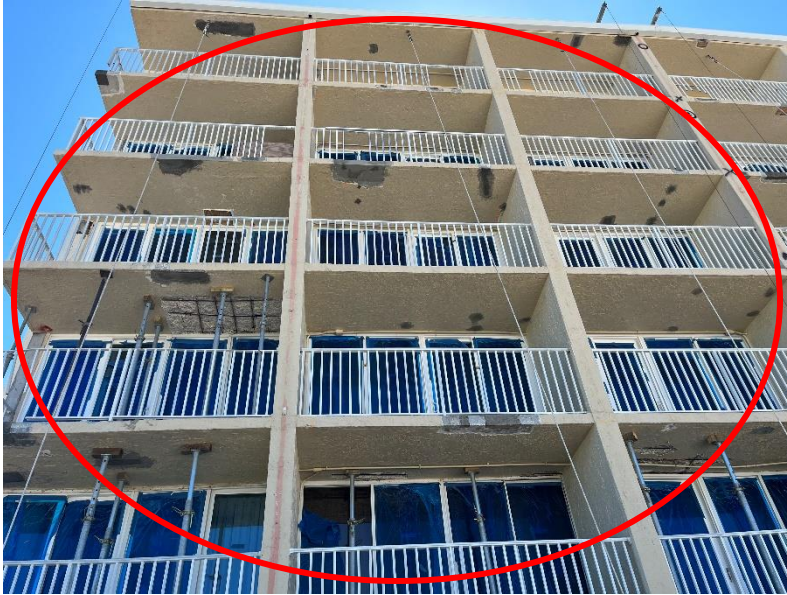
**PHOTOGRAPH #3**

**DROP #1 – REAR BALCONIES**  
**Concrete Repairs**

Application of repair mortar to damaged concrete areas in progress at the rear balcony decks and ceilings.

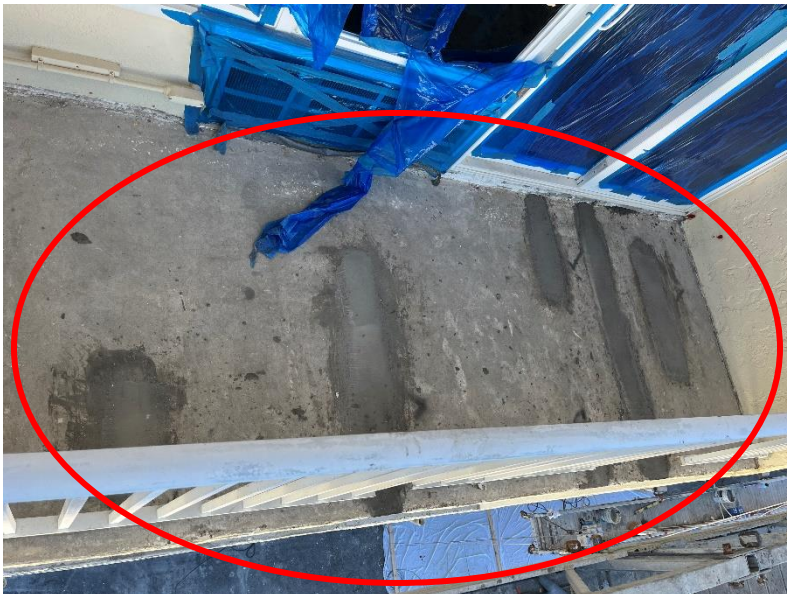
**PHOTOGRAPH #4**

**DROP #1 – SIXTH FLOOR**  
**Concrete Repairs**

Application of repair mortar to damaged concrete areas in progress at the rear balcony decks and ceilings.

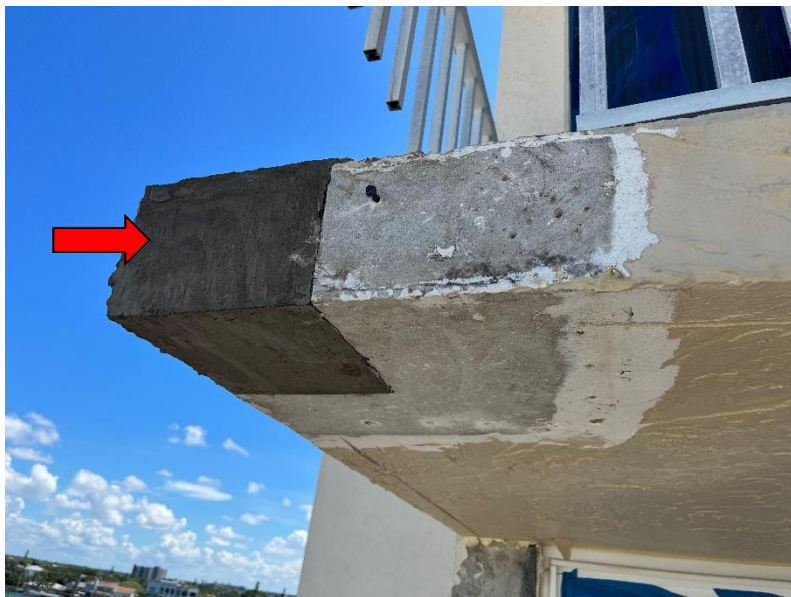
**PHOTOGRAPH #5**

**DROP #1 – SIXTH FLOOR  
Concrete Repairs**

Application of repair mortar to damaged concrete areas in progress at the rear balcony decks and ceilings.

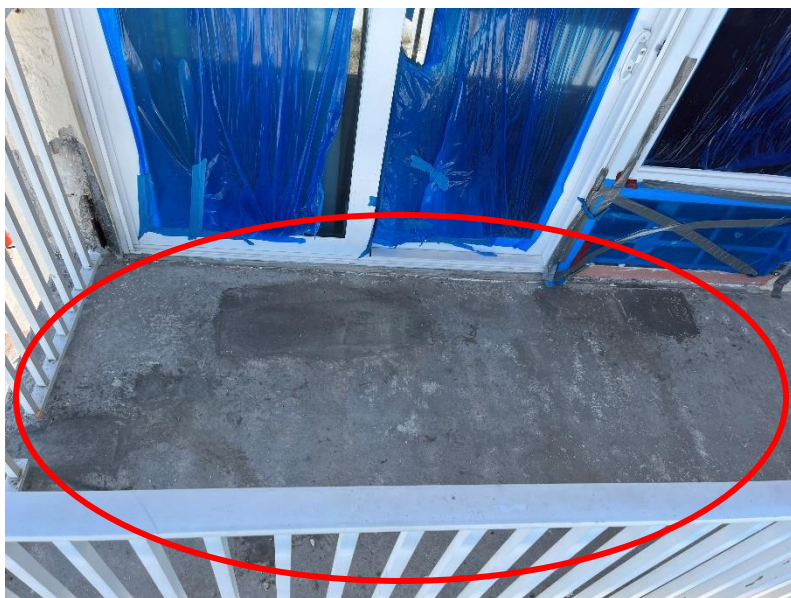
**PHOTOGRAPH #6**

**DROP #1 – FIFTH FLOOR  
Concrete Repairs**

Application of repair mortar to damaged concrete areas in progress at the rear balcony decks and ceilings.

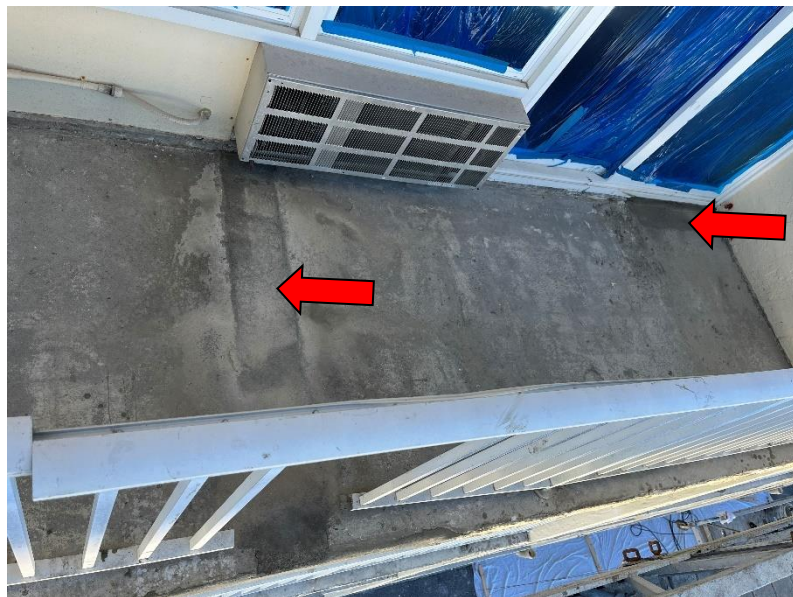
**PHOTOGRAPH #7**

**DROP #1 – FIFTH FLOOR  
Concrete Repairs**

Application of repair mortar to damaged concrete areas in progress at the rear balcony decks and ceilings.

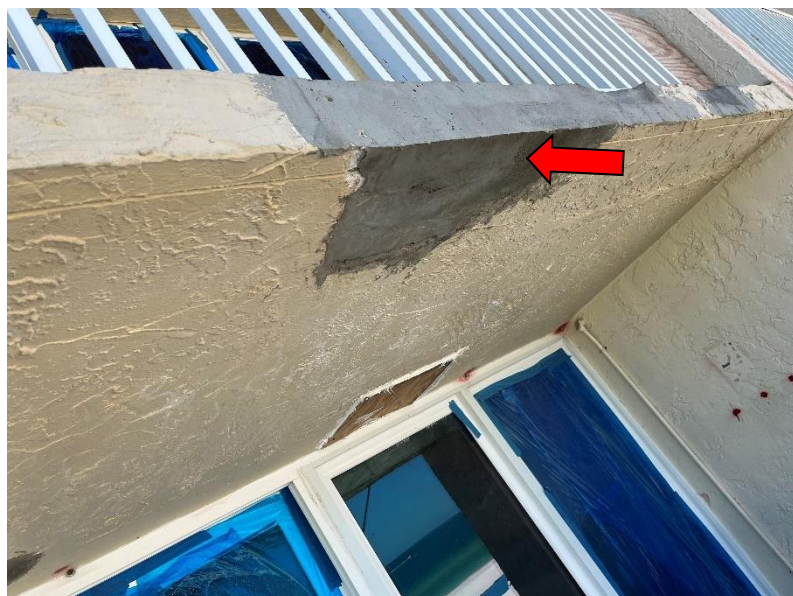
**PHOTOGRAPH #8**

**DROP #1 – FOURTH FLOOR  
Concrete Repairs**

Application of repair mortar to damaged concrete areas in progress at the rear balcony decks and ceilings.

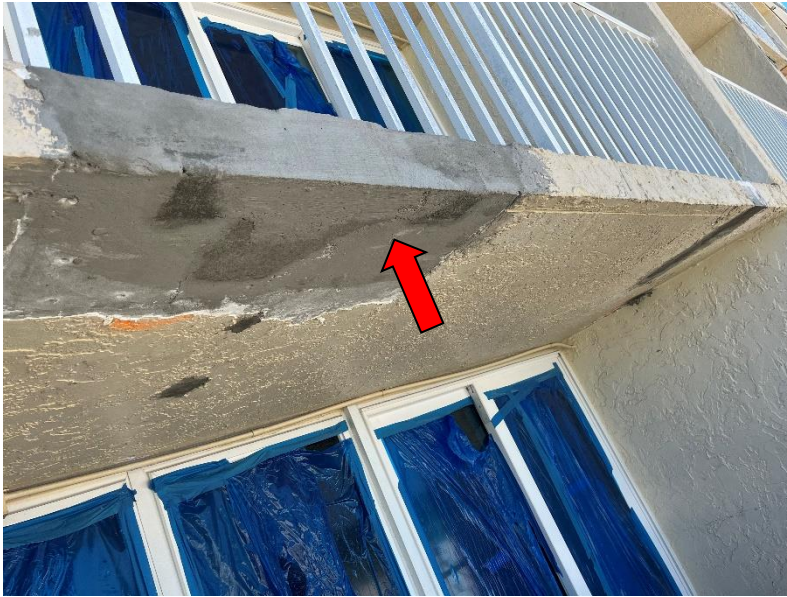
**PHOTOGRAPH #9**

**DROP #1 – FOURTH FLOOR  
Concrete Repairs**

Application of repair mortar to damaged concrete areas in progress at the rear balcony decks and ceilings.

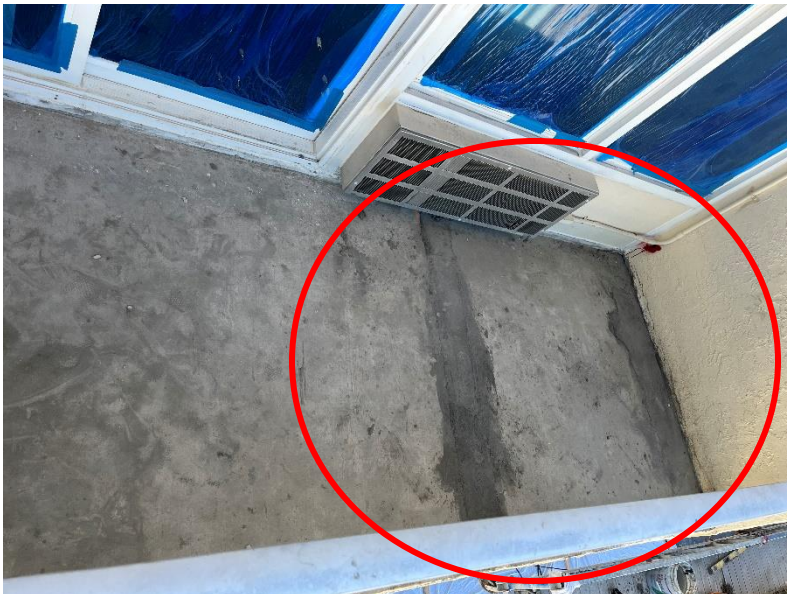
**PHOTOGRAPH #10**

**DROP #1 – FOURTH FLOOR  
Concrete Repairs**

Application of repair mortar to damaged concrete areas in progress at the rear balcony decks and ceilings.

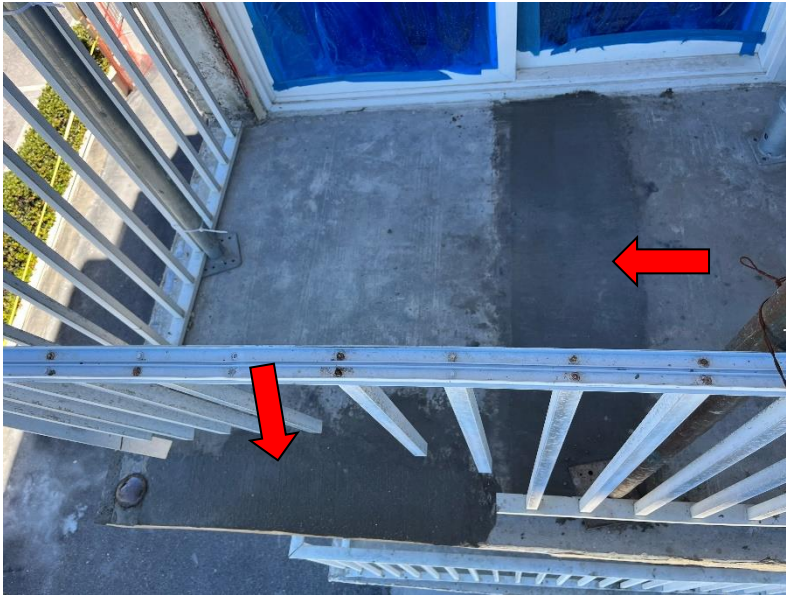
**PHOTOGRAPH #11**

**DROP #1 – THIRD FLOOR  
Concrete Repairs**

Application of repair mortar to damaged concrete areas in progress at the rear balcony decks and ceilings.

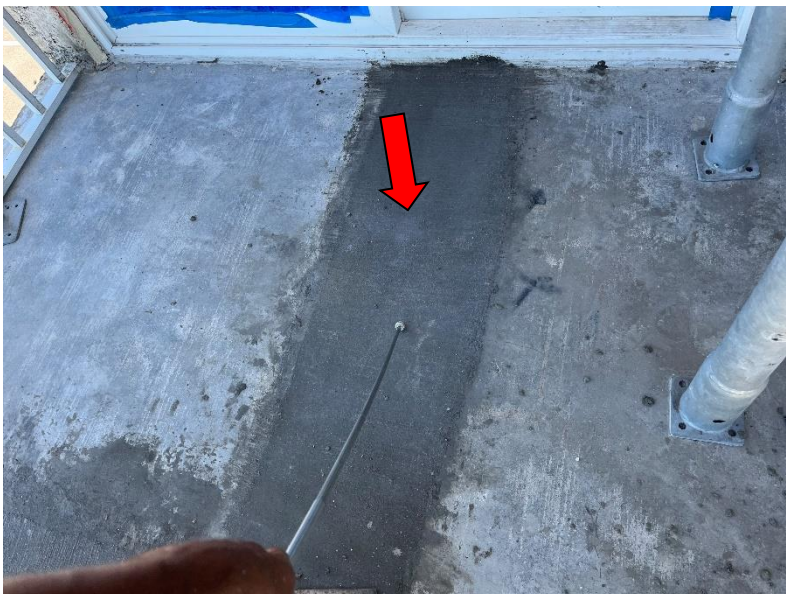
**PHOTOGRAPH #12**

**DROP #1 – THIRD FLOOR  
Concrete Repairs**

Application of repair mortar to damaged concrete areas in progress at the rear balcony decks and ceilings. Repaired areas sounded for proper adhesion of new repair mortar to existing concrete.

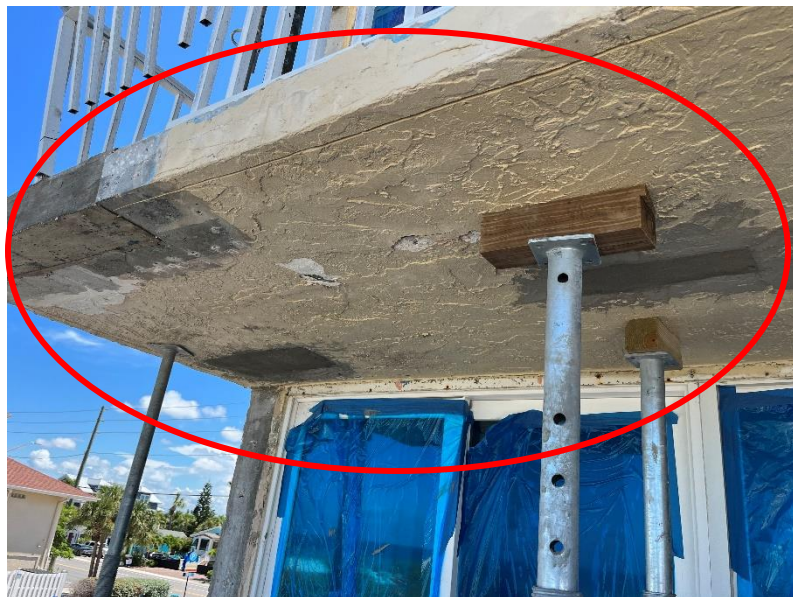
**PHOTOGRAPH #13**

**DROP #1 – SECOND FLOOR  
Concrete Repairs**

Application of repair mortar to damaged concrete areas in progress at the rear balcony decks and ceilings.

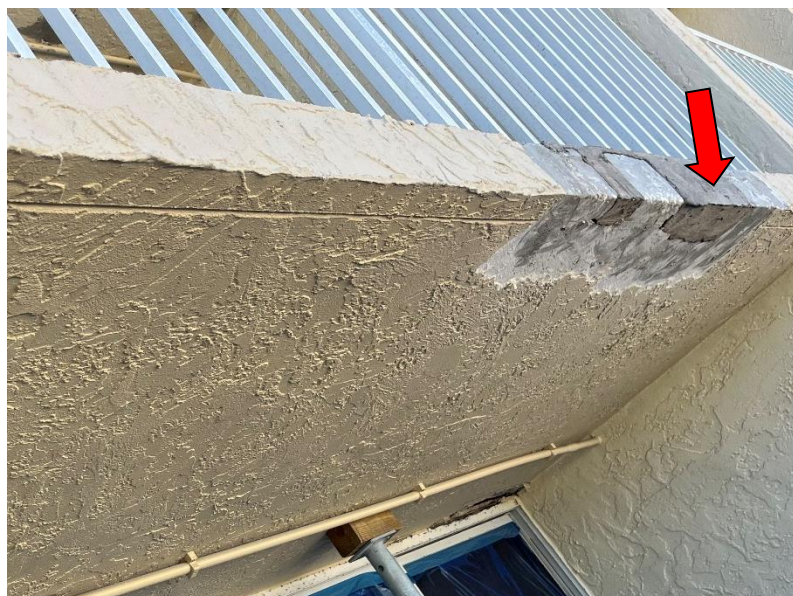
**PHOTOGRAPH #14**

**DROP #1 – SECOND FLOOR  
Concrete Repairs**

Application of repair mortar to damaged concrete areas in progress at the rear balcony decks and ceilings.

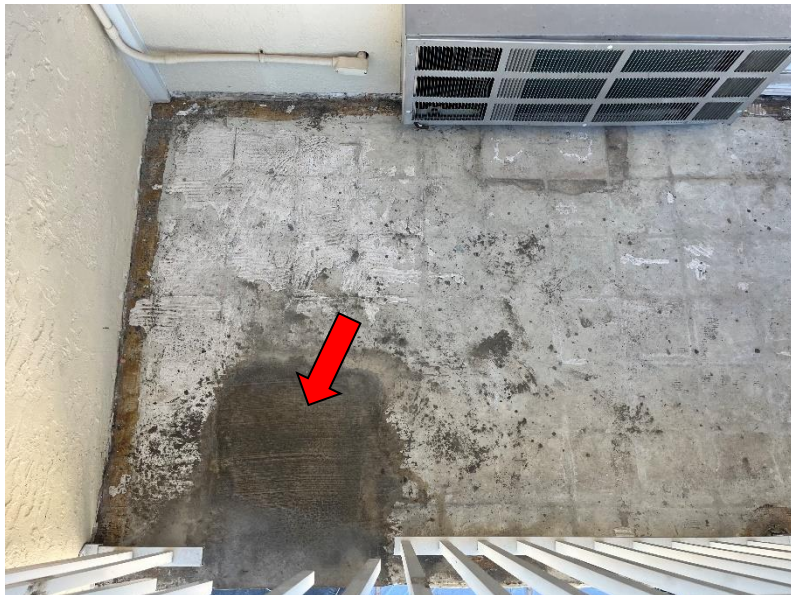
**PHOTOGRAPH #15**

**DROP #2 – SIXTH FLOOR  
Concrete Repairs**

Application of repair mortar to damaged concrete areas in progress at the rear balcony decks and ceilings.

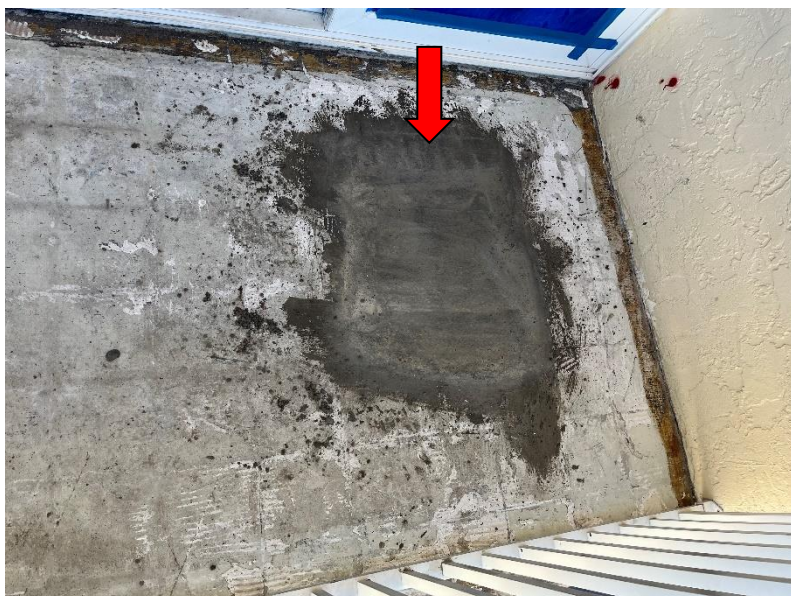
**PHOTOGRAPH #16**

**DROP #2 – SIXTH FLOOR  
Concrete Repairs**

Application of repair mortar to damaged concrete areas in progress at the rear balcony decks and ceilings.

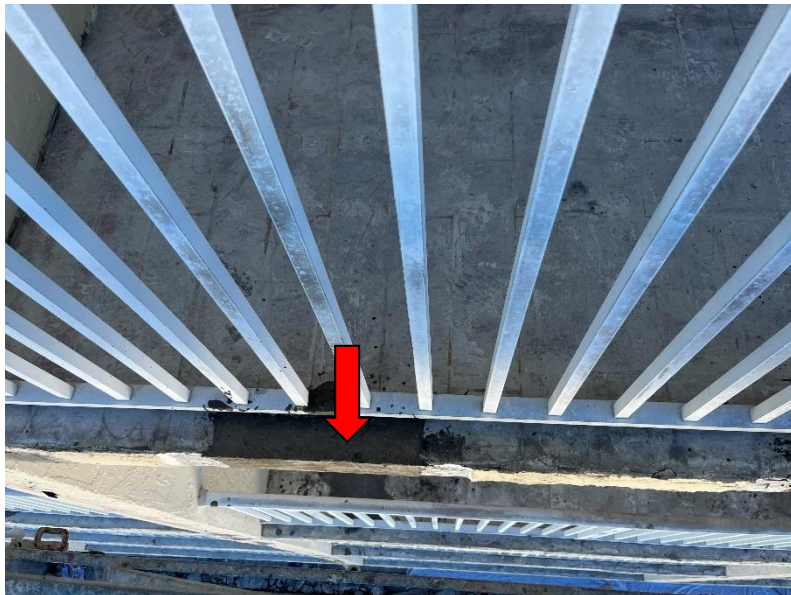
**PHOTOGRAPH #17**

**DROP #2 – FIFTH FLOOR  
Concrete Repairs**

Application of repair mortar to damaged concrete areas in progress at the rear balcony decks and ceilings.

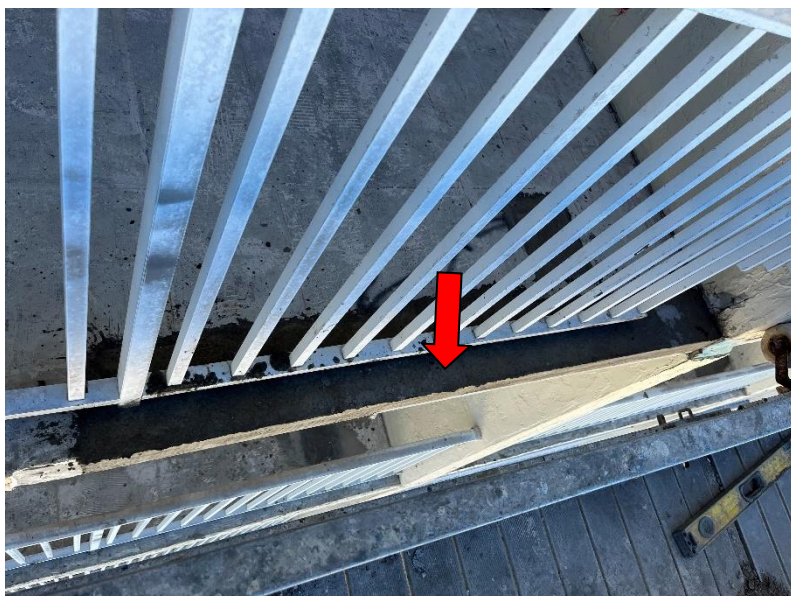
**PHOTOGRAPH #18**

**DROP #2 – FIFTH FLOOR  
Concrete Repairs**

Application of repair mortar to damaged concrete areas in progress at the rear balcony decks and ceilings.

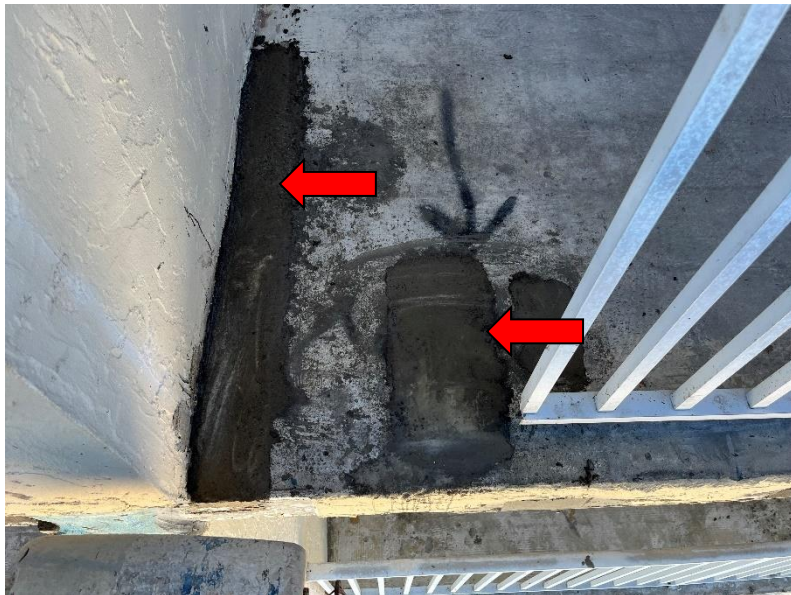
**PHOTOGRAPH #19**

**DROP #2 – FIFTH FLOOR  
Concrete Repairs**

Application of repair mortar to damaged concrete areas in progress at the rear balcony decks and ceilings.

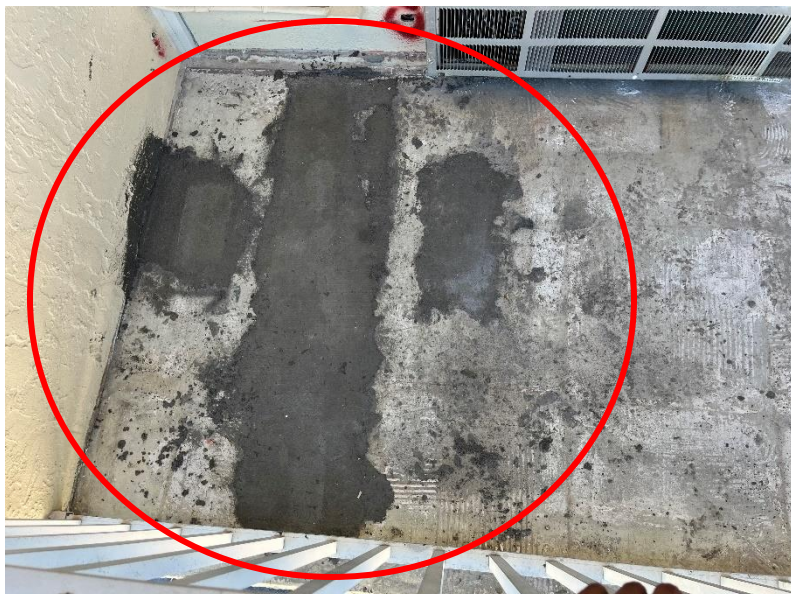
**PHOTOGRAPH #20**

**DROP #2 – FOURTH FLOOR  
Concrete Repairs**

Application of repair mortar to damaged concrete areas in progress at the rear balcony decks and ceilings.

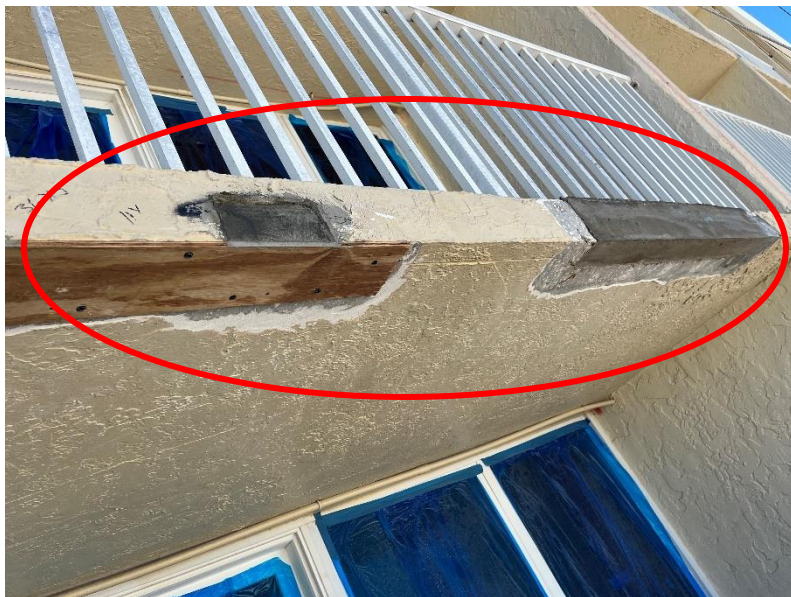
**PHOTOGRAPH #21**

**DROP #2 – FOURTH FLOOR  
Concrete Repairs**

Application of repair mortar to damaged concrete areas in progress at the rear balcony decks and ceilings.

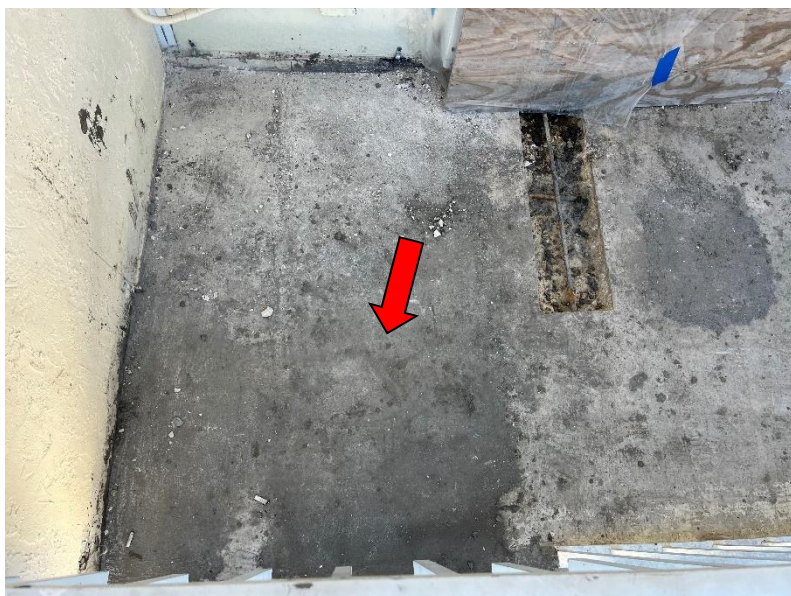
**PHOTOGRAPH #22**

**DROP #2 – FOURTH FLOOR  
Concrete Repairs**

Application of repair mortar to damaged concrete areas in progress at the rear balcony decks and ceilings.

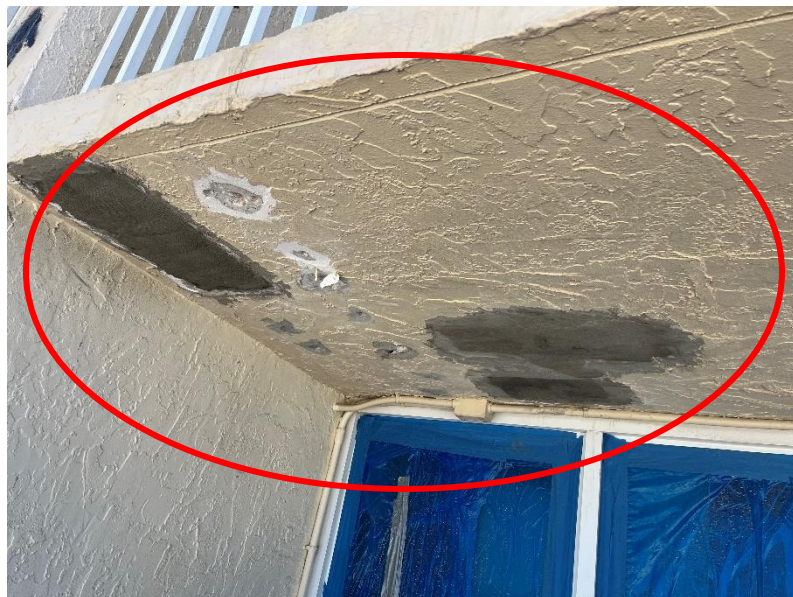
**PHOTOGRAPH #23**

**DROP #2 – THIRD FLOOR  
Concrete Repairs**

Application of repair mortar to damaged concrete areas in progress at the rear balcony decks and ceilings.

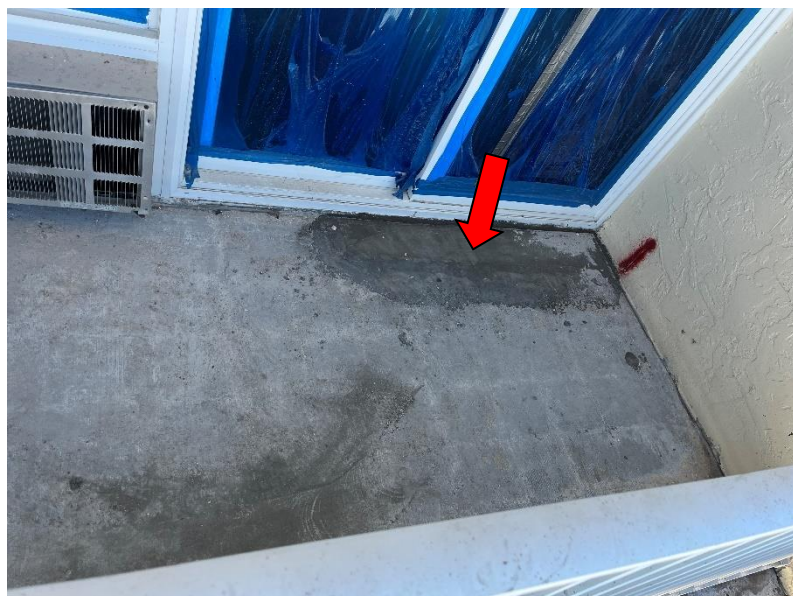
**PHOTOGRAPH #24**

**DROP #2 – THIRD FLOOR  
Concrete Repairs**

Application of repair mortar to damaged concrete areas in progress at the rear balcony decks and ceilings.

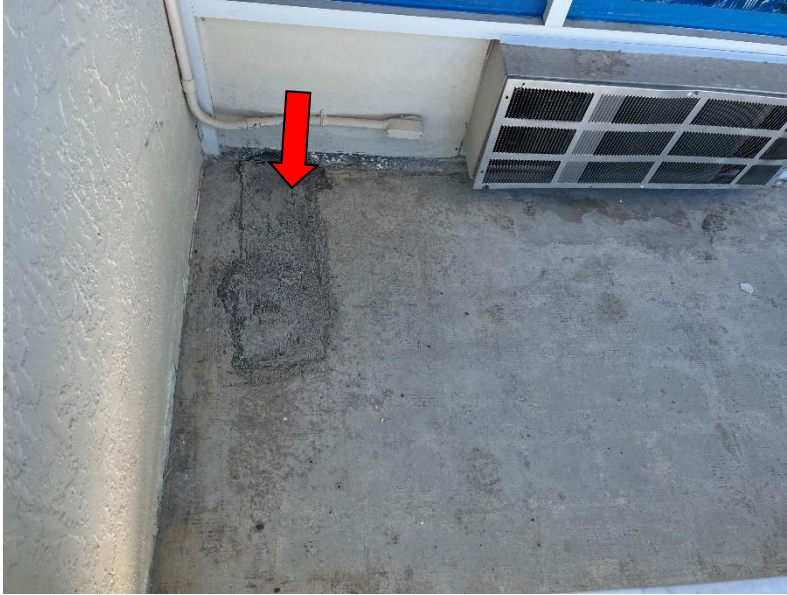
**PHOTOGRAPH #25**

**DROP #2 – THIRD FLOOR  
Concrete Repairs**

Application of repair mortar to damaged concrete areas in progress at the rear balcony decks and ceilings.

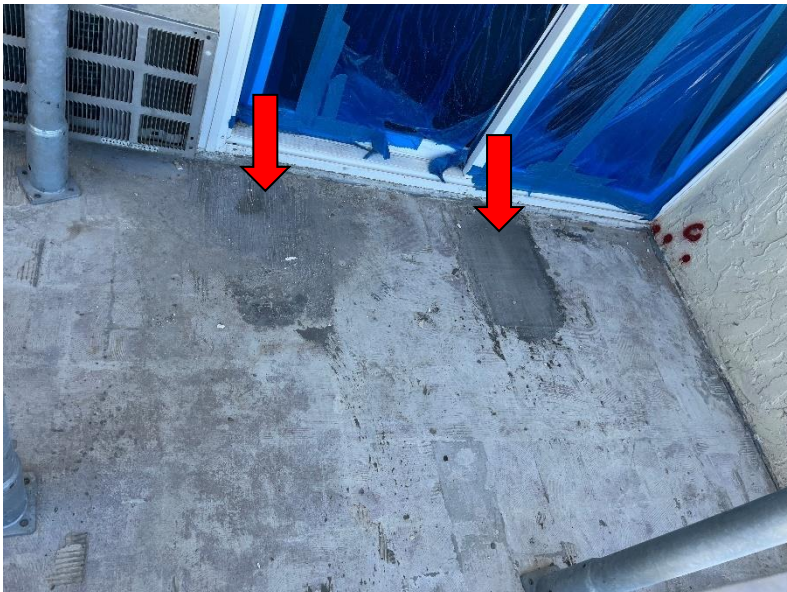
**PHOTOGRAPH #26**

**DROP #2 – SECOND FLOOR  
Concrete Repairs**

Application of repair mortar to damaged concrete areas in progress at the rear balcony decks and ceilings.

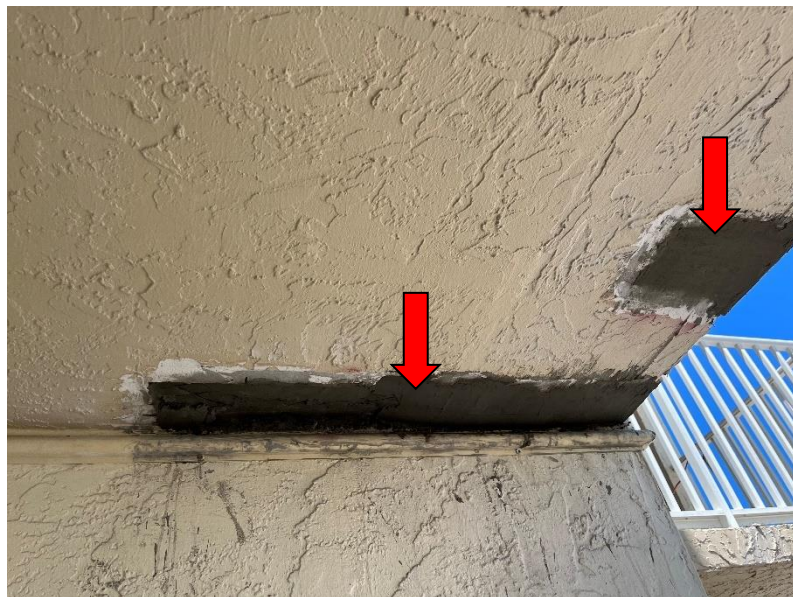
**PHOTOGRAPH #27**

**UNIT #402**  
**Concrete Repairs**

Application of repair mortar to damaged concrete areas in progress at the balcony deck and ceiling.

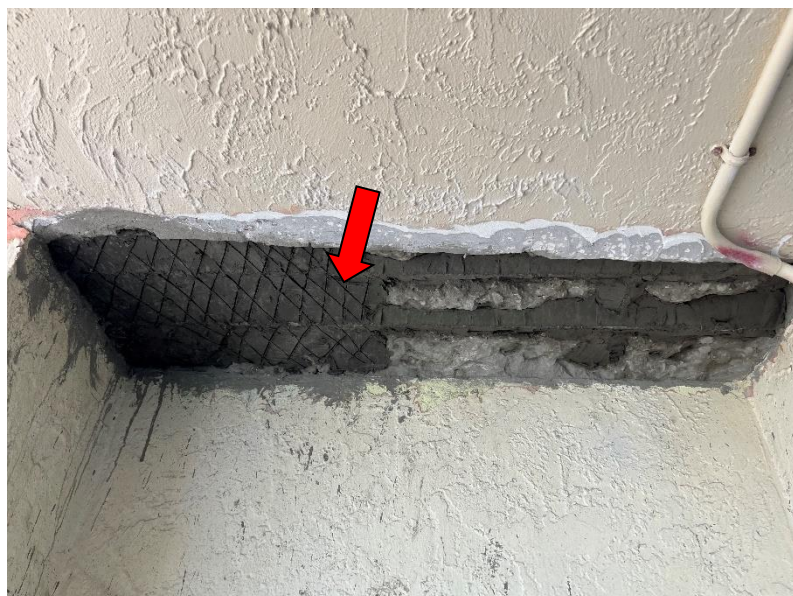
**PHOTOGRAPH #28**

**UNIT #402**  
**Concrete Repairs**

Application of repair mortar to damaged concrete areas in progress at the balcony deck and ceiling.

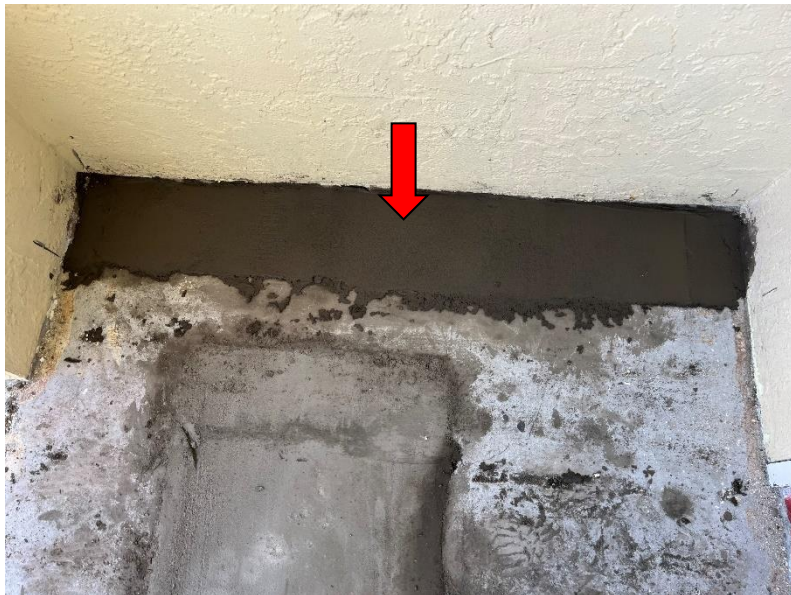
**PHOTOGRAPH #29**

**UNIT #304**  
**Concrete Repairs**

Application of repair mortar to damaged concrete areas in progress at the balcony deck and ceiling.

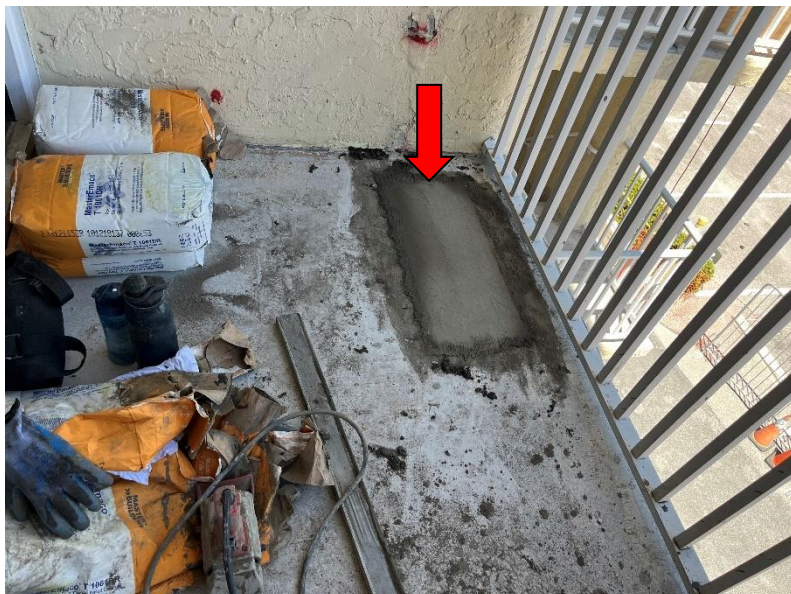
**PHOTOGRAPH #30**

**UNIT #304**  
**Concrete Repairs**

Application of repair mortar to damaged concrete areas in progress at the balcony deck and ceiling.

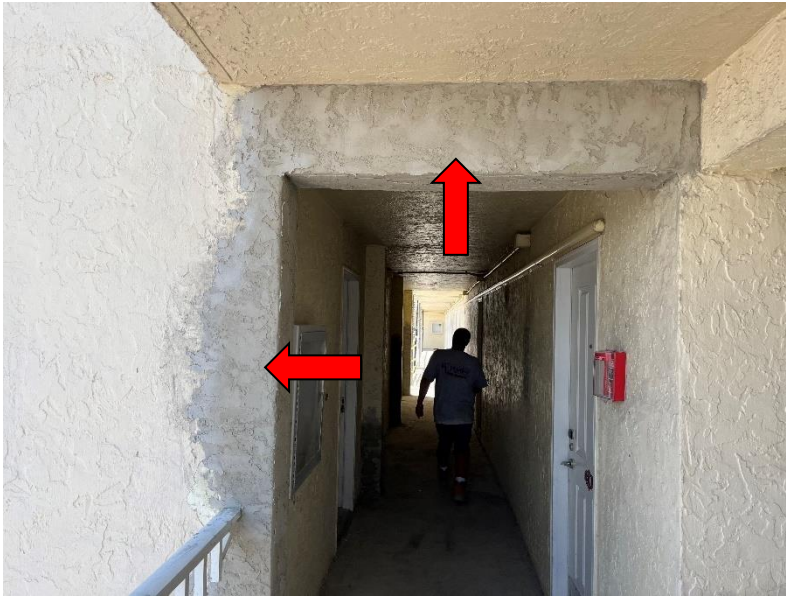
**PHOTOGRAPH #31**

**WALKWAYS – FOURTH FLOOR**  
**Stucco Finish**

Textured stucco finish application to concrete damaged areas at the overhead slab in progress.

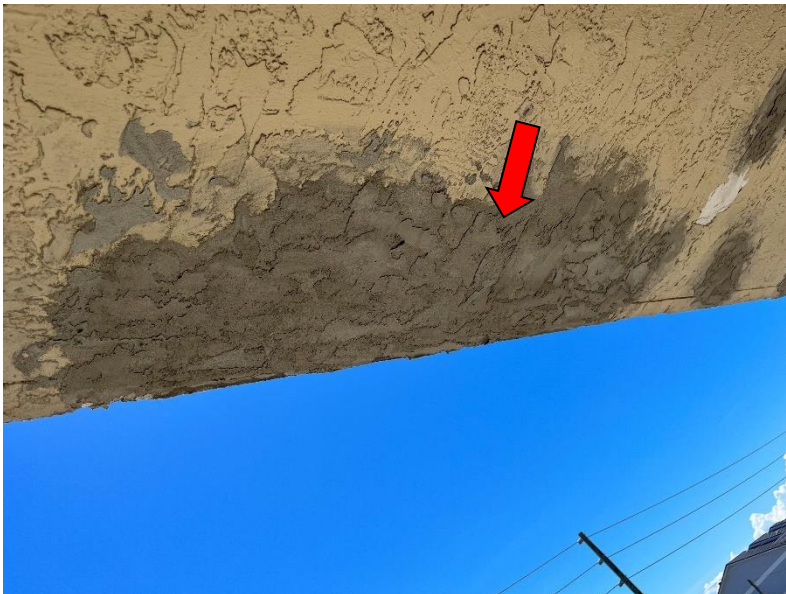
**PHOTOGRAPH #32**

**WALKWAYS – THIRD FLOOR**  
**Stucco Finish**

Textured stucco finish application to concrete damaged areas at the overhead slab in progress.

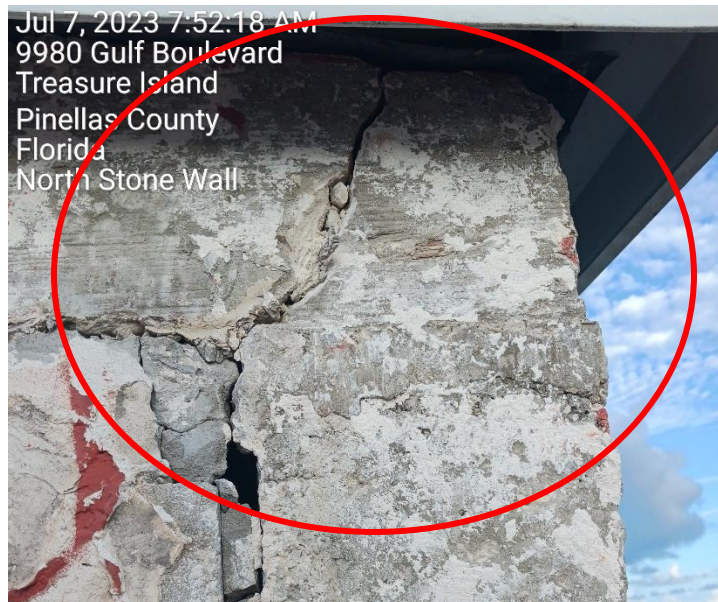
**PHOTOGRAPH #33**

**EAST ELEVATION  
EXTERIOR WALL  
Stone Removal**

After removal of the stone façade along the exterior wall, significant cracking observed in the concrete of the roof slab and support column.

6. Remove damaged CMU block below tie-beam and patch area with repair mortar or 4" CMU solid block with mortar (**See previous report**).
7. Significant structural damage to the roof slab and columns of the exterior wall will require immediate shoring w/ Karin's Engineering involved. In addition, the backside of this wall will need to be exposed from the inside of the units on the top floor, for us to inspect the full extent of damage to gather up the information needed to provide a structural design repair (**Photos #33 - #36**).

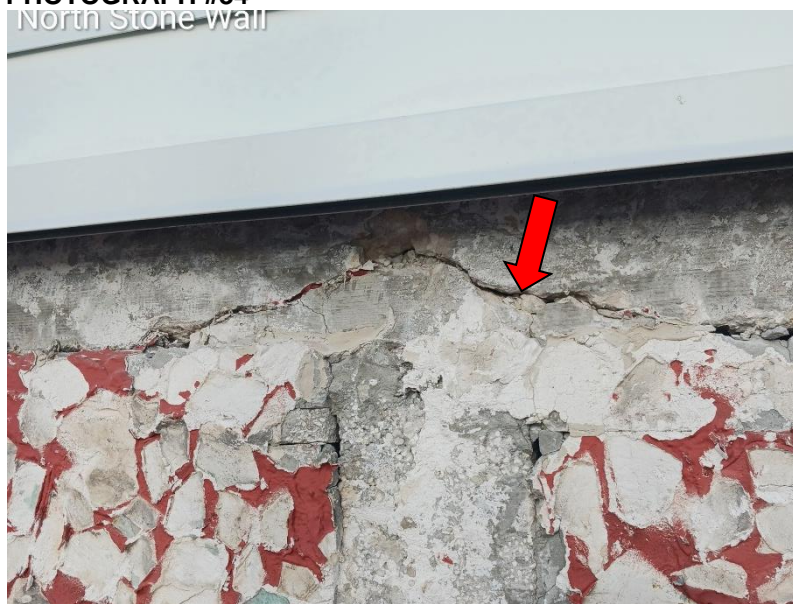
**PHOTOGRAPH #34**

**EAST ELEVATION  
EXTERIOR WALL  
Stone Removal**

After removal of the stone façade along the exterior wall, significant cracking observed in the concrete of the roof slab and support column.

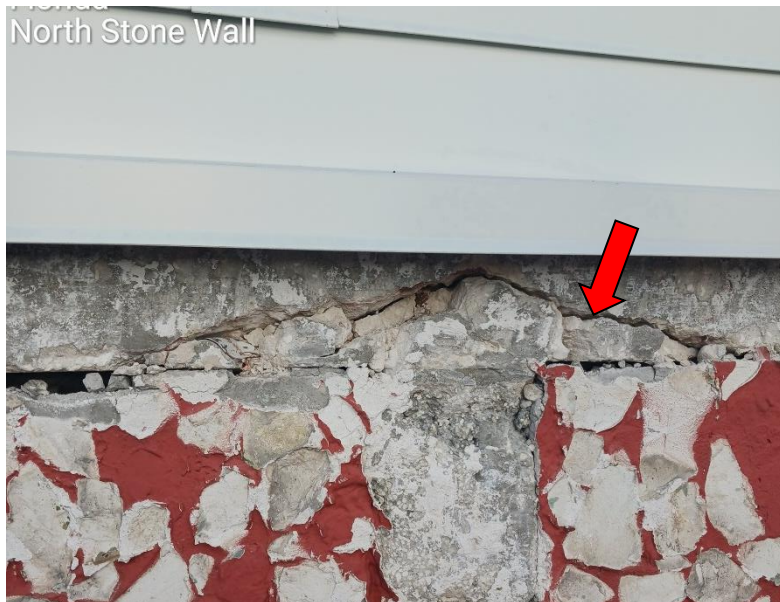
**PHOTOGRAPH #35**

**EAST ELEVATION  
EXTERIOR WALL  
Stone Removal**

After removal of the stone façade along the exterior wall, significant cracking observed in the concrete of the roof slab and support column.

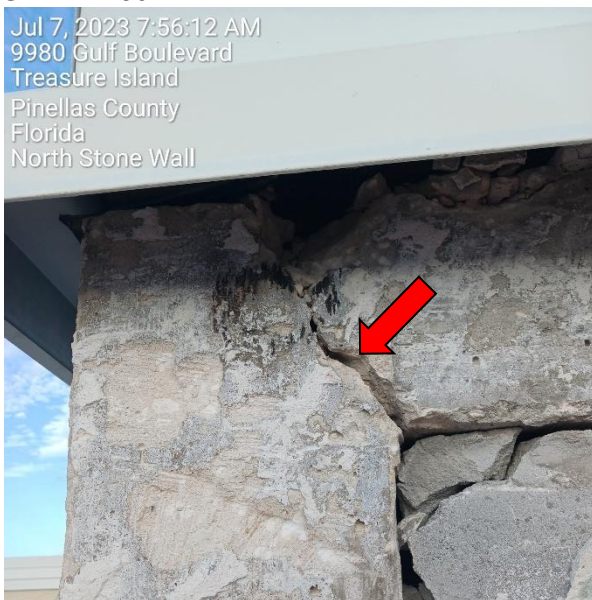
**PHOTOGRAPH #36**

**EAST ELEVATION  
EXTERIOR WALL  
Stone Removal**

After removal of the stone façade along the exterior wall, significant cracking observed in the concrete of the roof slab and support column.
