**FIELD OBSERVATION REPORT – WEEK OF: 11/27/2023**

Permit No.: BLDC-005621-2023  
Owner: Island Inn Condominium Association, Inc.  
Project Address: 9980 Gulf Blvd., Treasure Island, FL 33706  
Contractor: RL James, Inc.  
Inspector(s): Justin Chavis, EI and Dan Reed  
Type of Assessment: Progress

**FIELD OBSERVATION REPORT – WEEK OF: 11/27/2023**  
**R2107-012 Island Inn, Concrete Repairs:**

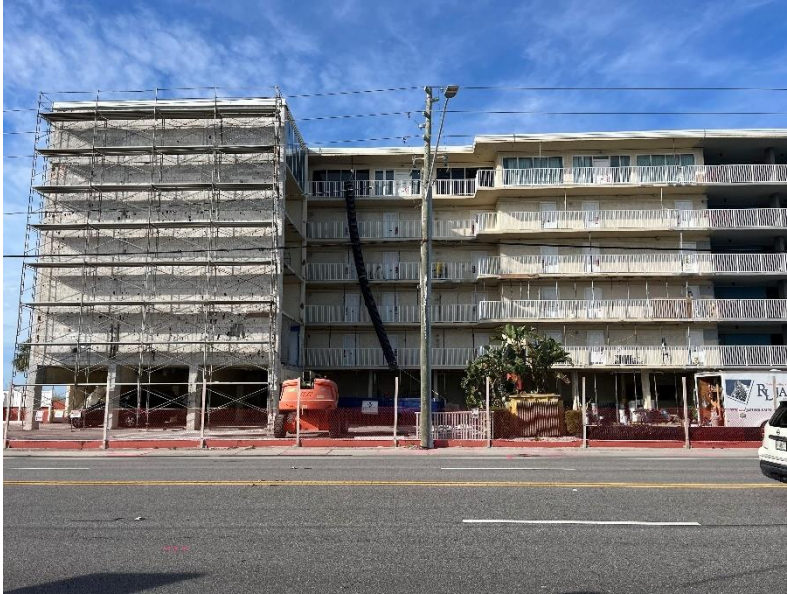
**PHOTOGRAPH #1**

### **ISLAND INN Overview of Work**

Overview of the progress of work. Damaged concrete currently being repaired at walkway and balcony decks on all floor levels.

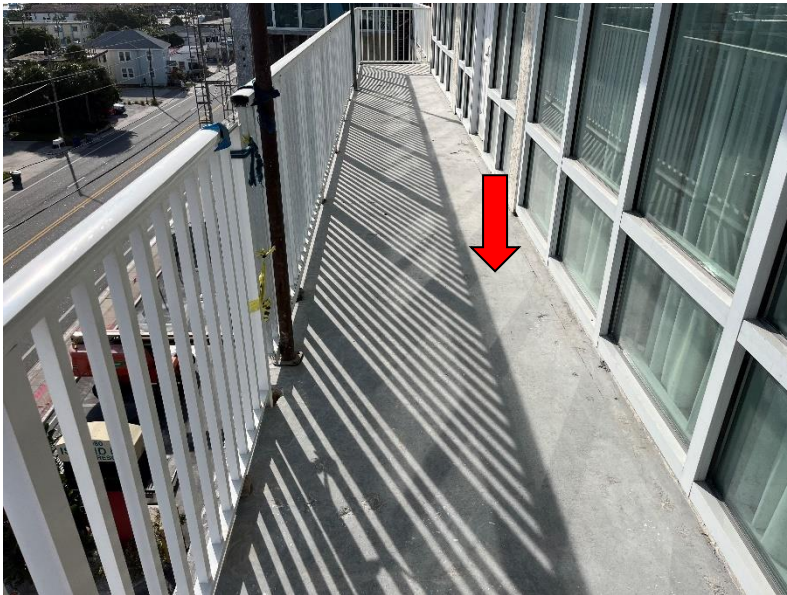
**PHOTOGRAPH #2**

### **SOUTH END WALKWAYS SIXTH FLOOR Deck Waterproofing**

Top surface of concrete slabs currently being scarified and smoothed out at walkway decks.

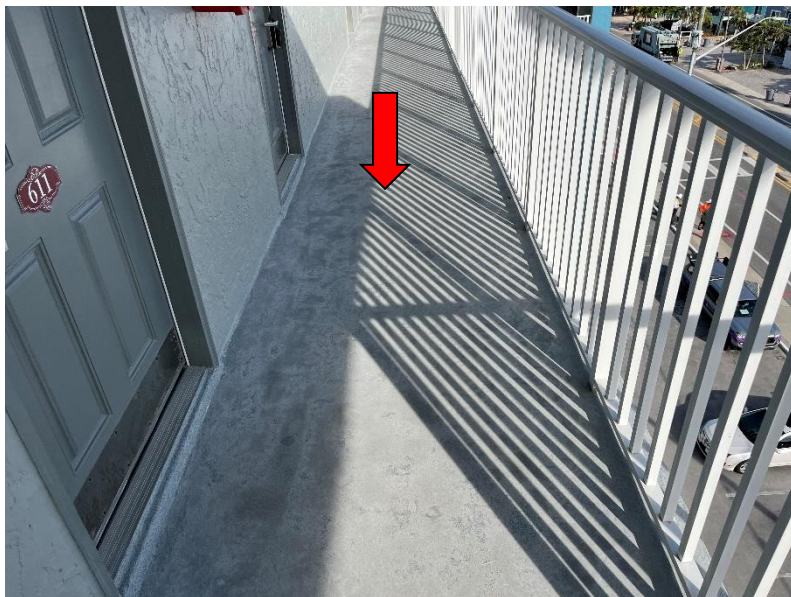
**PHOTOGRAPH #3**

**NORTH END WALKWAYS  
SIXTH FLOOR  
Deck Waterproofing**

Clear coat and top-coat finish stripped from recently applied deck waterproofing in preparation for Gemstone finish application.

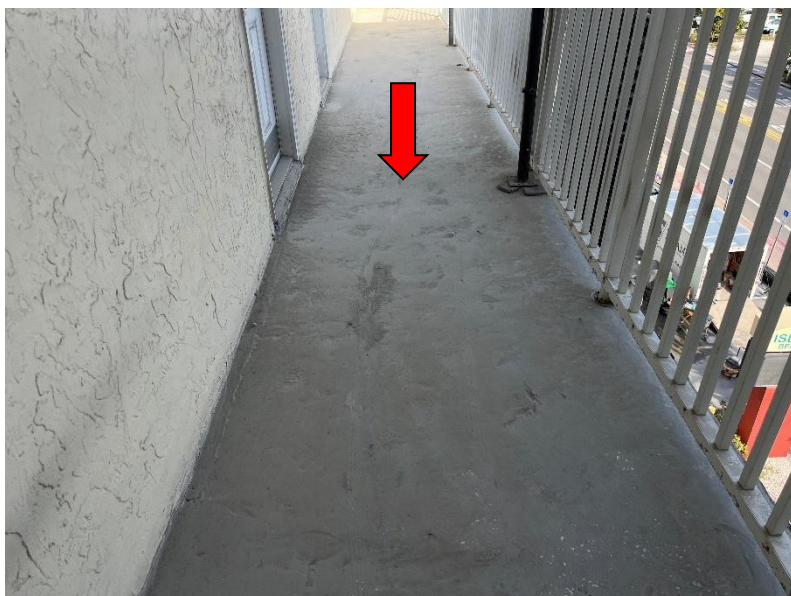
**PHOTOGRAPH #4**

**SOUTH END WALKWAYS  
FIFTH FLOOR  
Deck Waterproofing**

Top surface of concrete slabs currently being scarified and smoothed out at walkway decks.

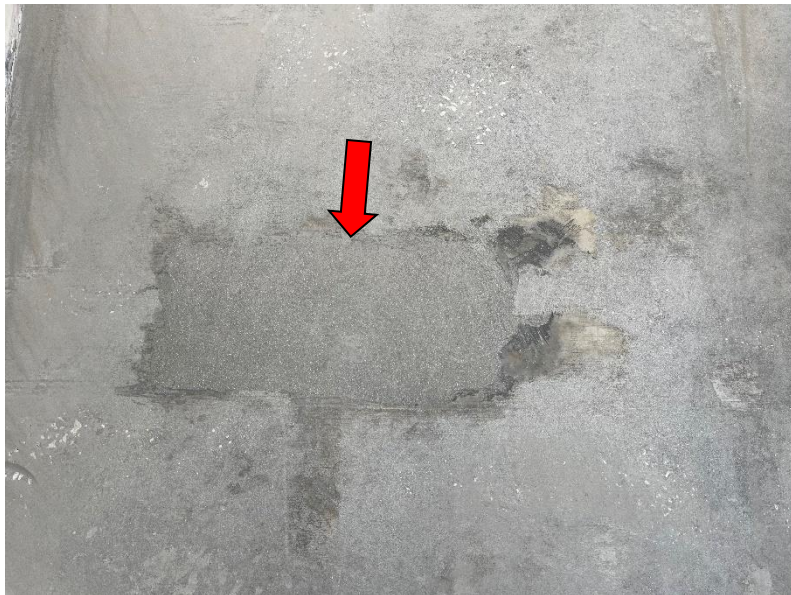
**PHOTOGRAPH #5**

**SOUTH END WALKWAYS  
FIFTH FLOOR  
Concrete Damage**

MasterEmaco 1061 applied at concrete damaged areas along the walkways.

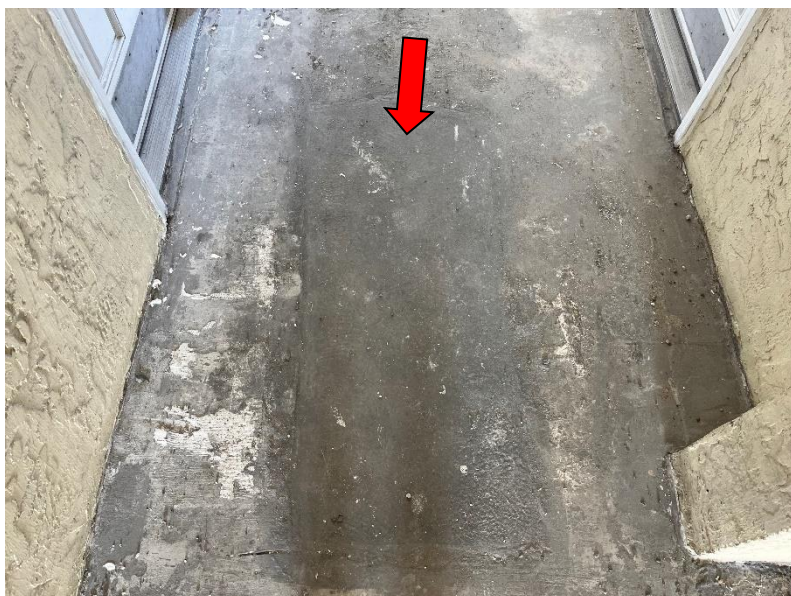
**PHOTOGRAPH #6**

**SOUTH END WALKWAYS  
THIRD FLOOR  
Concrete Damage**

MasterEmaco 1061 applied at concrete damaged areas along the walkways.

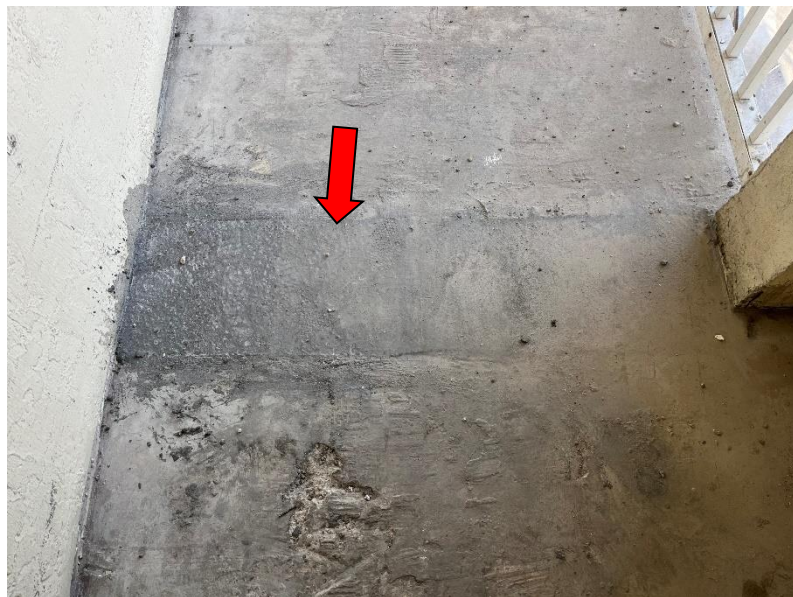
**PHOTOGRAPH #7**

**SOUTH END WALKWAYS  
THIRD FLOOR  
Concrete Damage**

MasterEmaco 1061 applied at concrete damaged areas along the walkways.

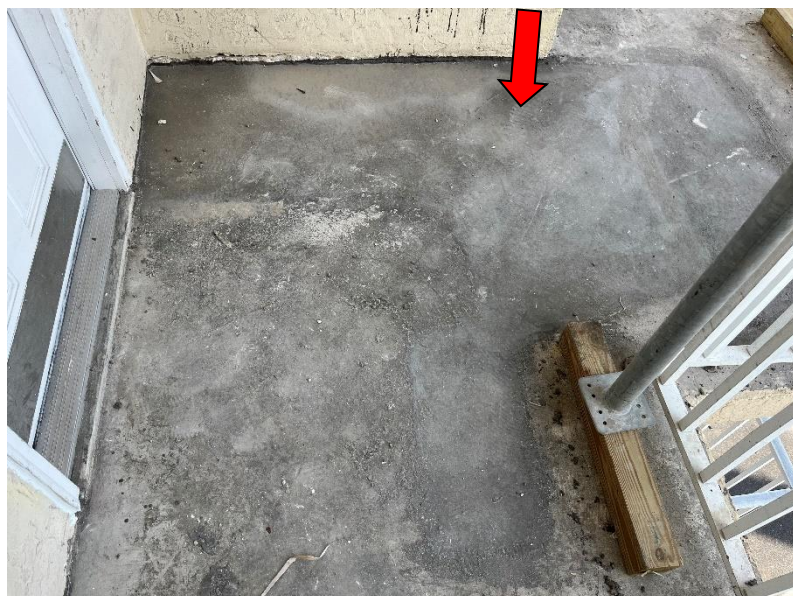
**PHOTOGRAPH #8**

**SOUTH END WALKWAYS  
THIRD FLOOR  
Concrete Damage**

MasterEmaco 1061 applied at concrete damaged areas along the walkways.

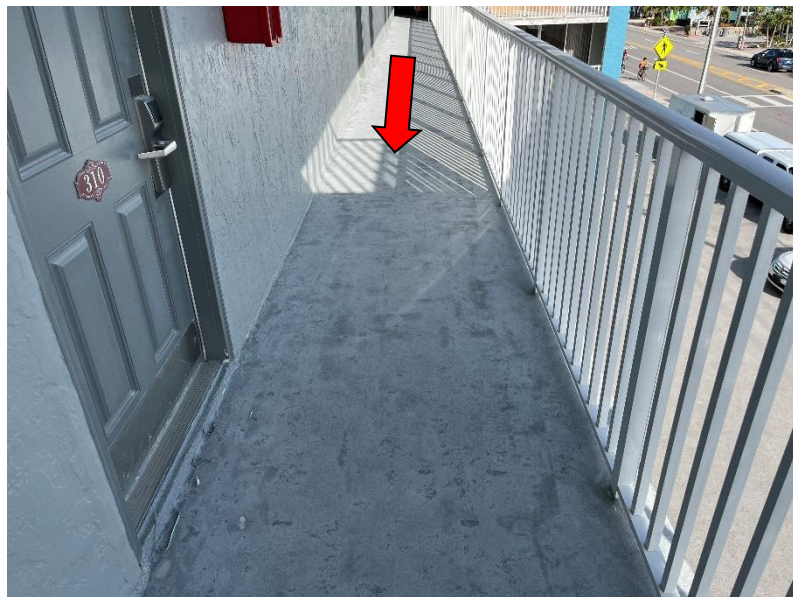
**PHOTOGRAPH #9**

**NORTH END WALKWAYS  
THIRD FLOOR  
Deck Waterproofing**

Clear coat and top-coat finish stripped from recently applied deck waterproofing in preparation for Gemstone finish application.

1. Provide design repair directive, ESI, for damaged reinforcing steel at the support beams and columns along the 2<sup>nd</sup> floor walkway and front balcony (**Photos #9 - #14**).

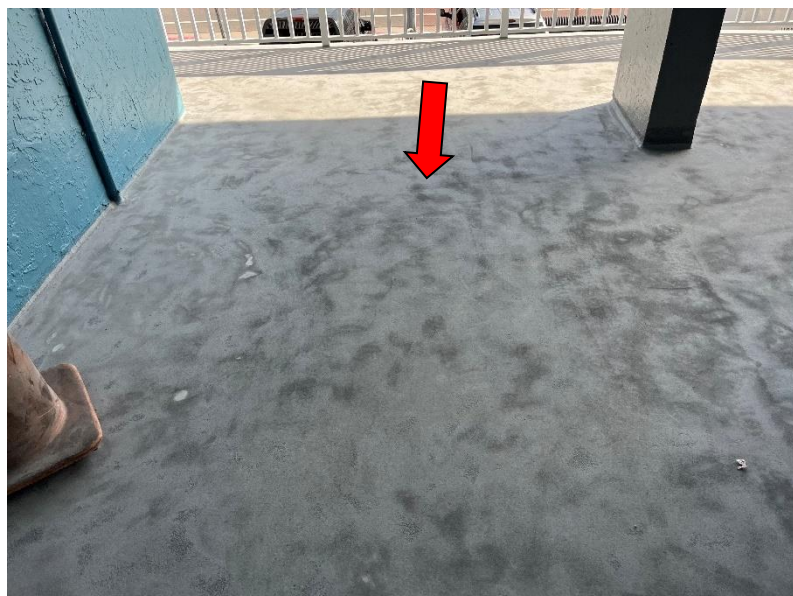
**PHOTOGRAPH #10**

**ELEVATOR LOBBY AREA  
SECOND FLOOR  
Deck Waterproofing**

Clear coat and top-coat finish stripped from recently applied deck waterproofing in preparation for Gemstone finish application.

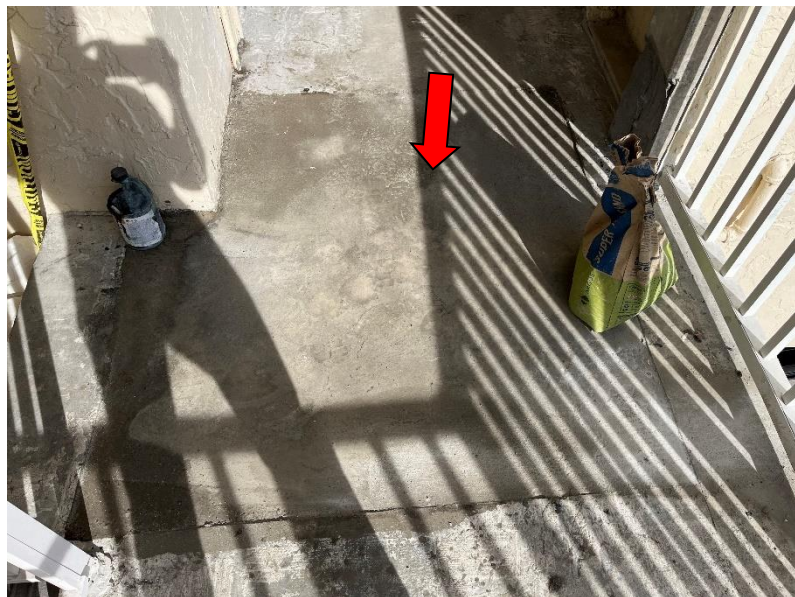
**PHOTOGRAPH #11**

**SOUTH END WALKWAYS  
SECOND FLOOR  
Concrete Damage**

MasterEmaco 1061 applied at concrete damaged areas along the walkways.

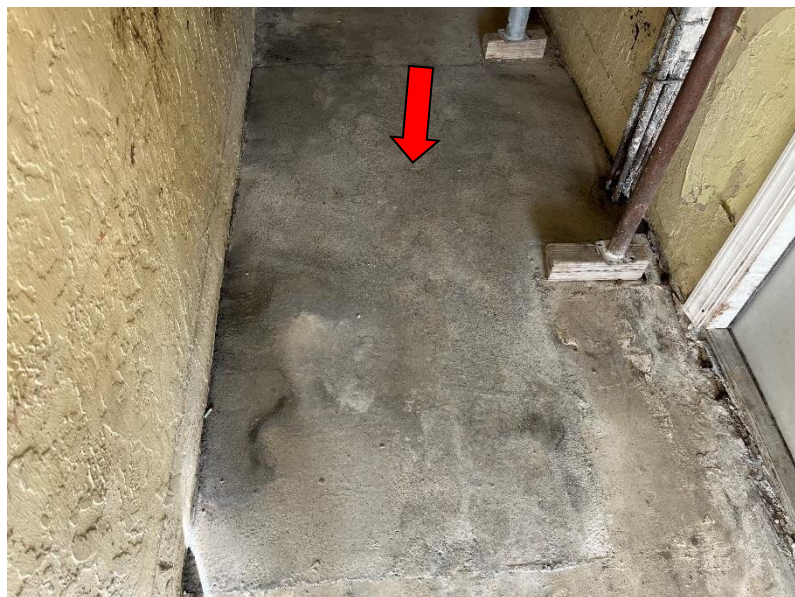
**PHOTOGRAPH #12**

**SOUTH END WALKWAYS  
SECOND FLOOR  
Concrete Damage**

MasterEmaco 1061 applied at concrete damaged areas along the walkways.

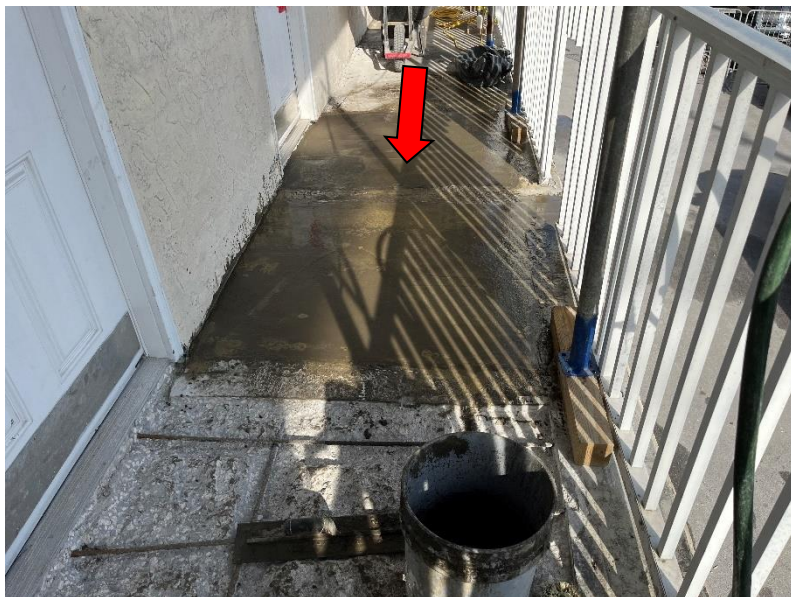
**PHOTOGRAPH #13**

**SOUTH END WALKWAYS  
SECOND FLOOR  
Concrete Damage**

MasterEmaco 1061 applied at concrete damaged areas along the walkways.

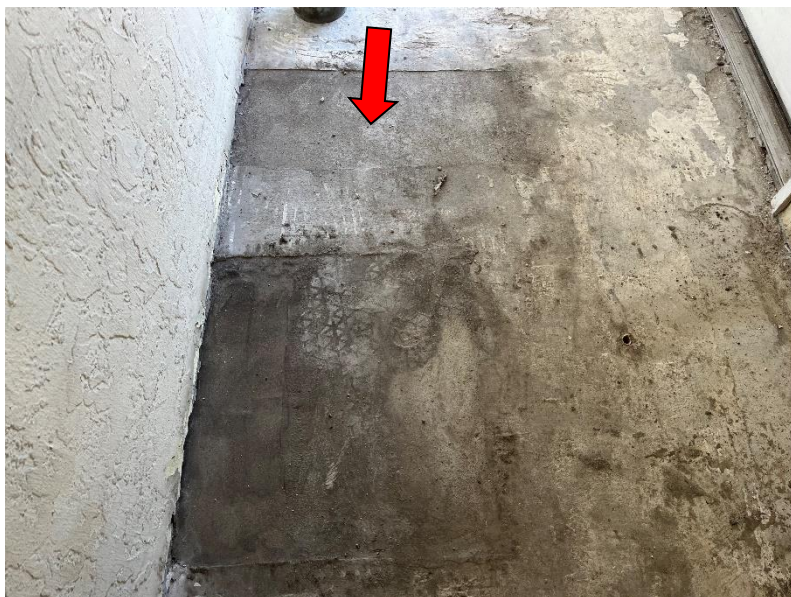
**PHOTOGRAPH #14**

**SOUTH END WALKWAYS  
SECOND FLOOR  
Concrete Damage**

MasterEmaco 1061 applied at concrete damaged areas along the walkways.

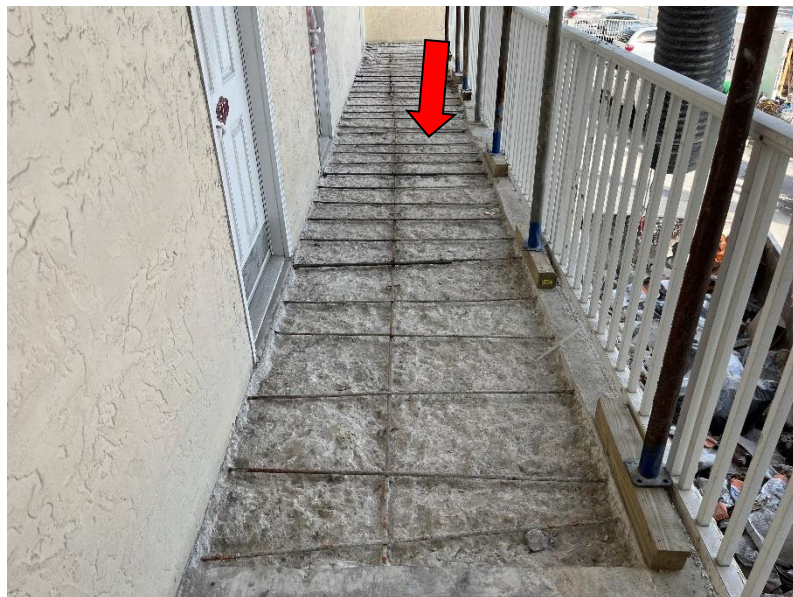
**PHOTOGRAPH #15**

**SOUTH END WALKWAYS  
SECOND FLOOR  
Concrete Damage**

Debonded concrete chipped and removed, exposing rusted reinforcing steel.

2. Sister an additional #5 rebar to existing rebar, with significant section loss, as per project manual (**See previous report**).
3. Perform concrete repairs to concrete damaged areas per the project manual and manufacturer's installation instructions (**Photos #15, #16, #17, #18, #19, see previous report**).

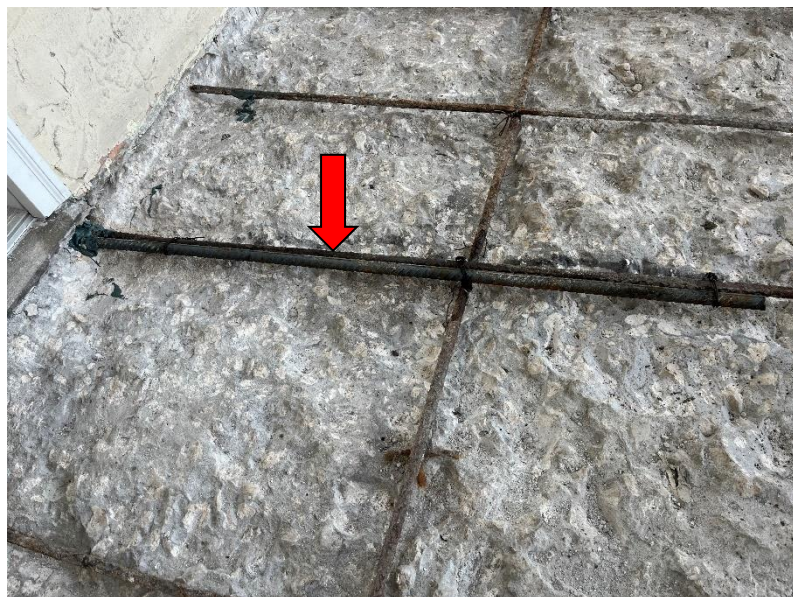
**PHOTOGRAPH #16**

**SOUTH END WALKWAYS  
SECOND FLOOR  
Concrete Damage**

#5 rebar epoxy doweled into concrete slab and sistered to damaged existing rebar as per drawings.

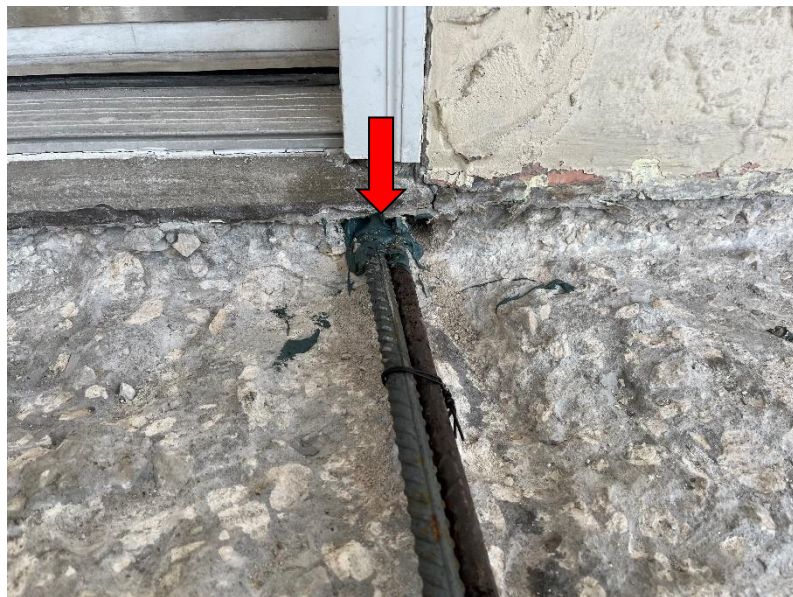
**PHOTOGRAPH #17**

**SOUTH END WALKWAYS  
SECOND FLOOR  
Concrete Damage**

#5 rebar epoxy doweled into concrete slab and sistered to damaged existing rebar as per drawings.

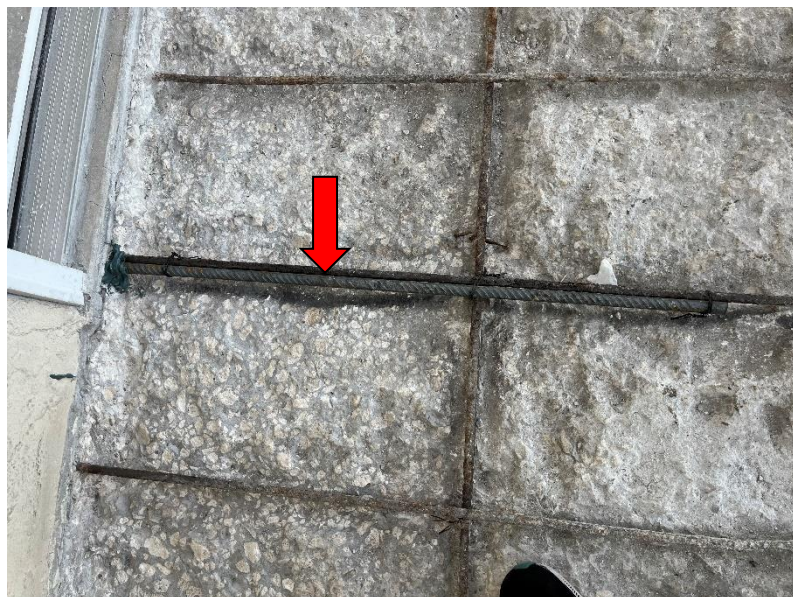
**PHOTOGRAPH #18**

**SOUTH END WALKWAYS  
SECOND FLOOR  
Concrete Damage**

#5 rebar epoxy doweled into concrete slab and sistered to damaged existing rebar as per drawings.

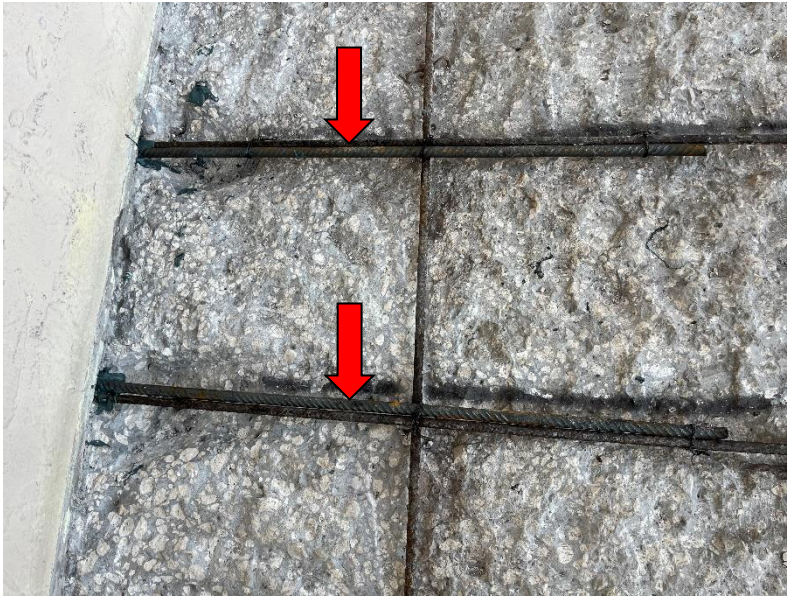
**PHOTOGRAPH #19**

**SOUTH END WALKWAYS  
SECOND FLOOR  
Concrete Damage**

#5 rebar epoxy doweled into concrete slab and sistered to damaged existing rebar as per drawings.

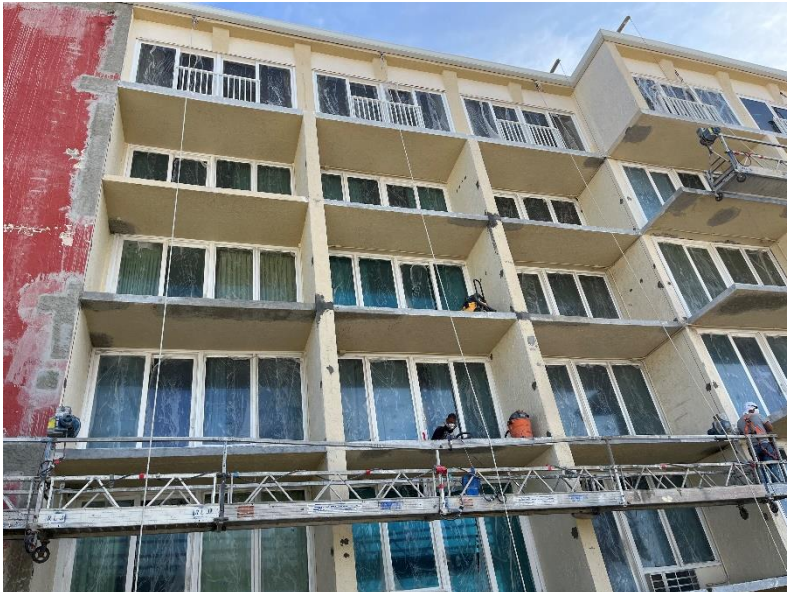
**PHOTOGRAPH #20**

**SOUTH END REAR BALCONIES  
Concrete Damage**

Post pocket cores currently being drilled and balcony concrete decks currently being scarified and smoothed out in preparation for deck waterproofing application.

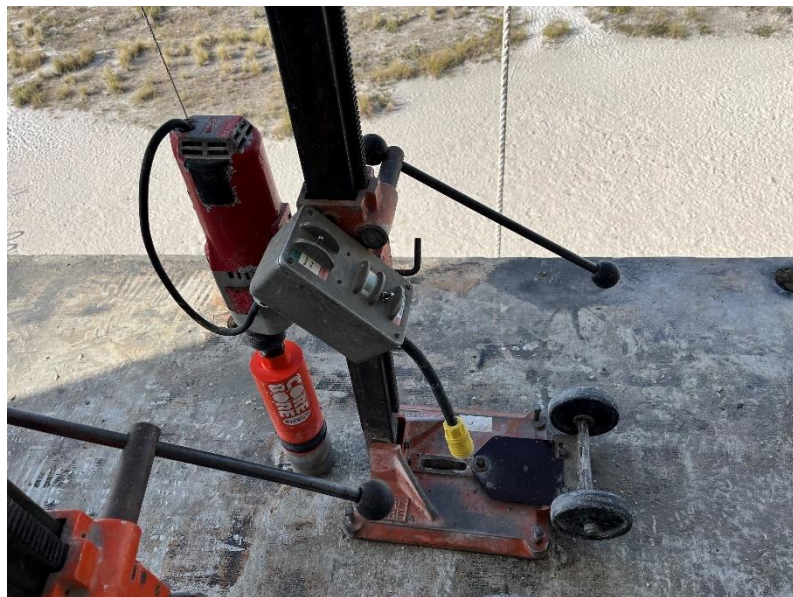
**PHOTOGRAPH #21**

**SOUTH END REAR BALCONIES  
UNIT #523  
Post Pocket Cores**

Core drill used to core post pockets along rear balcony concrete slabs.

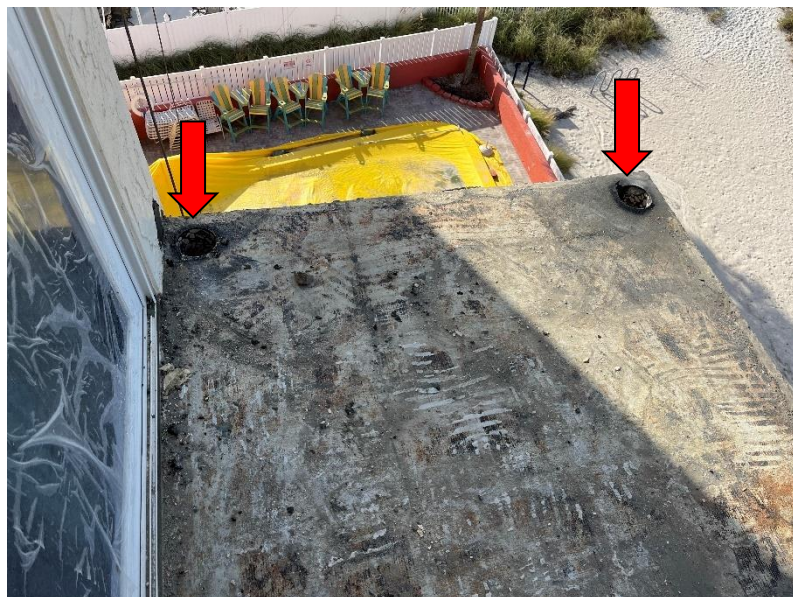
**PHOTOGRAPH #22**

**SOUTH END REAR BALCONIES  
UNIT #523  
Post Pocket Cores**

Core drill used to core post pockets along rear balcony concrete slabs.

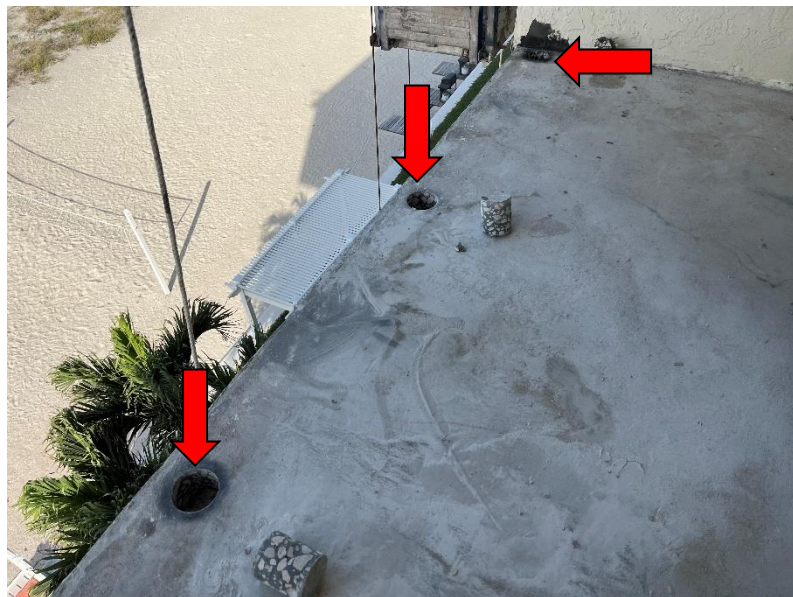
**PHOTOGRAPH #23**

**SOUTH END REAR BALCONIES  
UNIT #521  
Post Pocket Cores**

Core drill used to core post pockets along rear balcony concrete slabs.

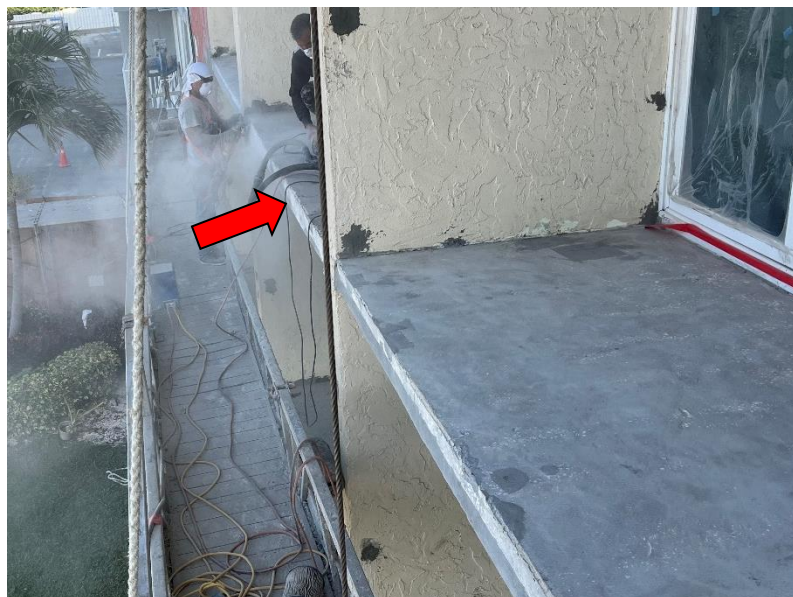
**PHOTOGRAPH #24**

**SOUTH END REAR BALCONIES  
THIRD FLOOR  
Slab Edge**

Existing stucco finish currently being stripped from the balcony slab edges.
